REPORT OF PETROGRAPHIC EXAMINATION

Date: July 15, 2005

Re: Petrographic Examination of Concrete Curb and Gutter Samples

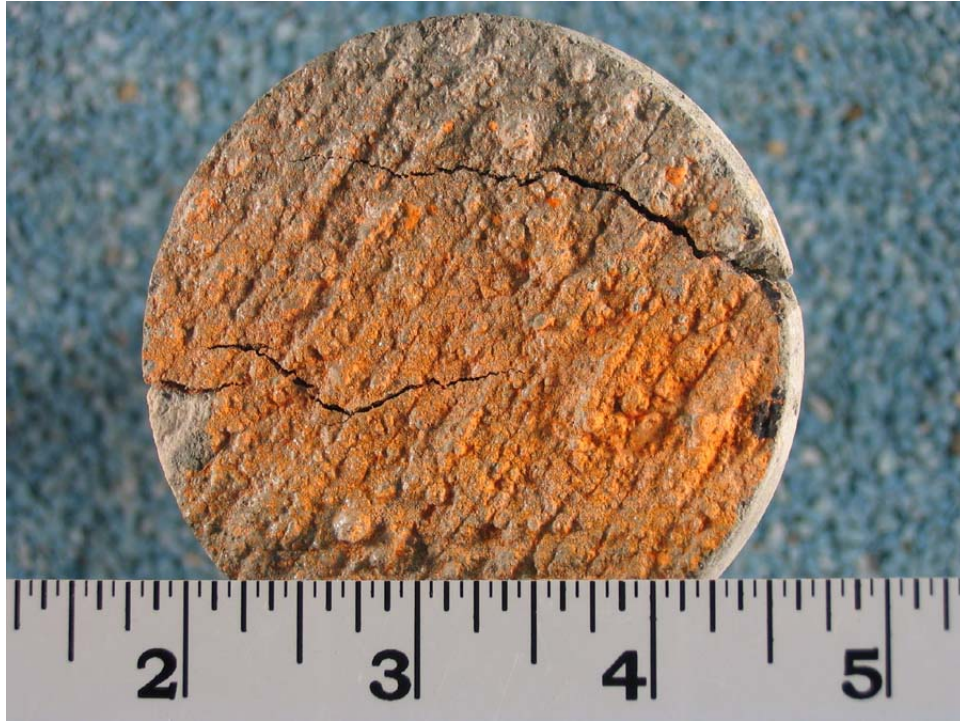
Fig. 1 Top surface of core sample, as received.

Top Surface: Broom-finished surface exhibits discontinuous cracks.

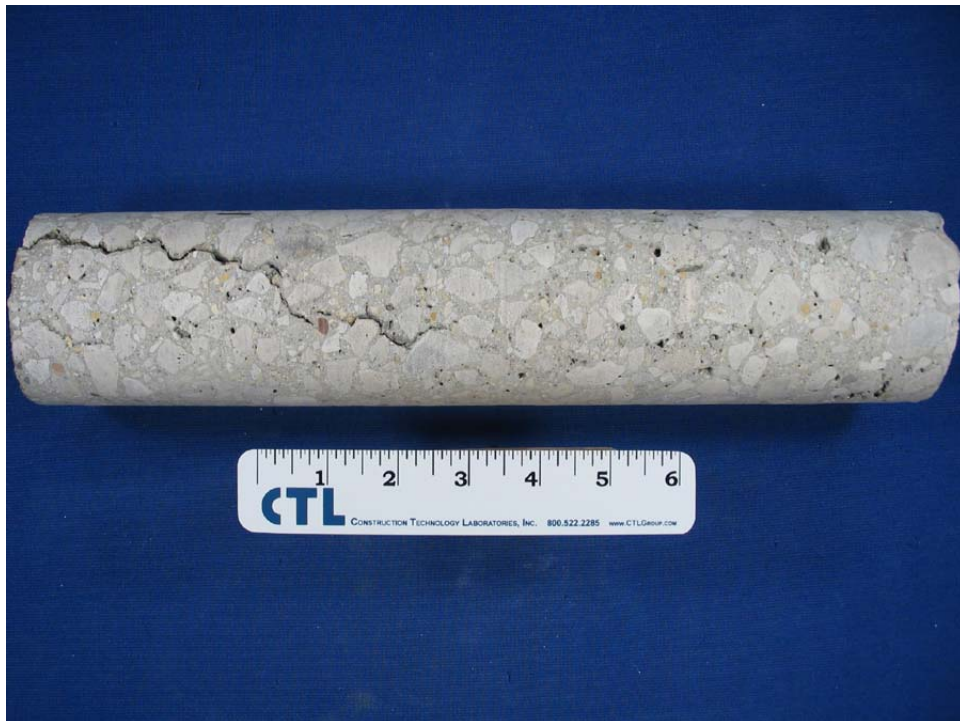
Fig. 2 Side view of core sample, as received. Top surface is to the left.

Cracks, Joints or Large Voids: A few discontinuous cracks observed on core top surface extend nearly vertically to depths as much as 9.7 in., and passing around aggregate particles. No joints or unusually large voids observed.

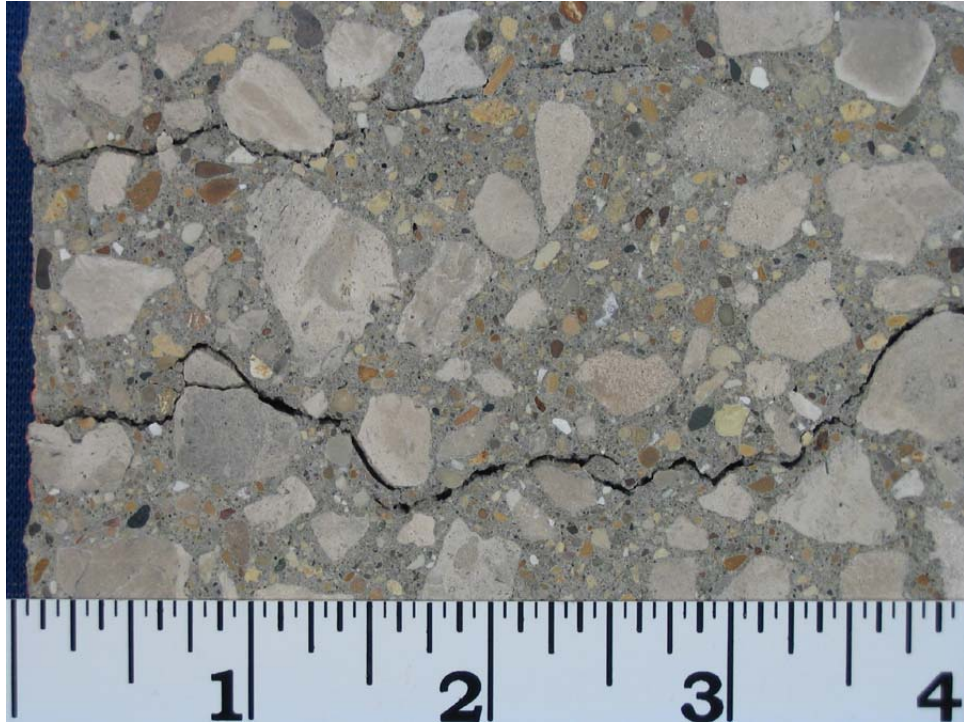
3a. Lapped surface.

Based on petrographic findings, the general nature and characteristics of the cracks strongly suggests they occurred while the concrete was still plastic. The cracks (Fig. 3) are discontinuous, pass around aggregate particles and do not extend full gutter thickness (9.7-in. depth). The cracks are not straight or sharp, as would be expected if cracking occurred at a later age (while the concrete was in the hardened state). A definitive cause for the observed cracks is not determined, although the cracks do not appear to be materials related. A site visit by an engineer is recommended to confirm joint spacing and establish a map of the overall crack pattern to assist in determining a definitive cause for the early-age cracking.

Fig. 3 Photomicrograph of near-surface concrete showing the crack(s).

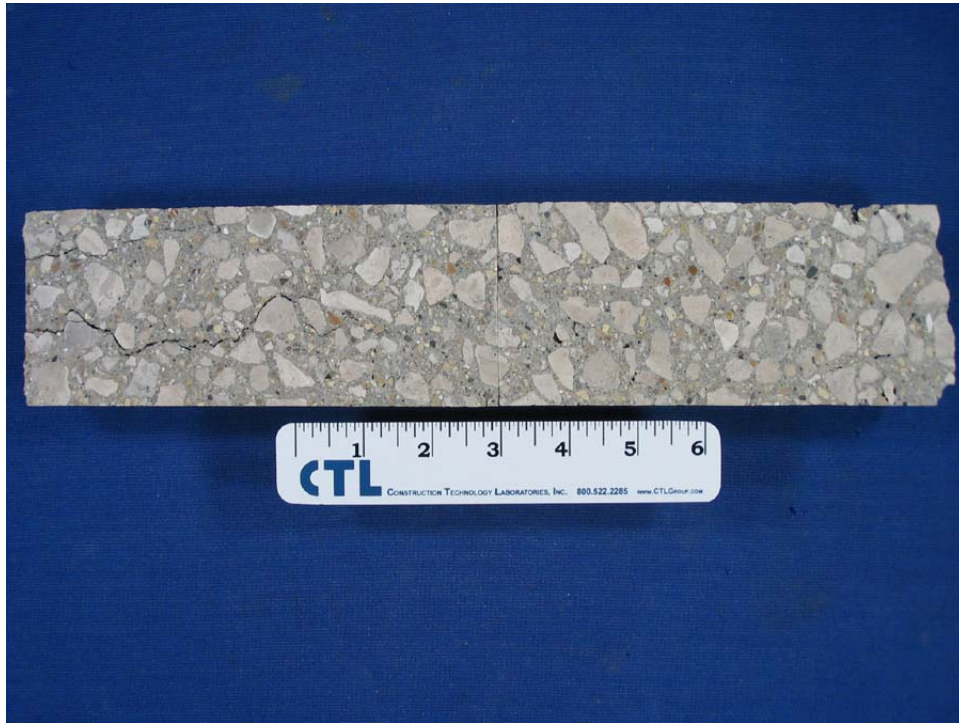
The concrete was produced using a relatively well-graded, ¾-in. top size, crushed limestone coarse aggregate and a natural sand fine aggregate dispersed fairly uniformly (Fig. 4) in a air-entrained, portland-cement paste. No supplementary cementitious materials, such as fly ash, are observed in the hardened paste matrix. The concrete is well consolidated.

Fig. 4 Lapped cross-section of the core sample showing the general appearance and condition of the concrete. Top surface is to the left.
