CONCISE REPORT

REPORT OF PETROGRAPHIC EXAMINATION

Re: Petrographic Examination of Concrete Curb and Gutter Samples

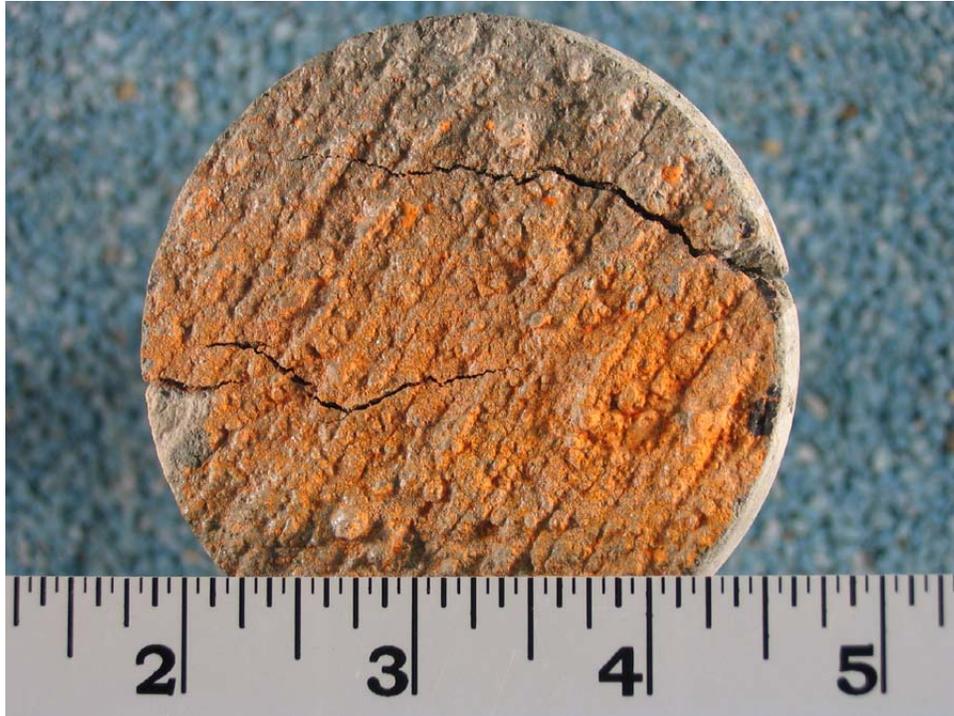
Fig. 1 Top surface of core sample, as received.

Top Surface: Broom-finished surface exhibits discontinuous cracks.

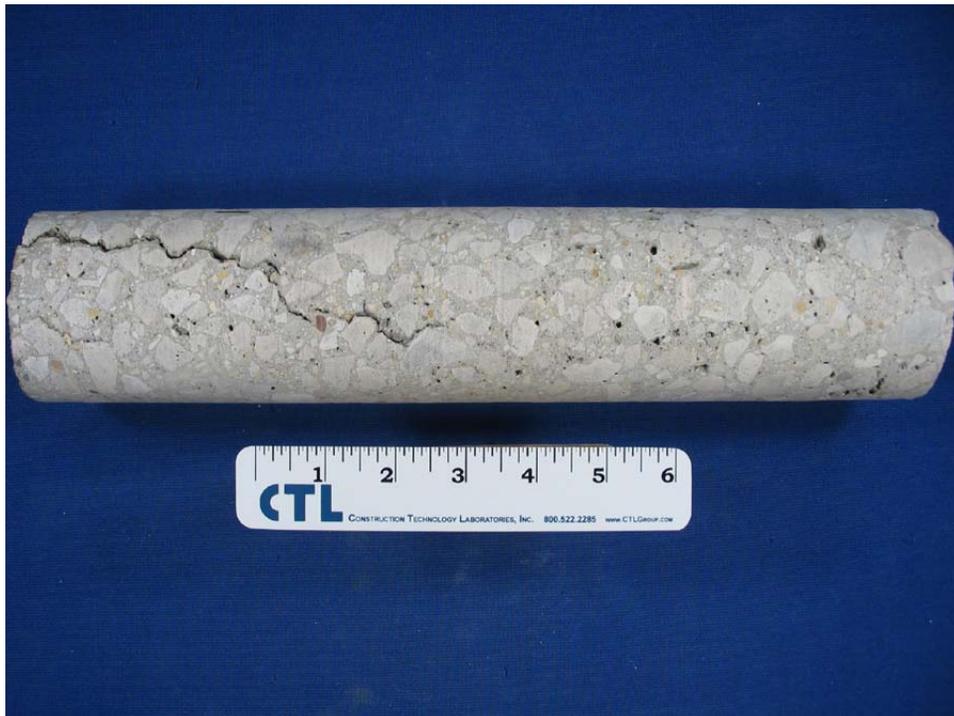
Fig. 2 Side view of core sample, as received. Top surface is to the left.

Cracks, Joints or Large Voids: A few discontinuous cracks observed on core top surface extend nearly vertically to depths as much as 9.7 in., and passing around aggregate particles. No joints or unusually large voids observed.

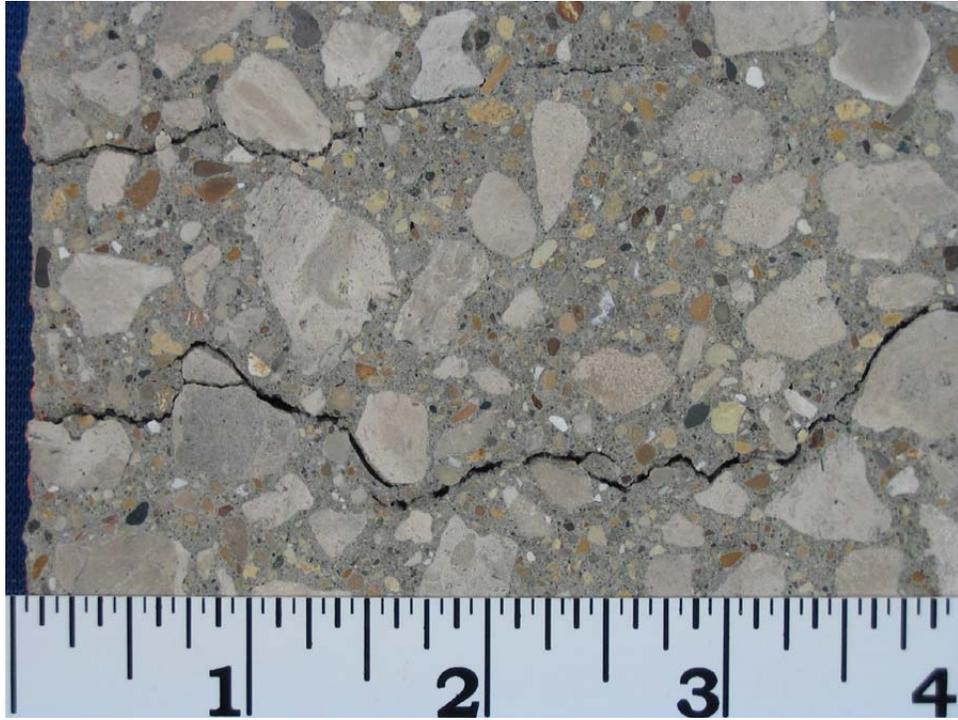
Based on petrographic findings, the general nature and characteristics of the cracks strongly suggests they occurred while the concrete was still plastic. The cracks (Fig. 3) are discontinuous, pass around aggregate particles and do not extend full gutter thickness (9.7-in. depth). The cracks are not straight or sharp, as would be expected if cracking occurred at a later age (while the concrete was in the hardened state). A definitive cause for the observed cracks is not determined, although the cracks do not appear to be materials related. A site visit by an engineer is recommended to confirm joint spacing and establish a map of the overall crack pattern to assist in determining a definitive cause for the early-age cracking.

3a. Lapped surface.

Fig. 3 Photomicrograph of near-surface concrete showing the crack(s).

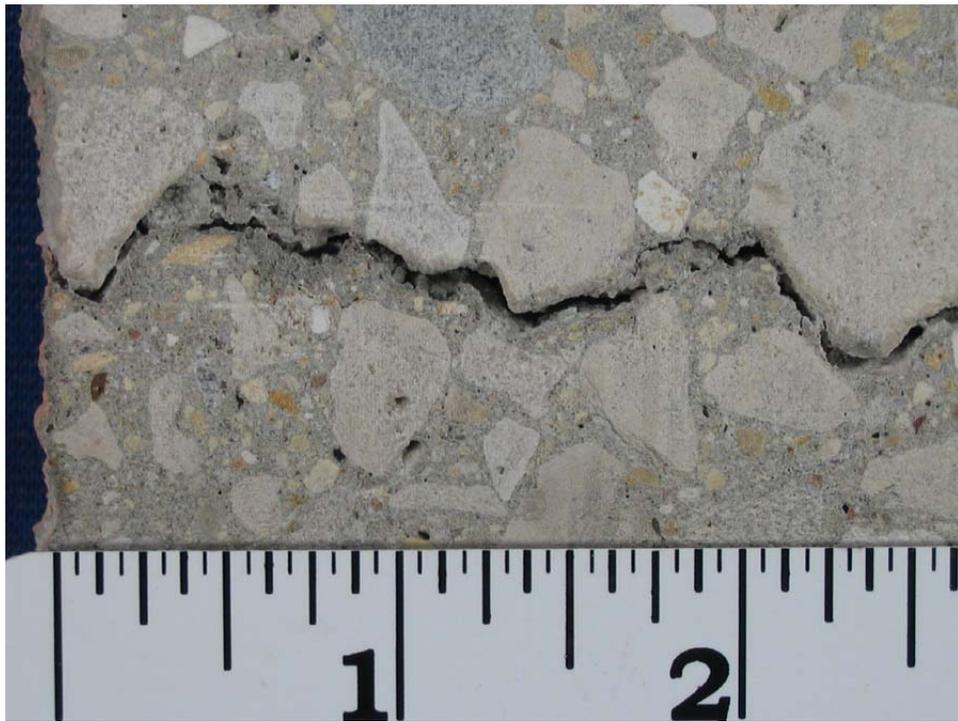
3b. Cored cylindrical surface

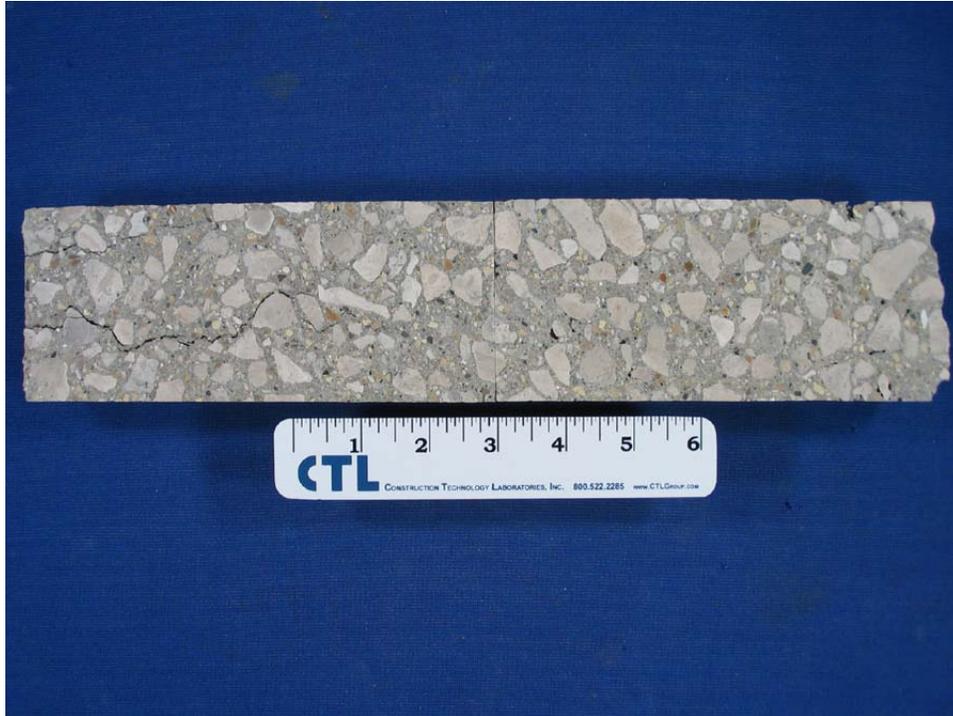
The concrete was produced using a relatively well-graded, ¾-in. top size, crushed limestone coarse aggregate and a natural sand fine aggregate dispersed fairly uniformly (Fig. 4) in a air-entrained, portland-cement paste. No supplementary cementitious materials, such as fly ash, are observed in the hardened paste matrix. The concrete is well consolidated.

Fig. 4 Lapped cross-section of the core sample showing the general appearance and condition of the concrete. Top surface is to the left.
