GE Hitachi Nuclear Energy

June 6, 2012
MFN 12-006 R1

**Subject: Part 21 60-Day Interim Report Notification - Closure:
Failure of CRD Collet Retainer Tube/Outer Tube Weld**

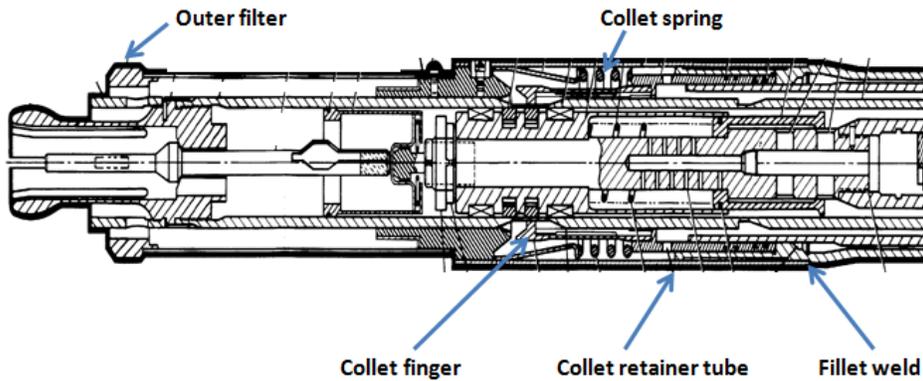
The fillet weld design in question is applicable to all 919D258G002 and G003 Cylinder, Tube and Flange assemblies since the collet retainer tube material, configuration and fillet weld design are the same for both groups. This fillet weld is located on the Outer Tube Assembly and is part of the Cylinder, Tube and Flange (CTF) assembly of the CRD mechanism.

The G003 CTF containing the failed fillet weld was removed from service in 2011. The collet retainer tube axial displacement was observed to be 0.15 inches. The observed displacement is bounded by two dimensions for potential movement of the collet retainer tube:

1. Per drawing dimensions, after separation, the collet retainer tube could displace a nominal axial distance of ~1.3 inches, before the top of the CRD outer filter would stop against the bottom of the control rod guide tube base.
2. After separation, an axial displacement of ~1 inch would result in the collet spring, which is maintained in a compressed state per design requirements, returning to its free-length state. The collet spring in its free-length state would restrict the collet fingers from deflecting outward and clearing of the index tube notches.
