SUBJECT: PALISADES NUCLEAR PLANT – SUMMARY OF CONFERENCE CALL  
REGARDING THE SPRING 2012 STEAM GENERATOR INSPECTIONS  
(TAC NO. ME8129)

## CONFERENCE CALL SUMMARY

### PALISADES NUCLEAR PLANT SPRING 2012 (1R22) OUTAGE STEAM GENERATOR

## **STEAM GENERATOR TUBE INSPECTION DISCUSSION DURING PALISADES 2012 (1R22) OUTAGE**

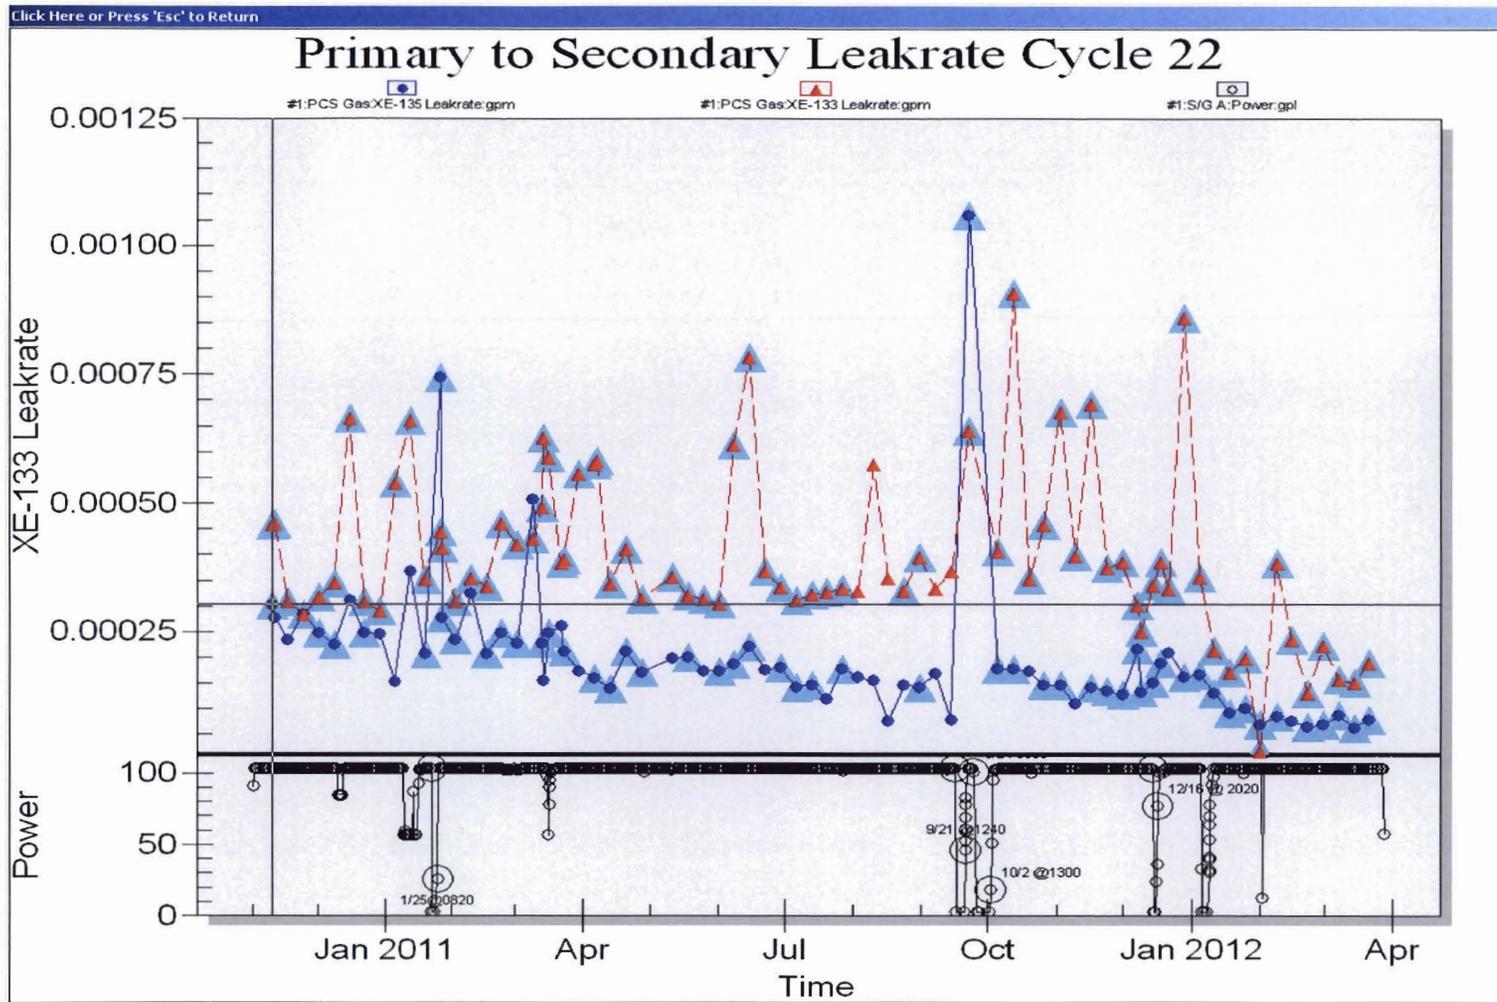
Refer to attached Primary to Secondary Leak Rate for Operational Cycle 22 Primary to Secondary Leak Rate graph. Leakage has been minimal all cycle
