Subject: Duke Energy Carolinas, LLC (Duke Energy) McGuire Nuclear Station, Units 1 and 2 Docket Nos. 50-369 and 50-370 Relief Request Serial # 11-MN-001, Response to Request for Additional Information on Limited Weld Examinations for Refueling Outages 1EOC20 and 2EOC19

Relief Request 11-MN-001 Request for Additional information (RAI)

1EOC-20 and 2EOC-19 Limited Weld Exam Third interval 10 Year ISI

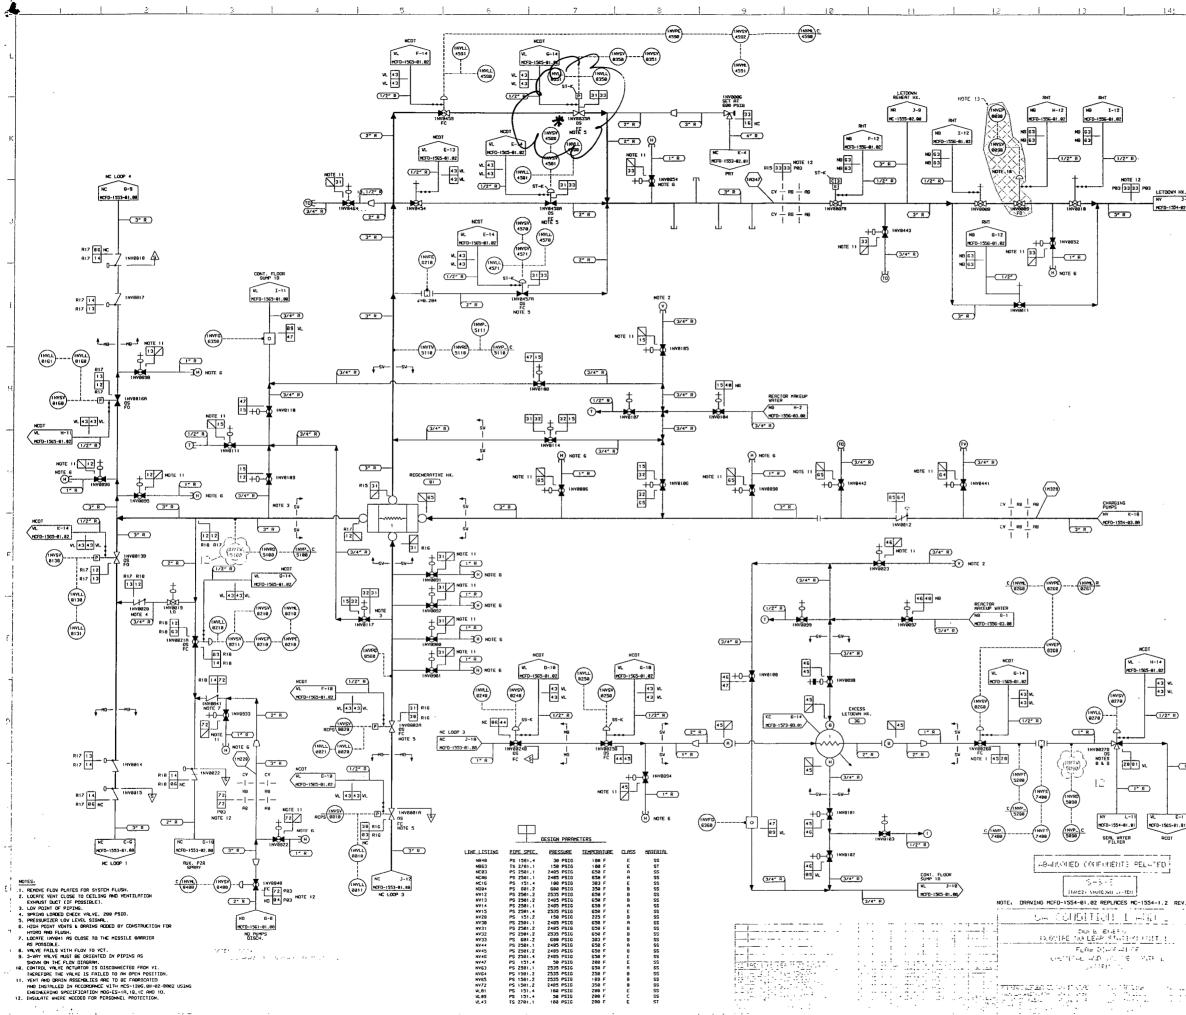
Attachment Number 1;

Duke Energy Response: The one weld associated with these sections that connects to a component fabricated from cast stainless steel is listed in Section #4 (weld #1NV1FW53-27). The specific component fabricated from cast stainless steel material (ASME SA 351 Grade CF8M) is valve 1NV-35A.

McGuire Flow Diagram MCFD-1554-01.02 rev 11 with weld location identified for Section 4 weld #1NV1FW53-27:

ATTACHMENT # 1 LETDOWN HCFD-1554-82.88 WELD LOCATION SECTION #4 TO 11-MN-001 RAI \* WIT 1 - NV1FW-53-27 VL · H-14 HDFD-1565-01.02 43 VL 43 VL (1/2" R) (1°R)
