UNITED STATES  
NUCLEAR REGULATORY COMMISSION  
OFFICE OF NUCLEAR REACTOR REGULATION  
OFFICE OF NEW REACTORS  
OFFICE OF NUCLEAR MATERIAL SAFETY AND SAFEGUARDS  
WASHINGTON, DC 20555-0001

August 9, 2012

NRC INFORMATION NOTICE 2012-15: USE OF SEAL CAP ENCLOSURES TO MITIGATE  
LEAKAGE FROM JOINTS THAT USE A-286  
BOLTS

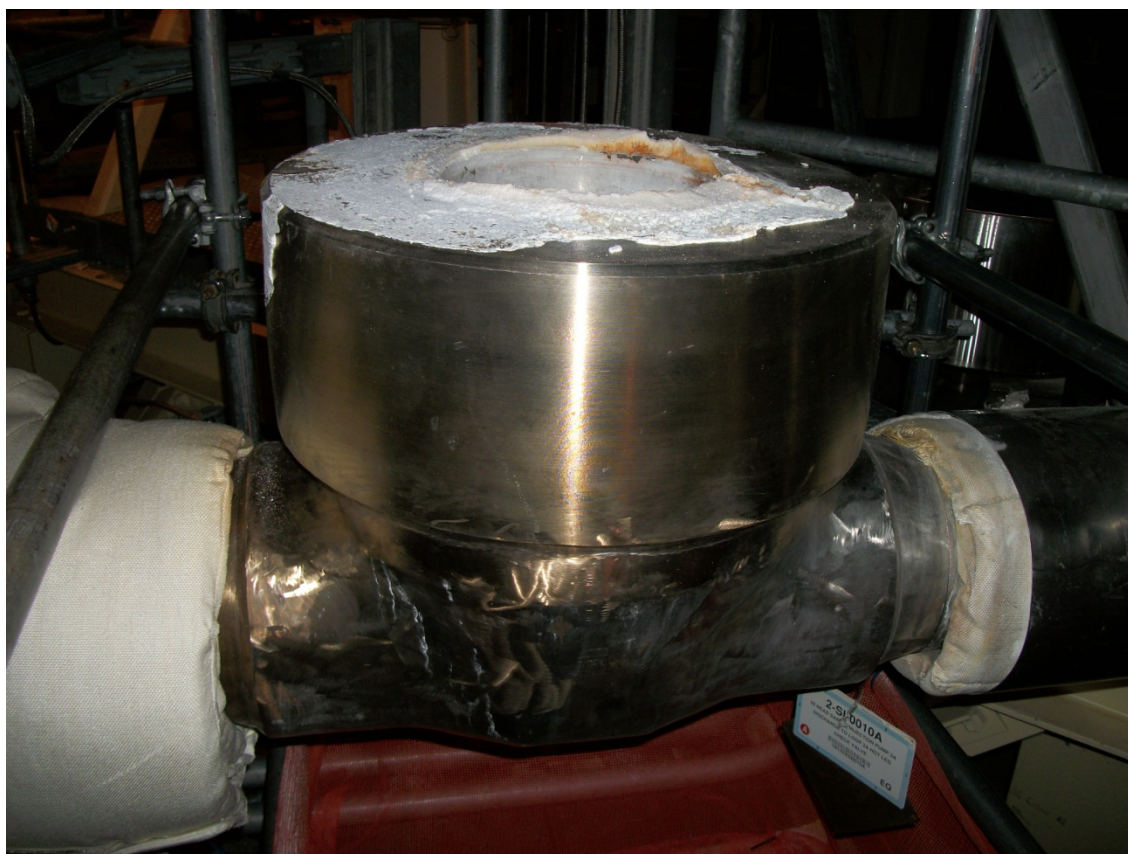
**Figure 2: Photo of the enclosure**

During the October 2011 refueling outage, the licensee identified water and boric acid crystals on the outside surface of the enclosure and on the valve bonnet (Figure 2). The licensee performed liquid penetrant testing and identified flaws on the weld joining the enclosure to the bonnet. Subsequently, the licensee repaired the fillet weld.
