UNITED STATES  
NUCLEAR REGULATORY COMMISSION  
OFFICE OF NUCLEAR REACTOR REGULATION  
OFFICE OF NEW REACTORS  
OFFICE OF NUCLEAR MATERIAL SAFETY AND SAFEGUARDS  
WASHINGTON, DC 20555-0001

August 9, 2012

NRC INFORMATION NOTICE 2012-15: USE OF SEAL CAP ENCLOSURES TO MITIGATE  
LEAKAGE FROM JOINTS THAT USE A-286  
BOLTS

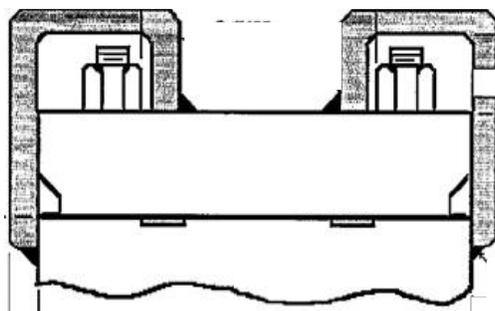
**Figure 1: Diagram of the enclosure**

In February 1997, South Texas Project Nuclear Operating Company (STPNOC) discovered steam wisping from the body-to-bonnet gasket of a swing check valve located in the 8-inch nominal diameter safety injection piping at South Texas Project, Unit 2 (STP-2). This valve is constructed from an austenitic stainless steel body (SA182, Type 316) and bonnet (SA240, Type 316) joined using type A-286 bolts. As a corrective action, the licensee welded a metal enclosure over the bonnet and the studs of the check valve to mitigate the leakage (Figure 1). This enclosure is designed to contain leakage only; it is welded to, but not part of, the reactor coolant system pressure boundary.

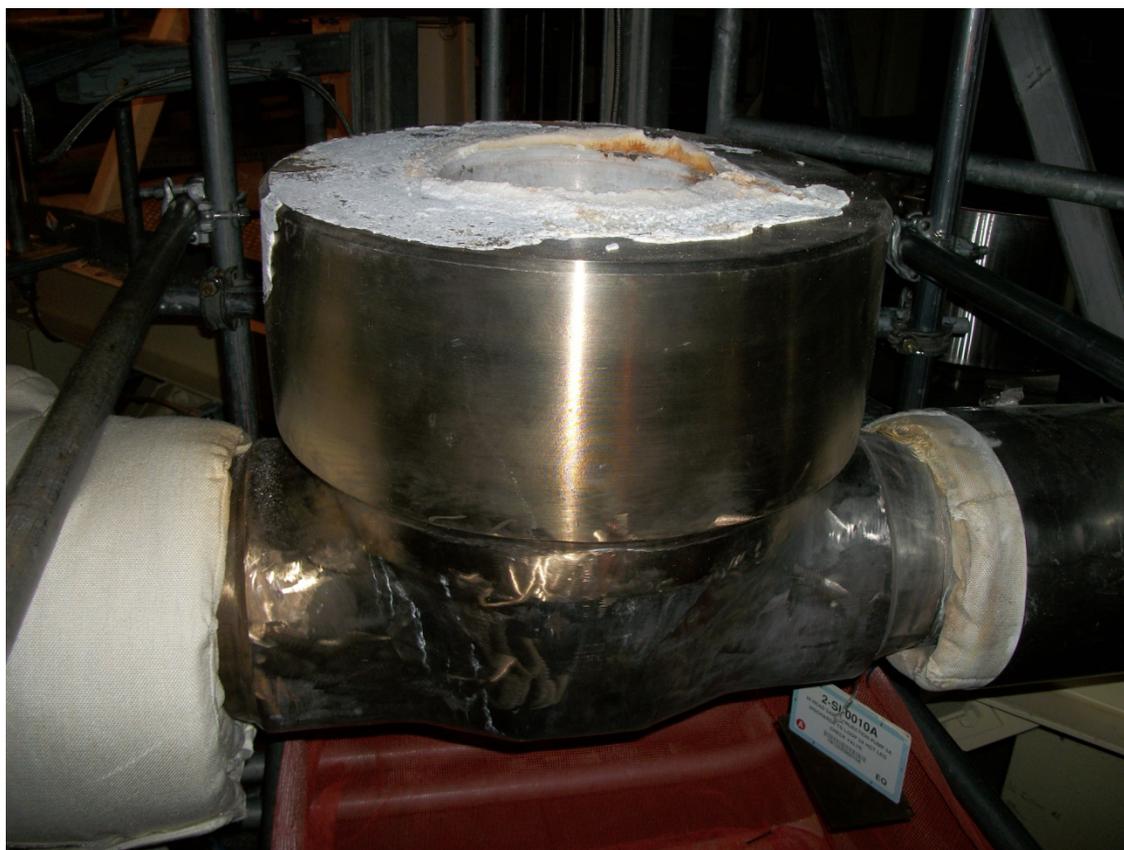
**Figure 2: Photo of the enclosure**

During the October 2011 refueling outage, the licensee identified water and boric acid crystals on the outside surface of the enclosure and on the valve bonnet (Figure 2). The licensee performed liquid penetrant testing and identified flaws on the weld joining the enclosure to the bonnet. Subsequently, the licensee repaired the fillet weld.

In April 2012, the licensee again found boric acid crystals in the weld joining the enclosure to the bonnet. Subsequently, the licensee removed the enclosure on the check valve and performed ultrasonic and visual examinations of the bolts. It did not find any degradation on the bolts. The enclosure was subsequently reinstalled. Permanent repair of the valve and removal of the enclosure are currently scheduled for the next refueling outage planned in 2013.
