POEF-2086
ORNL/TM-11988

**Investigation of Breached Depleted
UF₆ Cylinders**

Date Published: September 1991

Prepared by the
OAK RIDGE NATIONAL LABORATORY
and
URANIUM ENRICHMENT
Oak Ridge, Tennessee 37831-6285
managed by
MARTIN MARIETTA ENERGY SYSTEMS, INC.
for the
U.S. DEPARTMENT OF ENERGY
under contract DE-AC05-84OR21400 and
DE-AC05-76OR00001

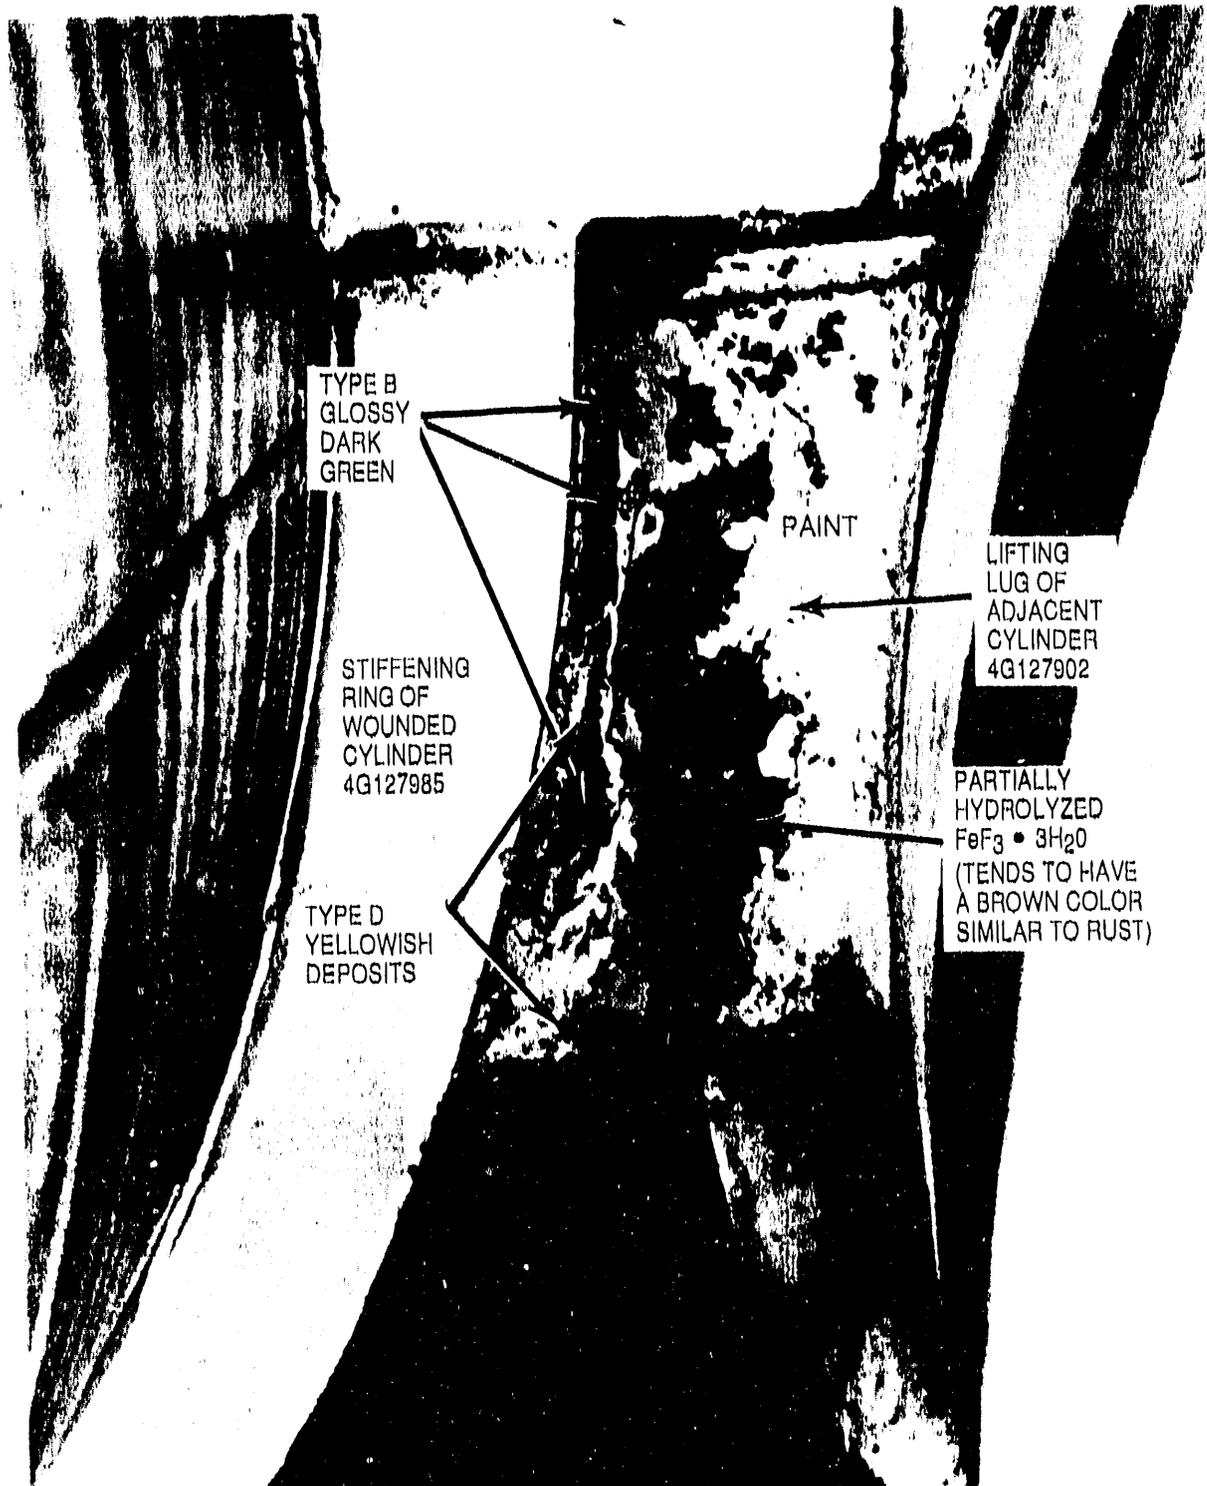
Fig. B1.1. Location of materials taken from surface of stiffening ring of cylinder 4G127985 and lifting lug of cylinder 4G127902. Photograph taken before separation of the cylinders. The hole is just above the longitudinal weld and on the other side of the stiffening ring.

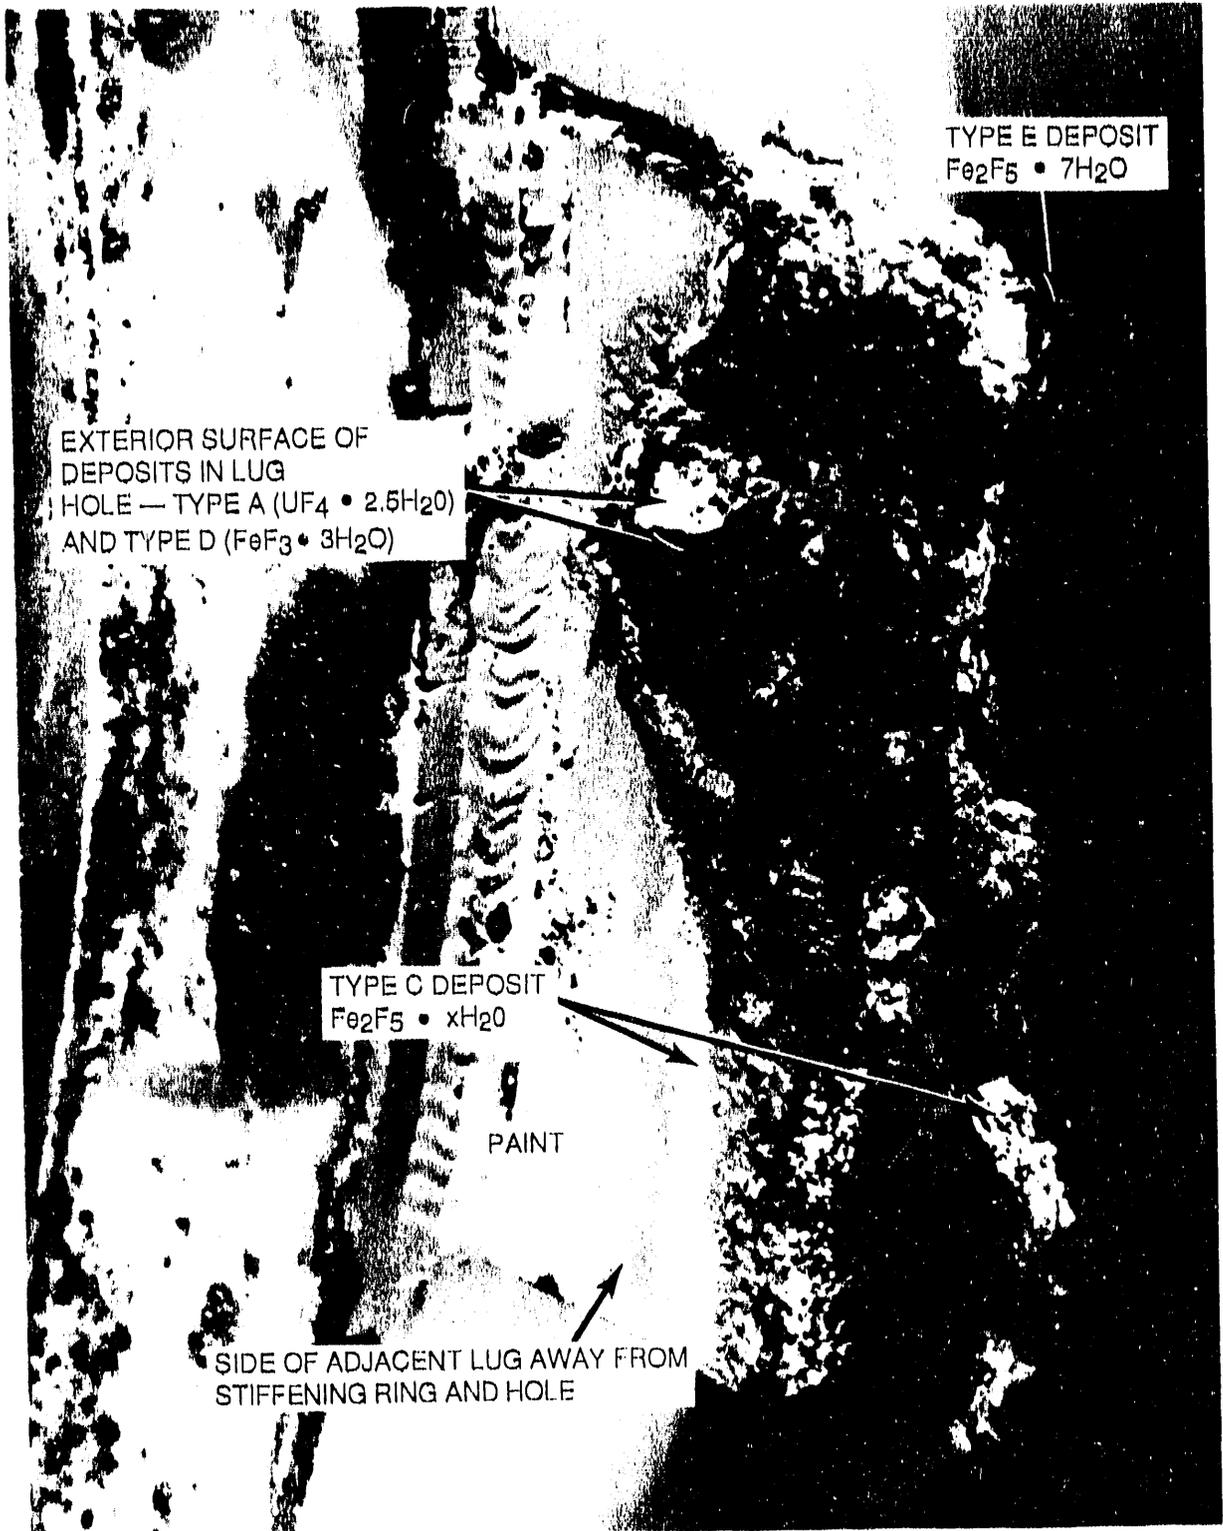
Fig. B1.2. Location of various materials in the lifting lug of cylinder 4G127902 as seen from the side away from the stiffening ring of cylinder 4G127985 after separation from cylinder 4G127985.

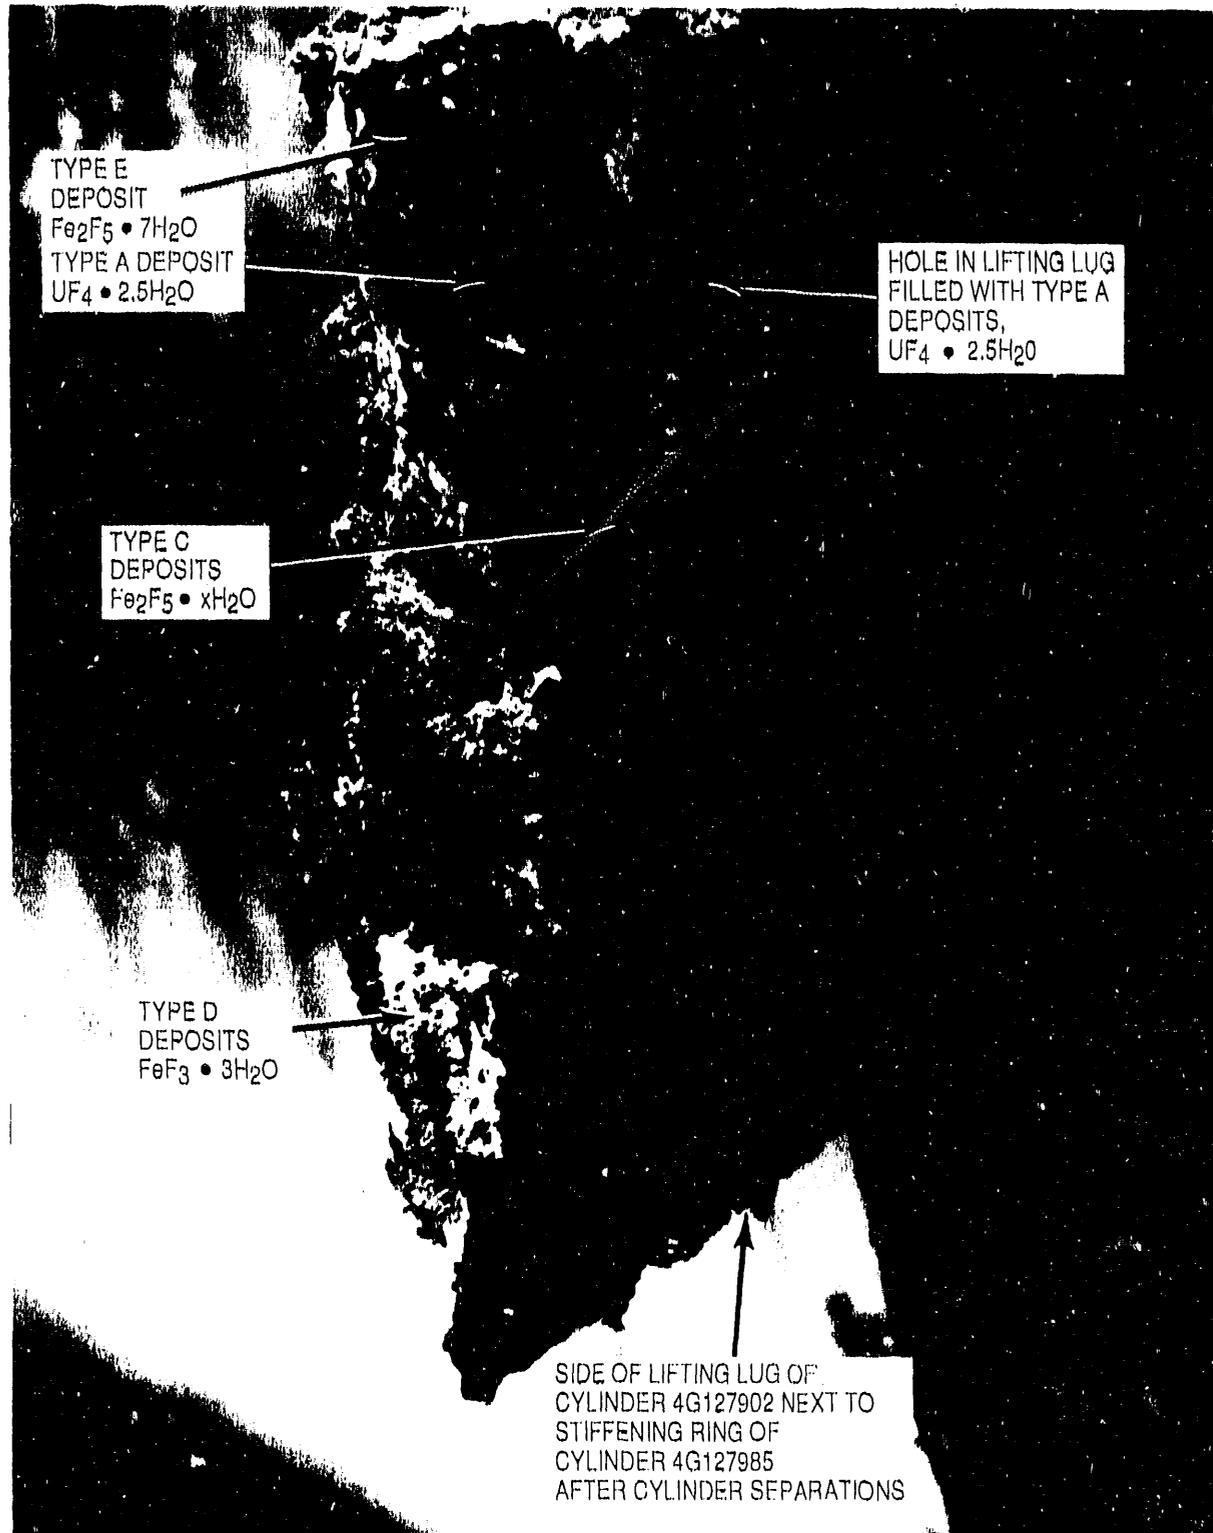
Fig. B1.3. Location of various materials on the lifting lug cylinder 4G127902 as seen from the side adjacent to the stiffening ring of cylinder 4G127985 after separation.

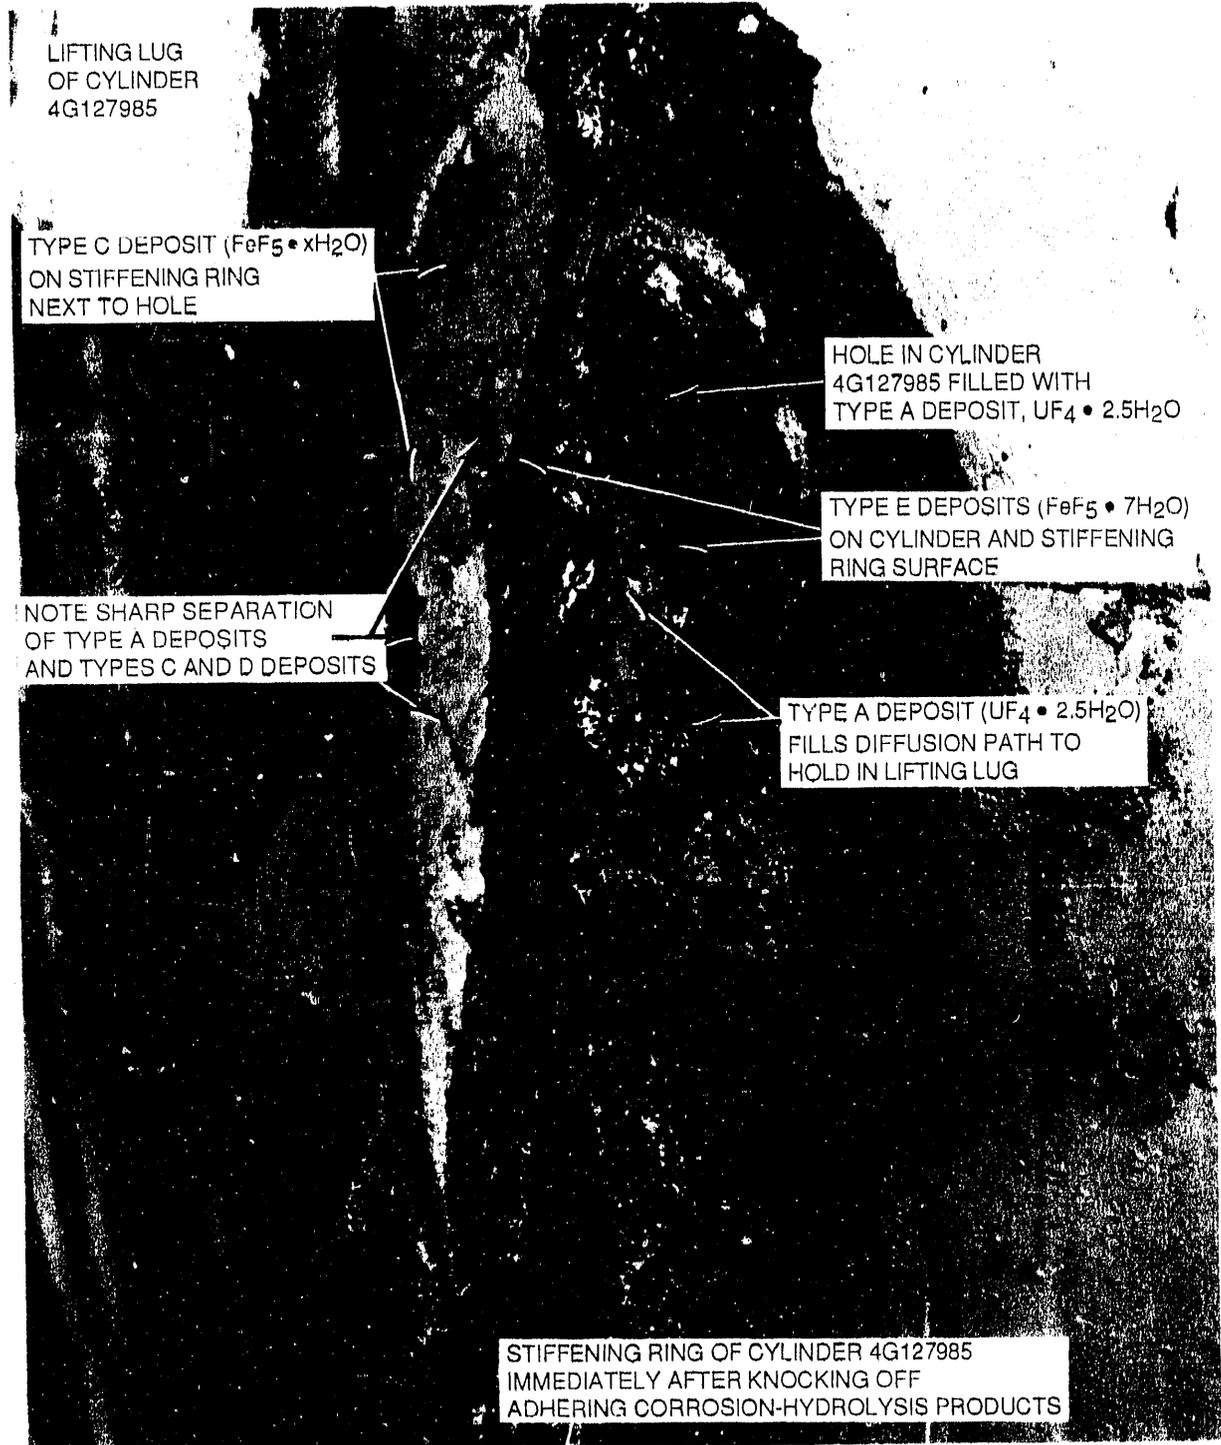
Fig. B1.5. Similar view as in Fig. B1.4 after the corrosion deposit was knocked off revealing the hole.

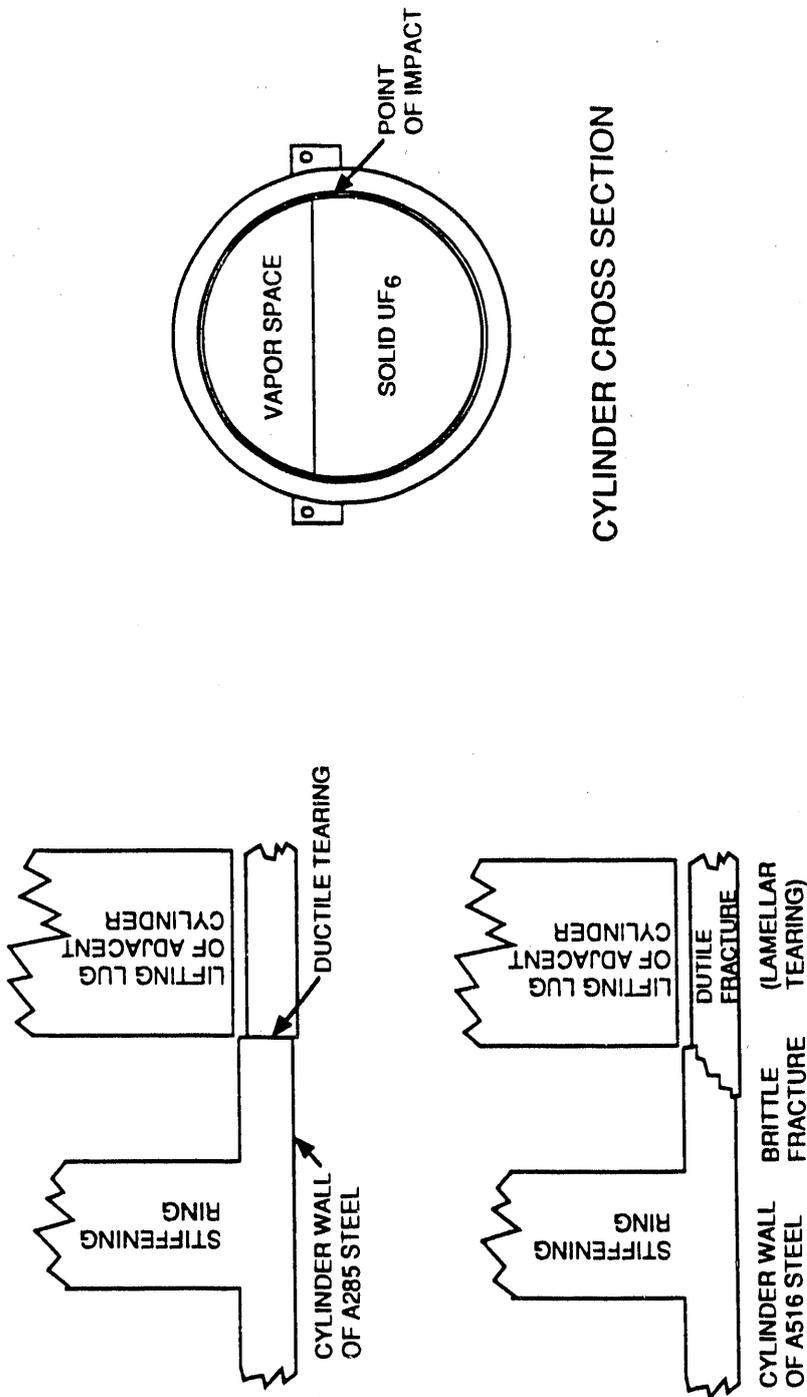
Fig. B3.4. Types of impact fractures encountered with ASTM A285 and A516 steel and the impact location experienced.
