**Subject:** Response to Nuclear Regulatory Commission Request for Additional Information  
Re: Request for Relief for the Fourth 10-Year Inservice Inspection Program (TAC  
No. ME7875)  
Cooper Nuclear Station, Docket No. 50-298, DPR-46

**Response to Nuclear Regulatory Commission Request for Additional Information  
Re: Request for Relief for the Fourth 10-Year Inservice Inspection Program  
(TAC No. ME7875)**

Cooper Nuclear Station, Docket No. 50-298, DPR-46

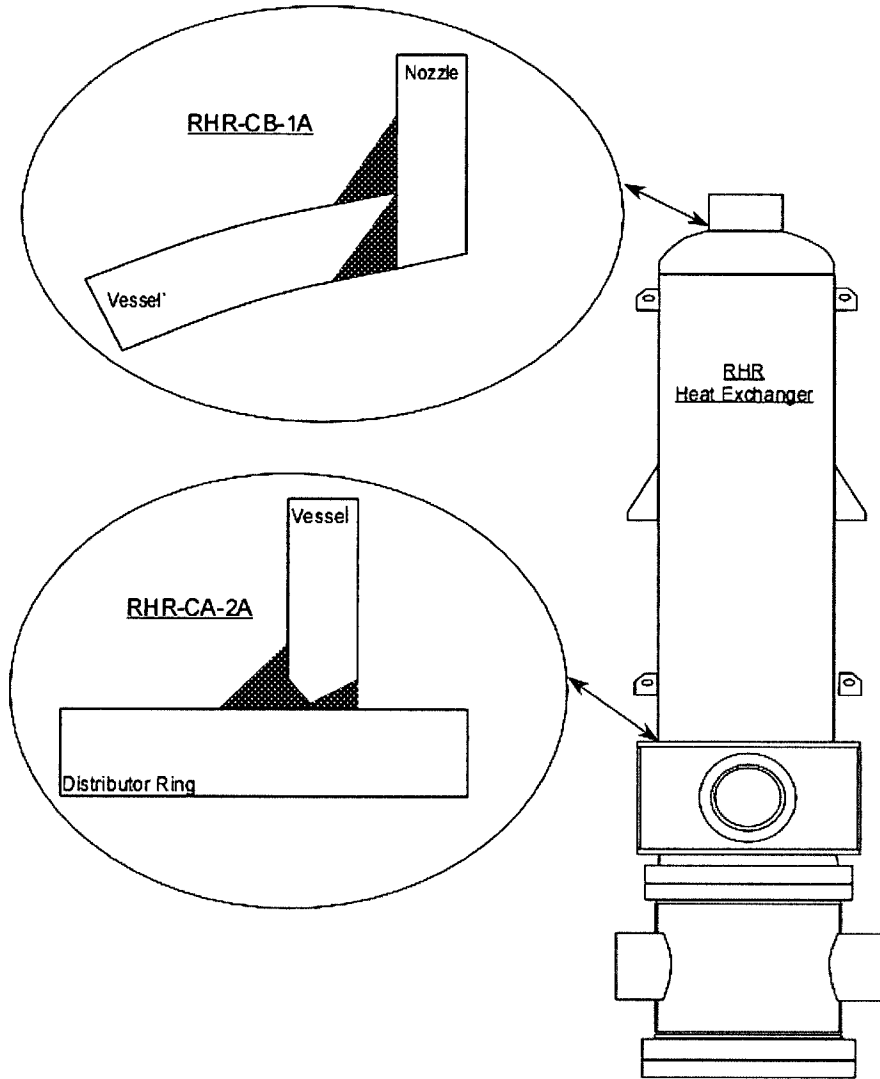
**FIGURE**

*Please provide a diagram of the residual heat removal vessel on which the examinations were performed indicating on the diagram where the welds of interest are located.*
