# DAVIS-BESSE SHIELD BUILDING CRACK

December 6, 2011

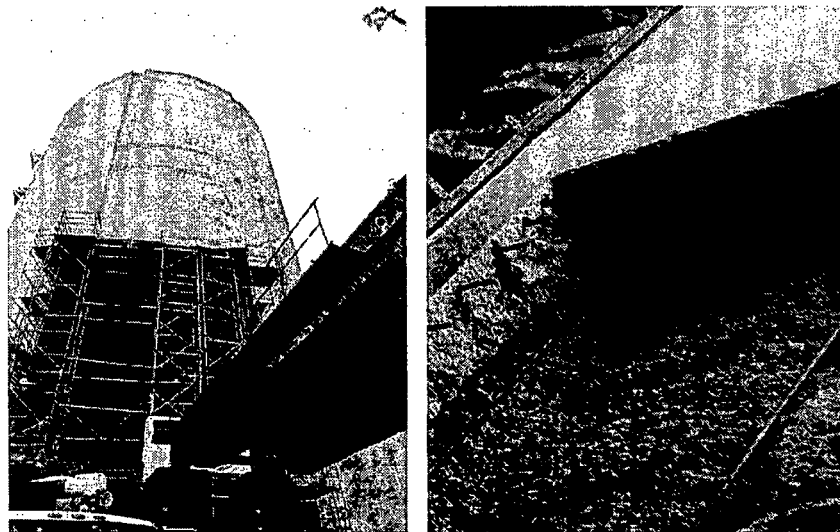
## Construction Opening

- Laminar crack identified in architectural flute shoulder area during hydro-demolition for replacement of reactor vessel closure head (October 10<sup>th</sup>)
- Crack found on the vertical side of the opening (left side, looking from the outside), generally along main reinforcing steel, and extends ~6' across the top and ~4' across the bottom

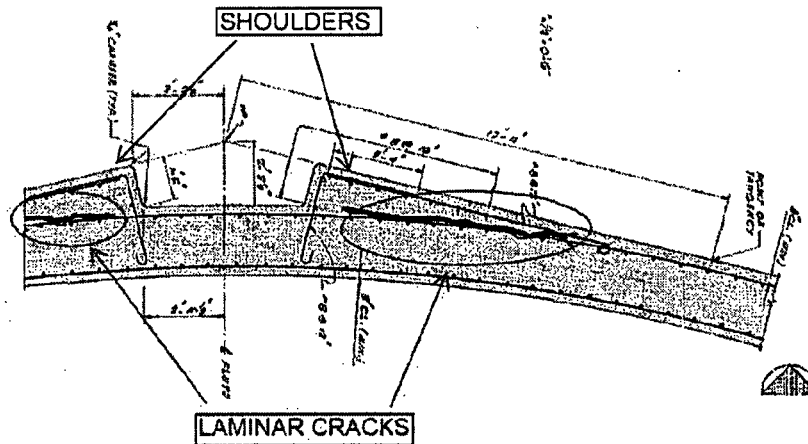
## Flute/Shoulder Geometry

- IR testing performed on 15 of 16 flute shoulders
- Core bores taken on 12 shoulders to confirm crack boundaries
- Core bores inspected using boroscope to identify crack depths and widths
  - Very tight, less than 0.01"
