# CONTAINMENT DELAMINATION: DAVIS-BESSE & CRYSTAL RIVER

BRYCE LEHMAN

December 27, 2011

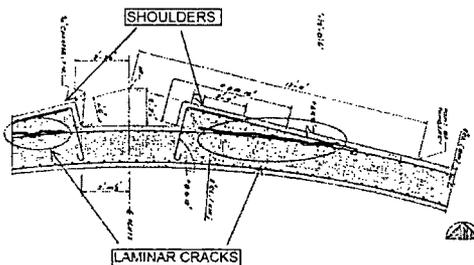
## Flute/Shoulder Geometry

- IR testing performed on 15 of 16 flute shoulders
  - Based on results, licensee assumed cracking throughout all shoulders
- Core bores taken on 12 shoulders to confirm crack boundaries
- Core bores inspected using boroscope to identify crack depths and widths
  - Very tight, less than 0.01"

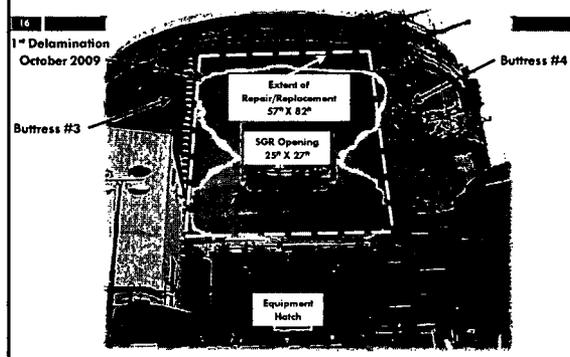
### CR-3 Update: Original Delamination

- **Dec. 2008:** License Renewal Application (LRA) submitted.
- **Oct. 2009:** Delamination of containment concrete in Bay 3-4.
- **Nov. 2009:** Applicant starts repair of concrete in Bay 3-4.
- **Dec. 2010:** SER issued with open item for containment repair.
- **Jan. 2011:** ACRS Subcommittee meeting.
  - \* Committee requested additional meeting after closeout of open item for containment repair.
- **Mar. 2011:** New delamination identified in containment Bay 5-6.
- **Jun. 2011:** NRC informs the applicant that a revised schedule for LRA review will be established after information on the containment repair plan is submitted.
- **Jul. 2011:** Spalling identified in Bay 1-2.
  - \* Concrete sections (approx. 1.5" X 12' X 3' & 5') fell on Intermediate Building
