SHIELD BUILDING / CONTAINMENT DELAMINATION: DAVIS-BESSE & CRYSTAL RIVER

BRYCE LEHMAN – NRR/DLR
JIM NEURAUTER – REGION III/DRS
DANIEL RICH – REGION II/DRP

December 22, 2011

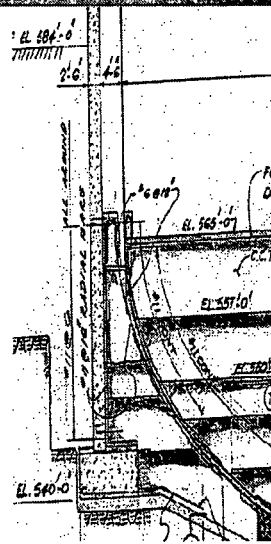
Davis-Besse Shield Building

- Free-standing steel containment vessel surrounded by reinforced concrete shield building
- Shield Building Functions:
 - Environmental & external missile protection for containment vessel
 - Biological shielding during normal operation and accident conditions
 - Means for collection and filtration of fission product leakage following accident

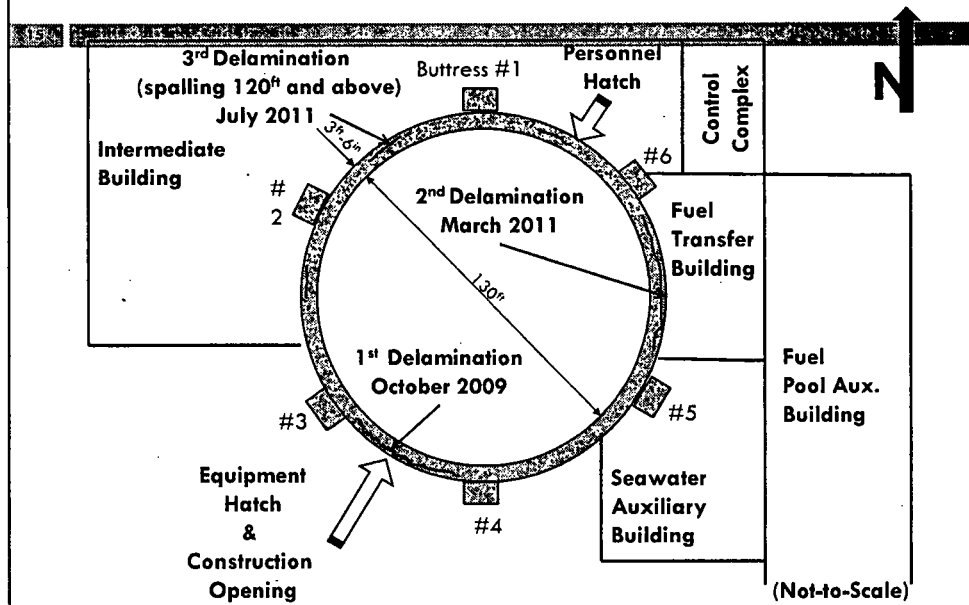
CR-3 Update: Plan View

- **Dec. 2008:** License Renewal Application (LRA) submitted.
- **Oct. 2009:** Delamination of containment concrete in Bay 3-4.
- **Mar. 2010:** Applicant starts repair of concrete in Bay 3-4.
- **Dec. 2010:** SER issued with open item for containment repair.
- **Jan. 2011:** ACRS Subcommittee meeting.
 - Committee requested additional meeting after closeout of open item for containment repair.
- **Mar. 2011:** New delamination identified in containment Bay 5-6.
- **Jun. 2011:** NRC informs the applicant that a revised schedule for LRA review will be established after information on the containment repair plan is submitted.
- **Jul. 2011:** Spalling and delamination identified in Bay 1-2.
 - Concrete sections (approx. 1.5' x 12' x 3' & 5') fell on Intermediate Building

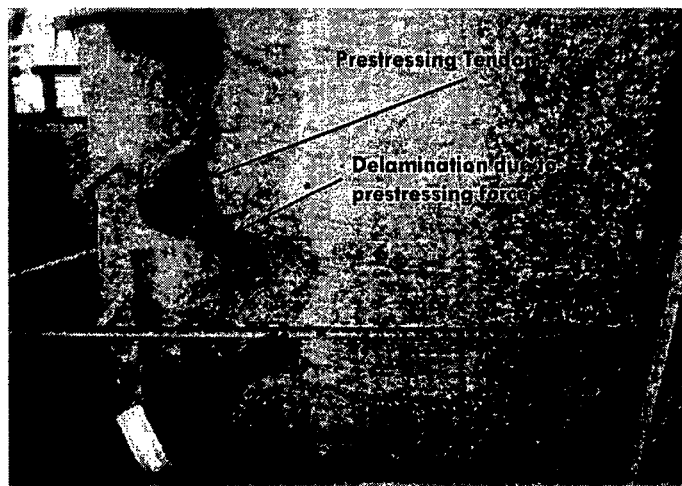
CR-3 Update: Original Delamination

Delamination between buttress 3 & 4

- Laminar cracking in the **prestressed concrete containment** building
- Crack widths between 125 – 2750 mils
- Cracking in the plane of horizontal prestressing tendons (8-9" from exterior face)
- Cracking due to redistribution of prestressing forces, weak aggregate, and lack of radial reinforcement

- Licensee reviewing repair proposals from Bechtel and URS
 - ▣ Anticipate contracts to be in place by Jan. 31
 - ▣ Repairs expected to require 2 to 3 years to complete
 - ▣ Detensioning currently on hold – will be included as part of the repair contract
- Licensee installed temporary anchors to limit propagation of delaminations and prevent future delaminations
- Staff expects licensee to submit a license amendment but that is not certain at this point
- Region II planning appropriate inspections during demolition, repair and testing
