BWRVIP / NRC Technical Update

Dissimilar Metal Weld Update for BWRs

**Chuck Wirtz, First Energy
BWRVIP Integration Chairman
July 20, 2012**

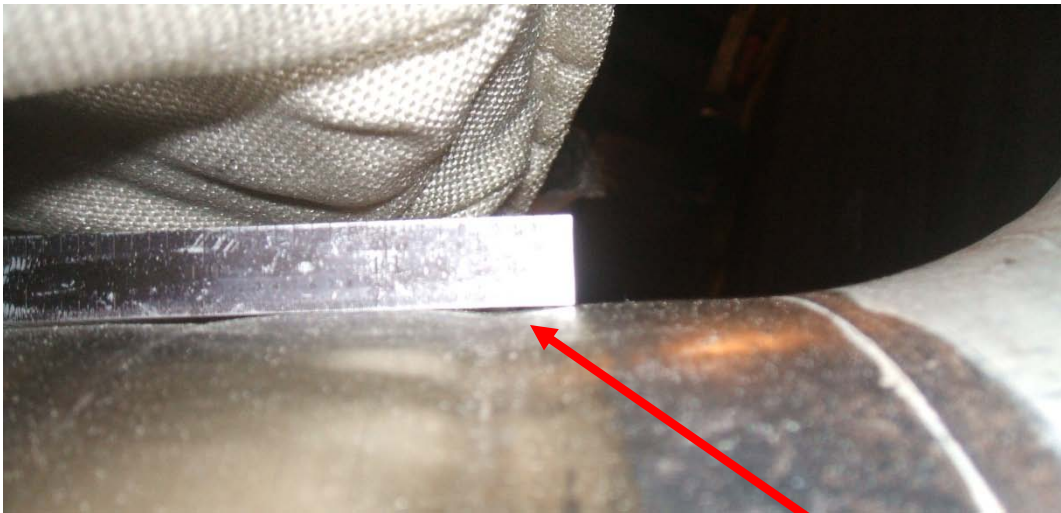
- Surface contour of weld region appears to be the major factor affecting accurate detection and sizing

- Irregular profile/surface condition
 - Presence of weld crowns
 - Radial shrinkage near the weld
- Inadequate probe coupling

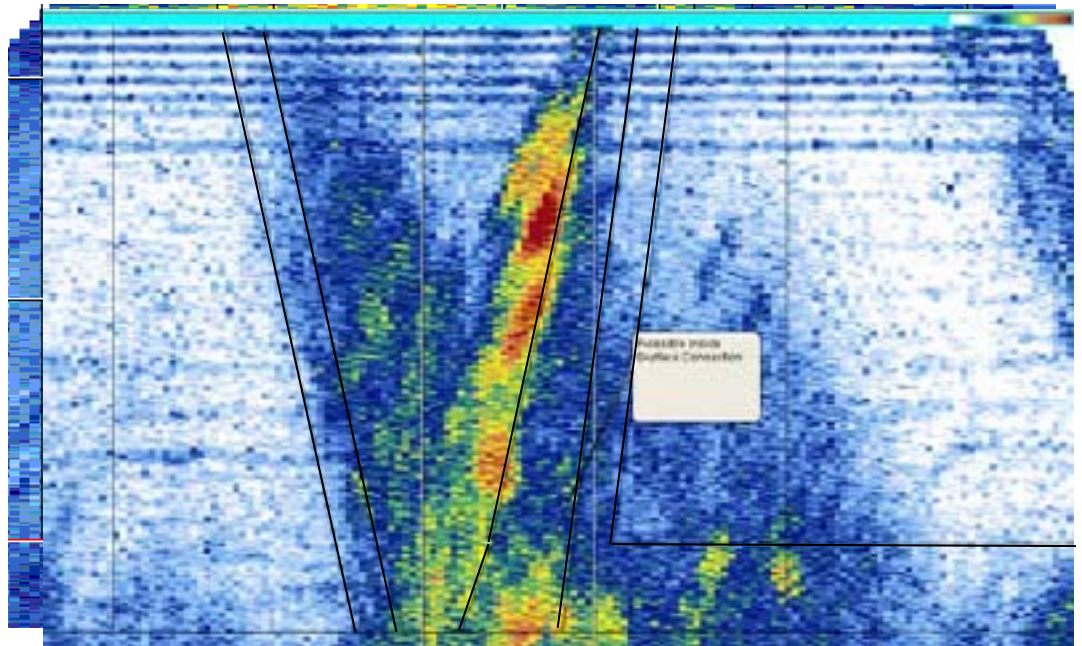
Example of Data Loss From a UT Examination

- Incomplete probe contact resulting in loss of signal
- Following weld resurfacing, weld was re-examined
- Indication was determined to be ID connected
