Davis-Besse Shield Building Laminar Cracking

**DAVIS-BESSE NUCLEAR POWER STATION
CONTAINMENT SHIELD BUILDING ISSUE
11/15/2011**

DAVIS-BESSE NUCLEAR POWER STATION UNIT NO. 1

EXTERIOR DEVELOPED ELEVATION

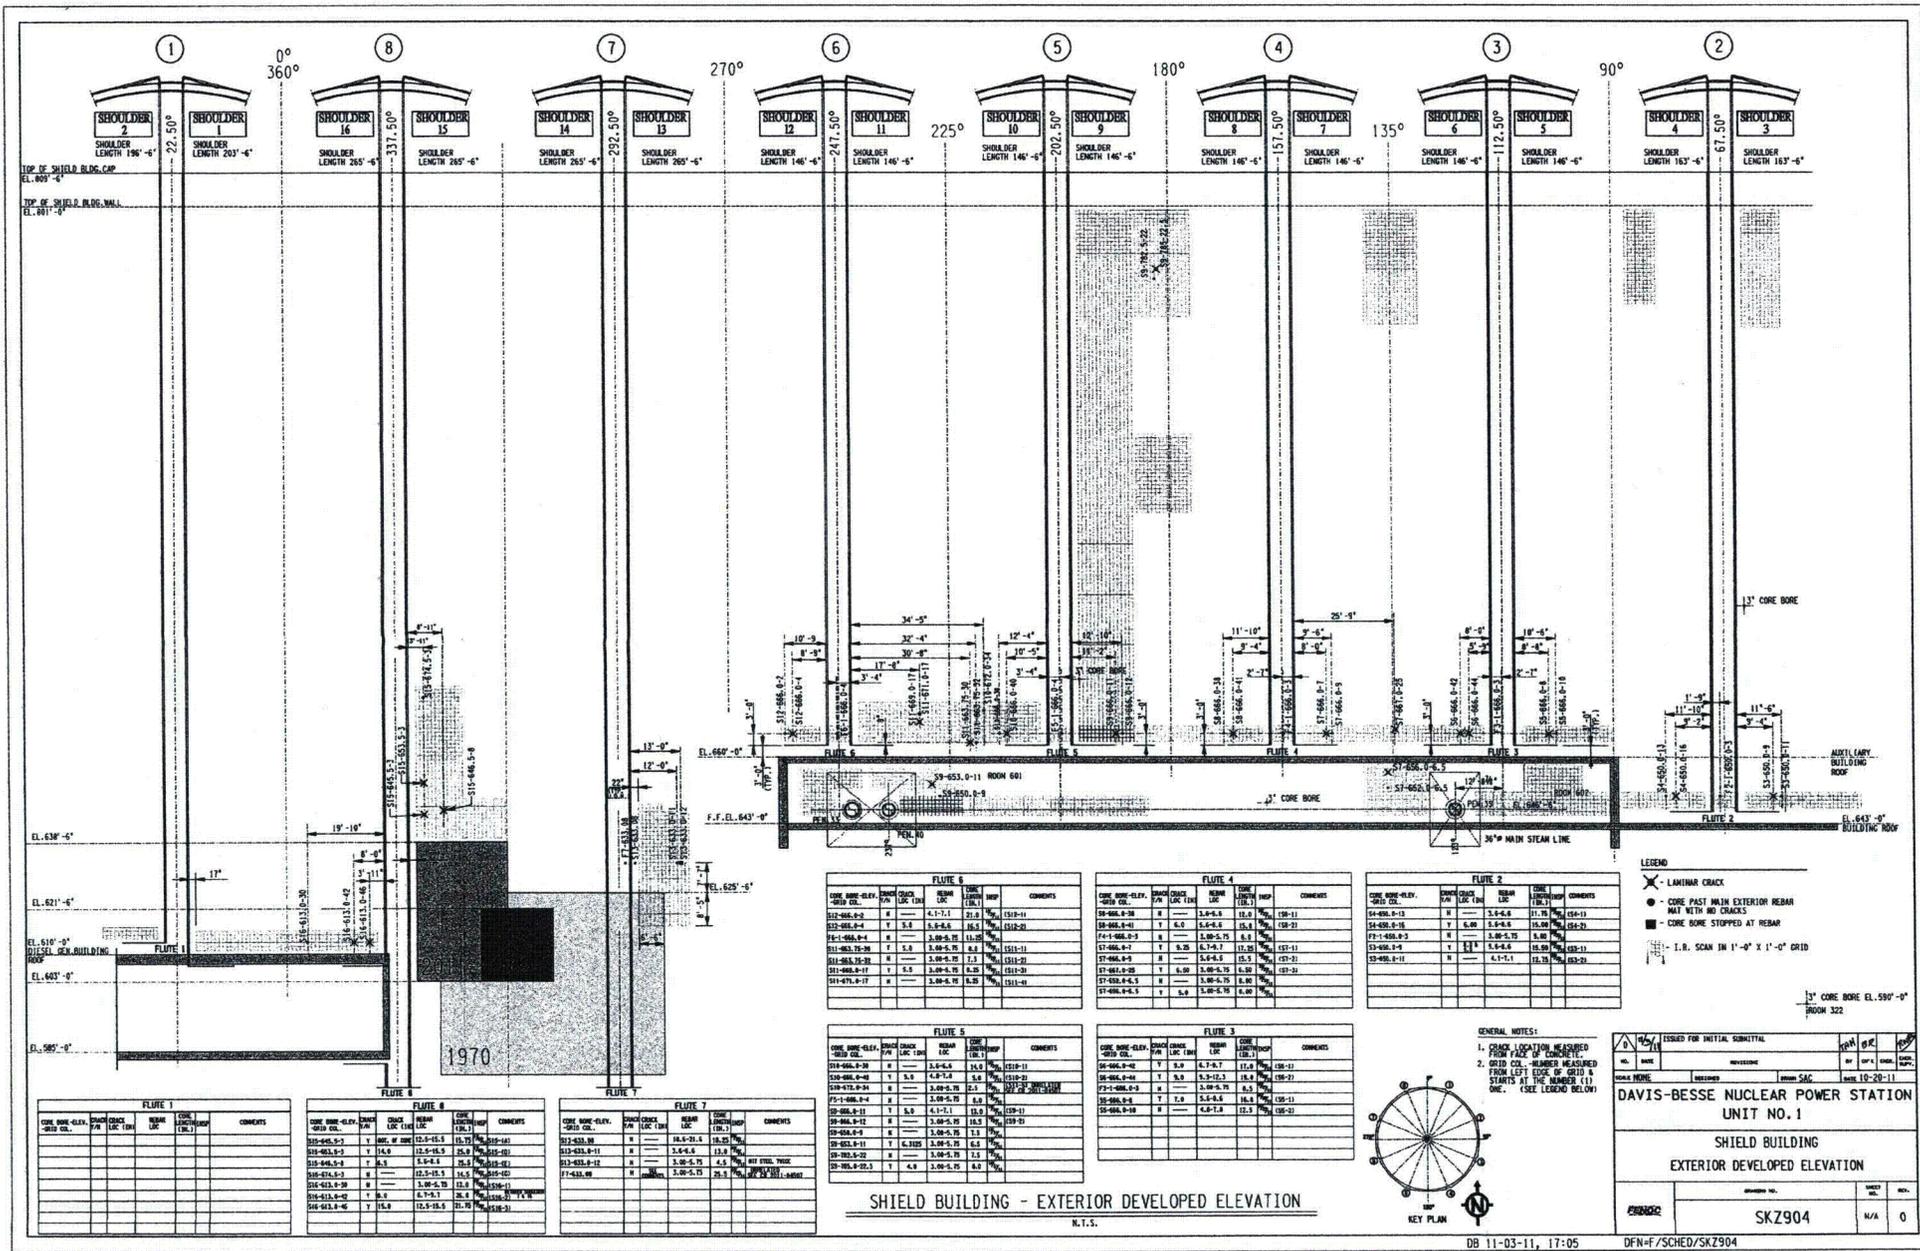
SHIELD BUILDING - EXTERIOR DEVELOPED ELEVATION

FLUTE 6					
CORE HOPE-CLY. GRID CO.	SHOULDER CRACK LRC	SHOULDER LRC	SHOULDER LRC	SHOULDER LRC	COMMENTS
S12-466.0-2	H	4.1-5.1	21.8	19.0	(130-1)
S12-466.0-3	T	5.0	5.0-5.6	16.5	(130-2)
S12-466.0-4	H	3.0-3.75	11.0	11.0	(130-3)
S11-466.0-1	T	5.0	5.0-5.75	6.0	(131-1)
S11-466.0-2	H	3.0-3.75	7.5	7.5	(131-2)
S11-466.0-3	T	5.0	5.0-5.75	6.0	(131-3)
S11-466.0-4	H	3.0-3.75	6.0	6.0	(131-4)

FLUTE 4					
CORE HOPE-CLY. GRID CO.	SHOULDER CRACK LRC	SHOULDER LRC	SHOULDER LRC	SHOULDER LRC	COMMENTS
S16-466.0-3	H	5.0-5.6	12.0	12.0	(130-1)
S16-466.0-4	T	5.0	5.0-5.6	15.0	(130-2)
S17-466.0-1	H	3.0-3.75	6.0	6.0	(131-1)
S17-466.0-2	T	5.0	5.0-5.75	12.0	(131-2)
S17-466.0-3	H	3.0-3.75	15.0	15.0	(131-3)
S17-466.0-4	T	5.0	5.0-5.75	6.0	(131-4)

FLUTE 2					
CORE HOPE-CLY. GRID CO.	SHOULDER CRACK LRC	SHOULDER LRC	SHOULDER LRC	SHOULDER LRC	COMMENTS
S4-466.0-1	H	3.0-4.0	11.75	10.0	(124-1)
S4-466.0-2	T	5.0	5.0-5.6	15.0	(124-2)
S7-466.0-1	H	3.0-3.75	6.0	6.0	(127-1)
S7-466.0-2	T	5.0	5.0-5.6	15.0	(127-2)
S7-466.0-3	H	3.0-3.75	15.0	15.0	(127-3)
S7-466.0-4	T	5.0	5.0-5.75	6.0	(127-4)

FLUTE 5					
CORE HOPE-CLY. GRID CO.	SHOULDER CRACK LRC	SHOULDER LRC	SHOULDER LRC	SHOULDER LRC	COMMENTS
S10-466.0-1	H	3.0-3.75	13.0	13.0	(132-1)
S10-466.0-2	T	5.0	5.0-5.75	16.0	(132-2)
S10-466.0-3	H	3.0-3.75	12.0	12.0	(132-3)
S10-466.0-4	T	5.0	5.0-5.75	6.0	(132-4)

FLUTE 3					
CORE HOPE-CLY. GRID CO.	SHOULDER CRACK LRC	SHOULDER LRC	SHOULDER LRC	SHOULDER LRC	COMMENTS
S6-466.0-1	T	5.0	4.7-4.7	11.0	(126-1)
S6-466.0-2	H	3.0-3.75	12.0	12.0	(126-2)
S6-466.0-3	T	5.0	5.0-5.75	6.0	(126-3)
S6-466.0-4	H	3.0-3.75	15.0	15.0	(126-4)

FLUTE 1					
CORE HOPE-CLY. GRID CO.	SHOULDER CRACK LRC	SHOULDER LRC	SHOULDER LRC	SHOULDER LRC	COMMENTS
S1-466.0-1	H	3.0-3.75	15.0	15.0	(121-1)
S1-466.0-2	T	5.0	5.0-5.75	12.0	(121-2)
S1-466.0-3	H	3.0-3.75	12.0	12.0	(121-3)
S1-466.0-4	T	5.0	5.0-5.75	6.0	(121-4)

FLUTE 8					
CORE HOPE-CLY. GRID CO.	SHOULDER CRACK LRC	SHOULDER LRC	SHOULDER LRC	SHOULDER LRC	COMMENTS
S15-466.0-1	H	3.0-3.75	15.0	15.0	(125-1)
S15-466.0-2	T	5.0	5.0-5.75	12.0	(125-2)
S15-466.0-3	H	3.0-3.75	12.0	12.0	(125-3)
S15-466.0-4	T	5.0	5.0-5.75	6.0	(125-4)

FLUTE 7					
CORE HOPE-CLY. GRID CO.	SHOULDER CRACK LRC	SHOULDER LRC	SHOULDER LRC	SHOULDER LRC	COMMENTS
S14-466.0-1	H	3.0-3.75	15.0	15.0	(125-1)
S14-466.0-2	T	5.0	5.0-5.75	12.0	(125-2)
S14-466.0-3	H	3.0-3.75	12.0	12.0	(125-3)
S14-466.0-4	T	5.0	5.0-5.75	6.0	(125-4)

- However, in at least one core bore, the crack extends slightly beyond the rebar concrete cover, but does not extend into the concrete between the interior rebar mat and the exterior rebar mat. [refer to SKZ904, Shield Building Exterior Developed Elevation, dated 10-28-11 @ 14:00; Flute 6 Core Bore S11-663.75-30: Crack identified at 5" from exterior surface; between rebar mat located 3" to 5.75" from exterior surface (3" concrete cover plus two 1.375" diameter rebar layers)]. The licensee is performing an analysis to demonstrate the rebar is unaffected. For defense in depth purposes the licensee will perform an additional calculation, removing some rebar from the analysis, with the intent of demonstrating that even without some of the rebar, the Shield Building would still be able to meet its design function.
