Rupture of Model 48Y UF₆ Cylinder and Release of Uranium Hexafluoride

Sequoyah Fuels Facility
Gore, Oklahoma
January 4, 1986

**U.S. Nuclear Regulatory
Commission**

Augmented Investigation Team

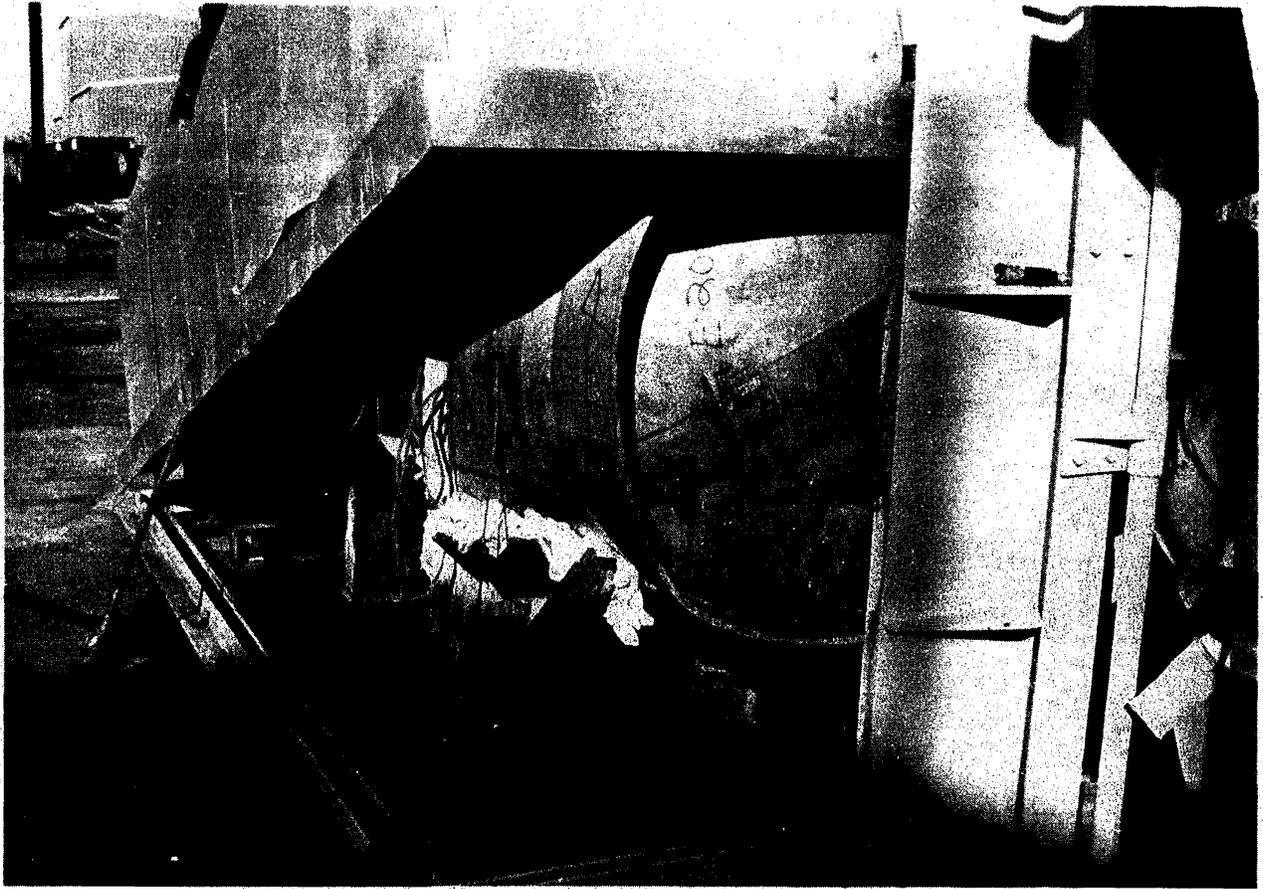
Figure 3.10 Ruptured cylinder

At approximately 11:30 a.m., the cylinder ruptures in the steam chest causing the cylinder to spin in its cradle. The 4-foot, lengthwise rupture which occurred along the top of the cylinder is oriented approximately 120 degrees from its

initial position after the cylinder comes to rest. The force of the explosion also ruptures the top of the steam chest enclosure. (See Figures 3.10 and 3.11.) Liquid UF_6 flows from the rupture and rapidly reacts with moisture in the air to form uranyl fluoride (UO_2F_2) and hydrofluoric acid (HF). The resulting vapor cloud is carried south by southeast by a wind gusting to 25 mph.

The ruptured cylinder, with its temporary rag plug in place, rests in the damaged steam chest. The fill valve, in the 8 o'clock position on the near end of the cylinder, was at 12 o'clock before the rupture occurred.

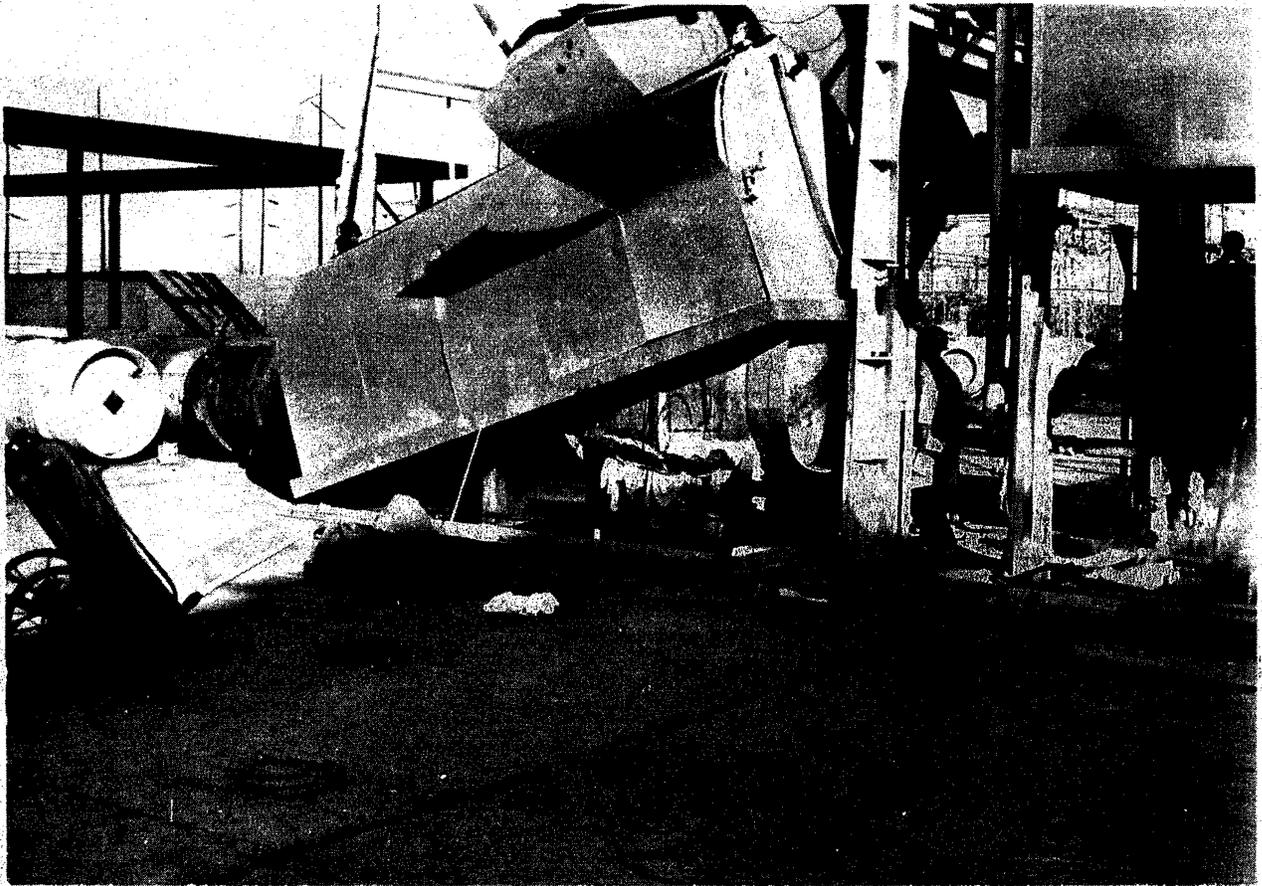
Figure 3.11 Damaged steam chest and cylinder

The force of the release caused damage to the steam chest cover.

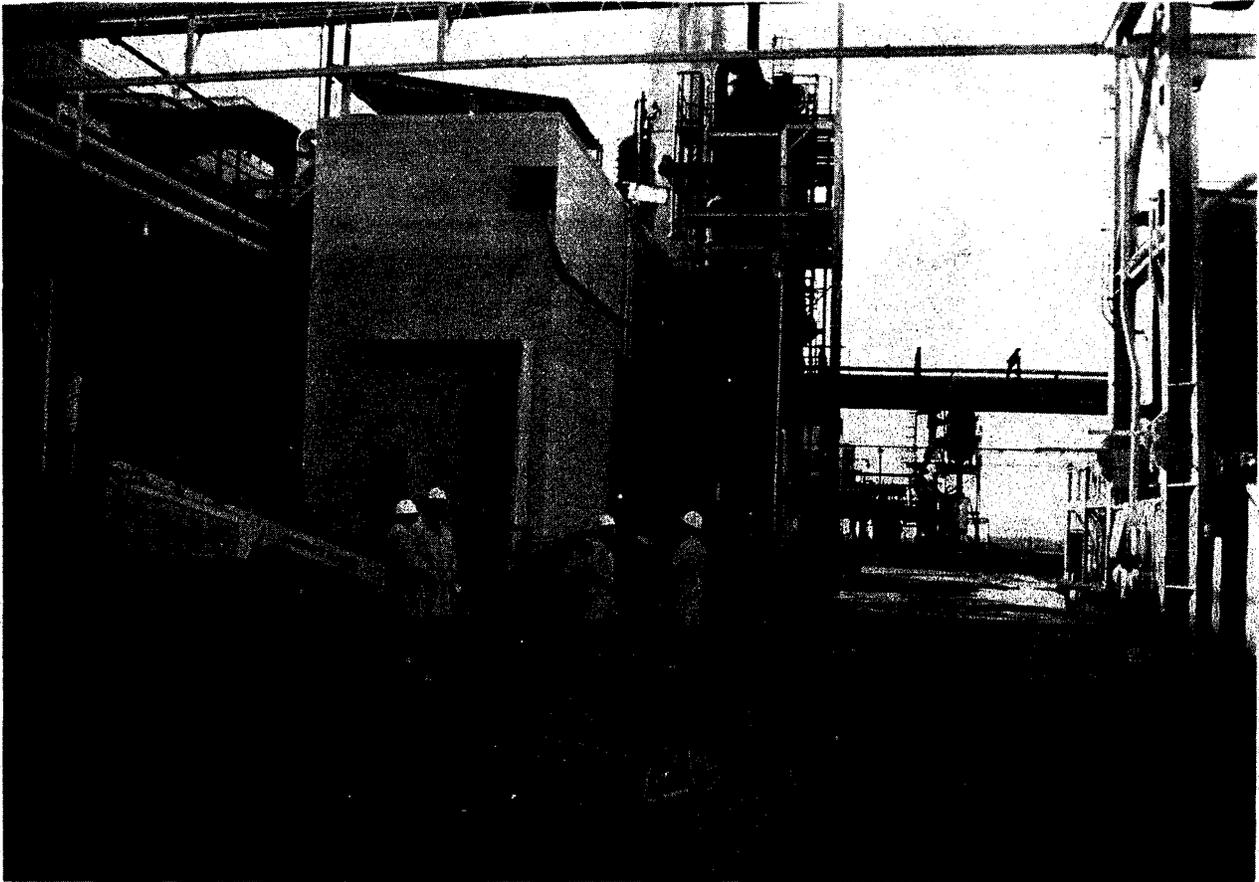
Figure 3.12 Scrubber building

The worker who was fatally injured was working on the upper level of the two-story white structure. He was engulfed by a cloud of vapors and gases consisting of hydrofluoric acid (HF), uranyl fluoride (UO_2F_2), and uranium hexafluoride (UF_6). The nearest steam chest is barely visible at the right edge of the photograph.

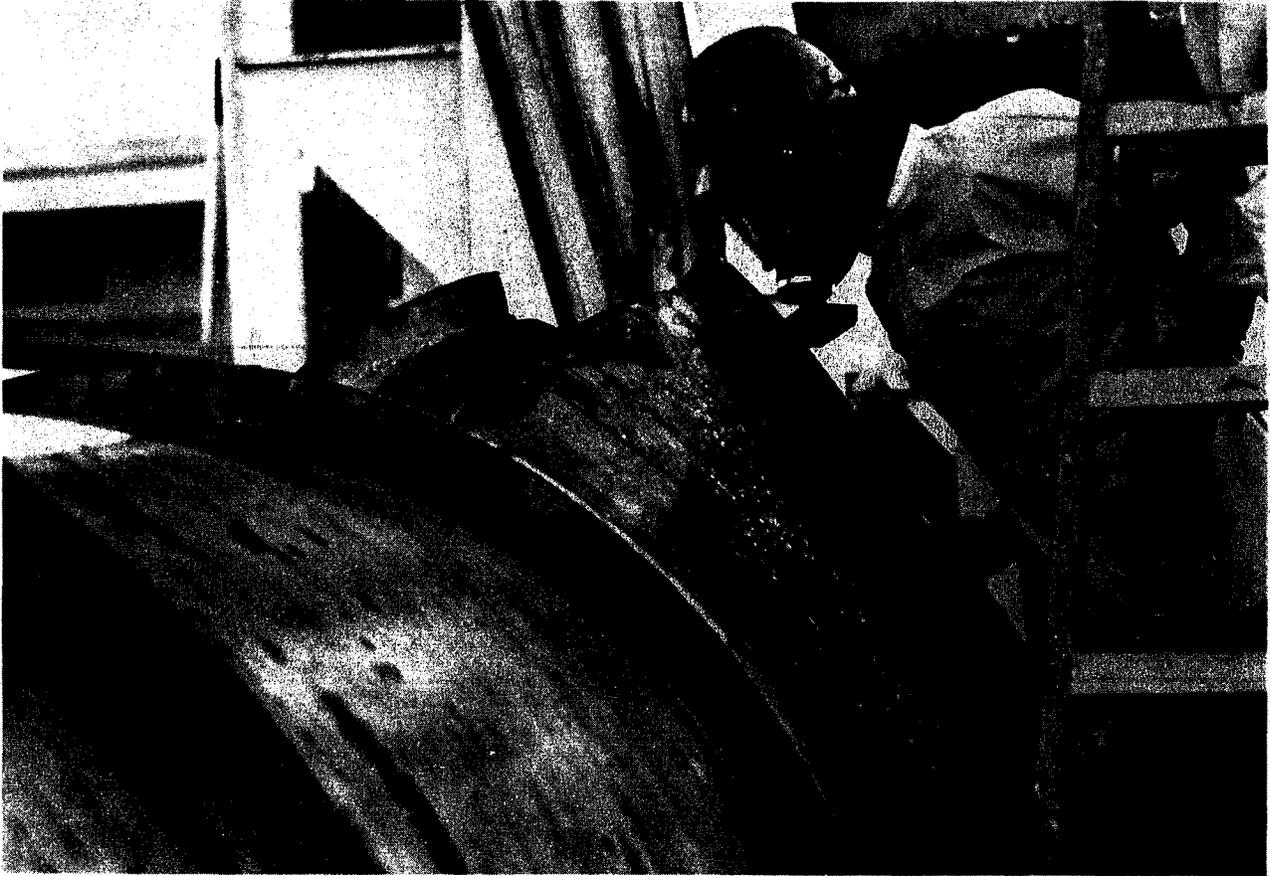
Figure 3.13 Damaged portion of the cylinder

Approximately 2 hours after heating began, the cylinder ruptured in the steam chest. A 4-foot lengthwise rupture occurred along the top of the cylinder.

The rupture is shown in this picture, which was taken shortly after the temporary rag plug was removed. The cylinder has been rotated from its position immediately after the accident.

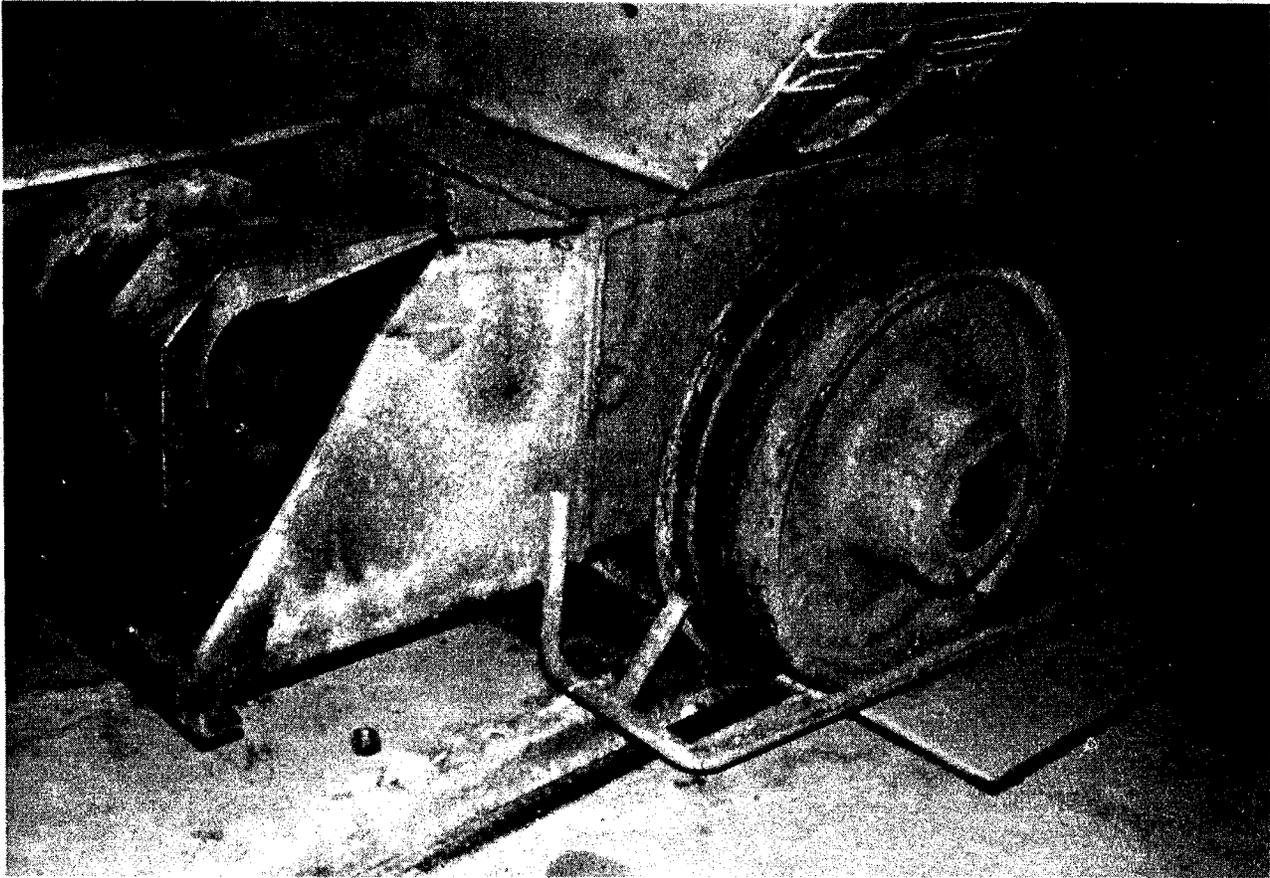
Figure 5.1 Cart wheel alignment

- (4) In the conduct of the scale testing and calibration, the investigators noted that the cart used to move cylinders on and off the scale platform apparently had been damaged in the past. As a result, the wheels at the east end of the cart were at an angle, confirming observations that only one of the wheels had hung up.

With a 14-ton cylinder placed in its optimum position on the cart and moved as close as possible to the drain station, the rear wheel is less than an inch from the edge of the scale platform.
