Boiling Water Reactor Vessel & Internals Project (BWRVIP) BWR Operating Experience

Charles Wirtz, FirstEnergy
BWRVIP Integration Committee Chairman
Industry/NRC Executive Meeting on Materials Program
July 31, 2012

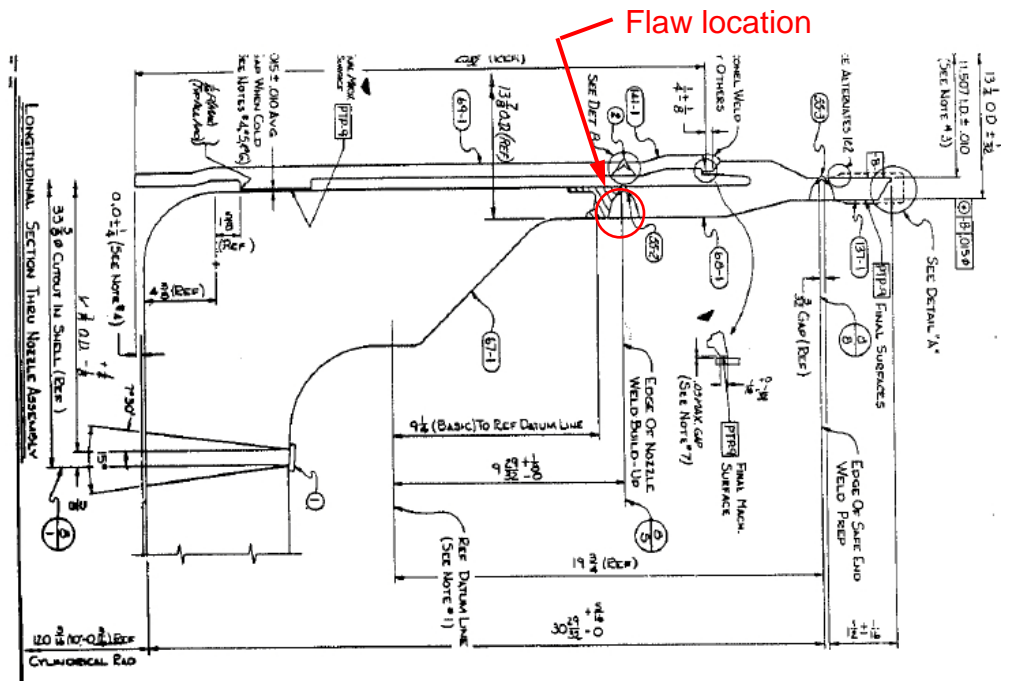
- During Spring 2012 outage Grand Gulf found an axial flaw in their N6B Low Pressure Core Injection Nozzle to Safe-End DM weld.
 - Flaw approx. 0.47” deep (0.90” remaining ligament), 0.95” long, and in the 182 butter
 - Weld was stress-improved by Induction Heating Stress Improvement (IHSI) in 1990
 - Examination was one of 13 GL 88-01 Category C weld examinations being performed in accordance with BWRVIP-222, Accelerated Inspection Program for Category C DM Welds
 - Weld did not previously have a qualified Supplement 10 exam and had to be prepped prior to examination
 - Automated data from previous exam (2002) corrupt so no way to evaluate if flaw was pre-existing
 - Weld overlay repaired
 - Of the 271 Category C welds in the BWR Fleet with 182 filler material exposed to the environment, only 4 remain to be examined with a Supplement 10 exam and they are scheduled for Spring of 2014

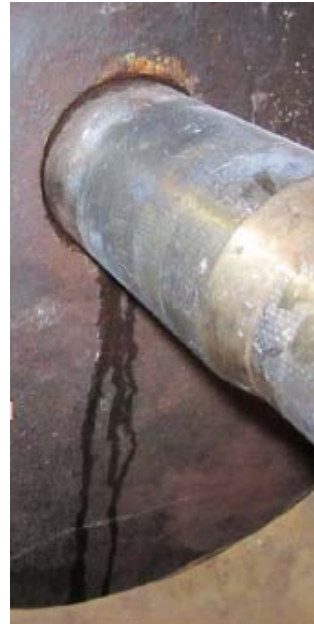
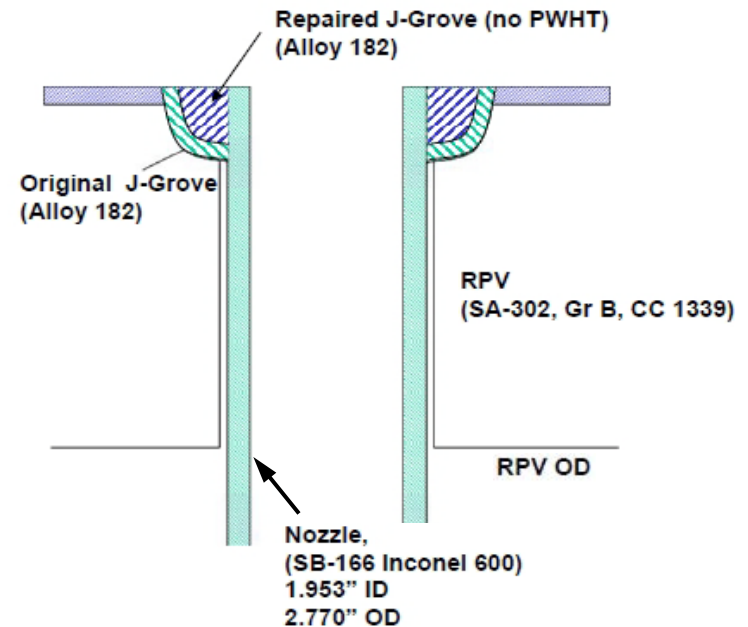
- During Spring 2012 outage Quad Cities 2 identified a leak coming from their N11B (Upper Water Level) Instrument Nozzle Penetration

- Leakage was found by VT-2 examination during the routine end-of-outage RPV Leak Test
- First instance of a BWR instrument nozzle leaking from inside the vessel or inside the nozzle penetration

- Repaired by a half-nozzle repair (typical repair for PWR partial penetration nozzles)
- Apparent cause is IGSCC in the J-groove weld or Alloy 600 instrument nozzle

- Most likely location is in J-groove weld due to repair without PWHT and the fact that no flaws or abnormal metallurgical or chemical conditions were found in the portion of the nozzle that was removed for the half-nozzle repair
