Seabrook Station

Relief Request – Proposed Alternative in accordance with 10 CFR 50.55a (a)(3)(ii)

SEABROOK STATION UNIT 1
RELIEF REQUEST RA-12-001, REVISION 0

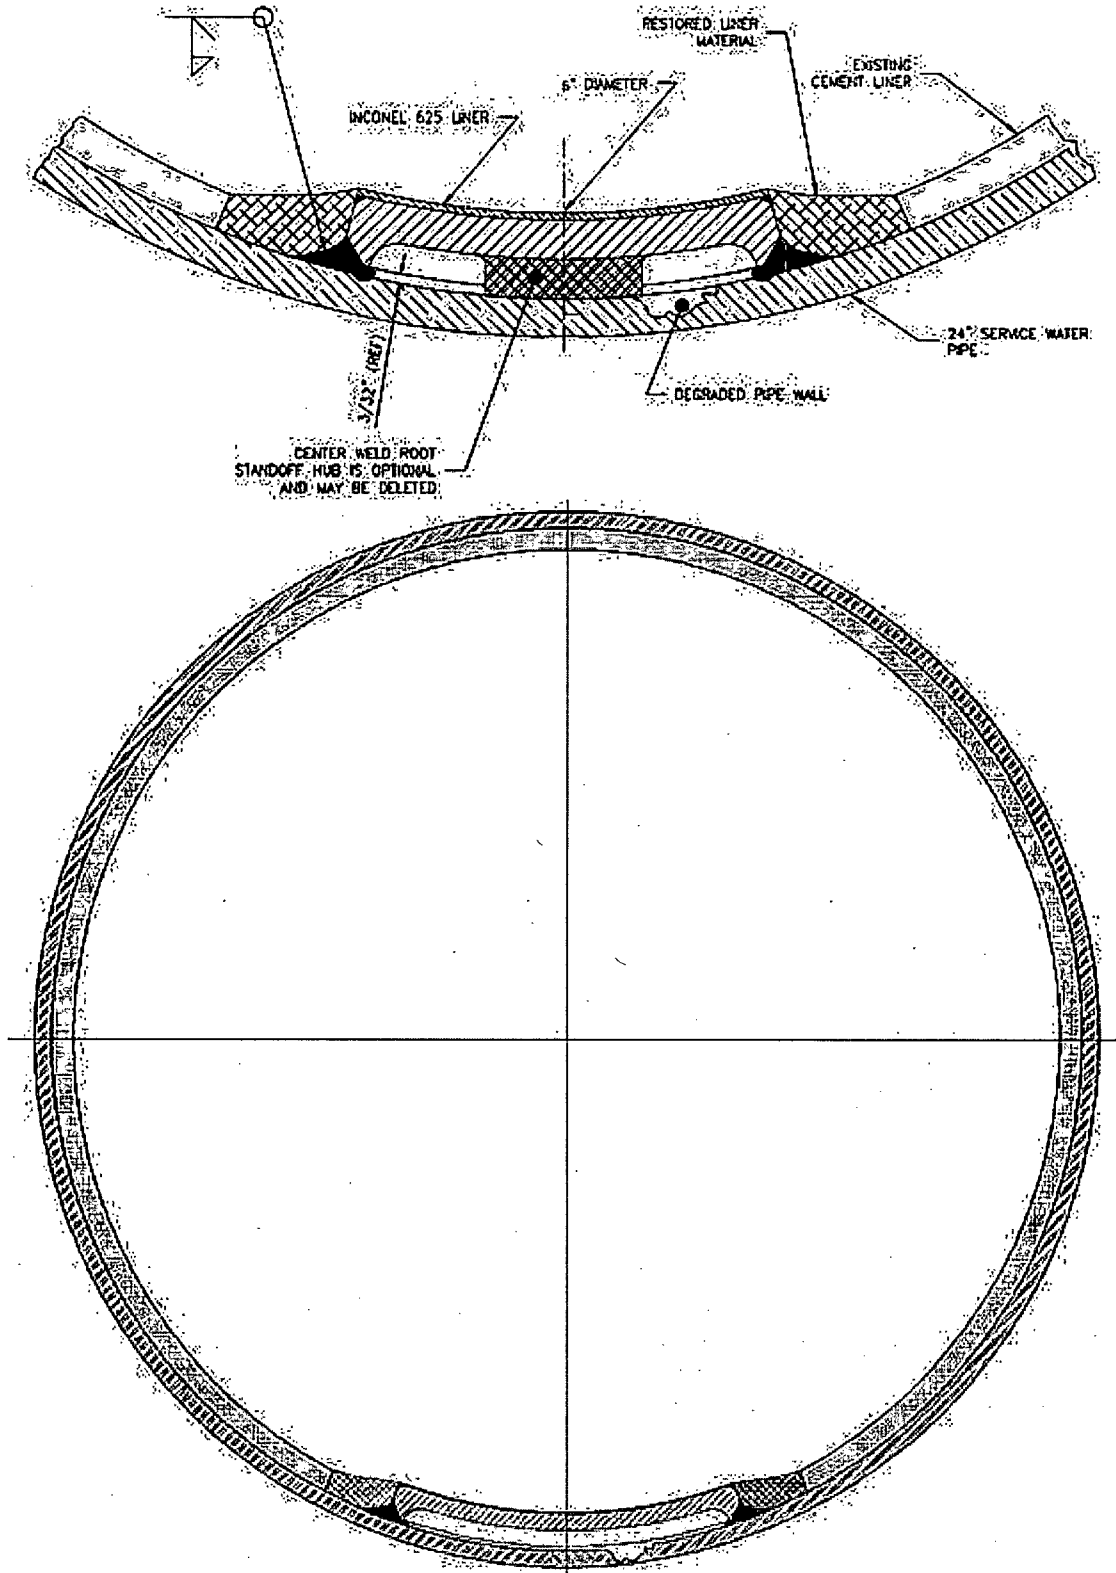
SEABROOK STATION UNIT 1
RELIEF REQUEST RA-12-001, REVISION 0
FIGURE A

the area will be repaired by the application of an encapsulation device (Figure A) in accordance with the provisions of IWA-4000.

The structural repair consists of a 6" diameter circular encapsulation device designed to accommodate the design pressure as well as mechanical loading. Since welding of the cap will impact the capability of the exterior wrap to preclude outer diameter (OD) corrosion due to contact with ground water, no credit will be taken for the localized external wrap in determining the service life of the repair. The encapsulation cap ID will be such that the inside diameter is greater than the maximum diameter of the defective area plus a minimum of twice the nominal thickness of the pipe.

The applied encapsulation device is a pipe restoration approach equivalent to an unstayed flat head. ASME Section III, Subsection ND Figure ND-3325-1 depicts acceptable configurations for flat heads. The relevant configuration for the encapsulation device is shown in Figure b-2 of Figure ND-3325-1. The dimension of the cap top, skirt, and full penetration weld to the pipe are based upon the metal area replacement Code methodology and considers design pressure, external soil pressure, as well as mechanical loading. The size (outer diameter) of the cap considered the conservative assumption of future metal loss due to both seawater (internal content) and groundwater (external environment) during the period of service.
