**UNITED STATES
NUCLEAR REGULATORY COMMISSION
REGION I**
2100 RENAISSANCE BOULEVARD, SUITE 100
KING OF PRUSSIA, PENNSYLVANIA 19406-2713

**SUBJECT: SUSQUEHANNA STEAM ELECTRIC STATION – NRC INTEGRATED
INSPECTION REPORT 05000387/2012003 AND 05000388/2012003**

Docket Nos. 50-387; 50-388
License Nos. NPF-14, NPF-22

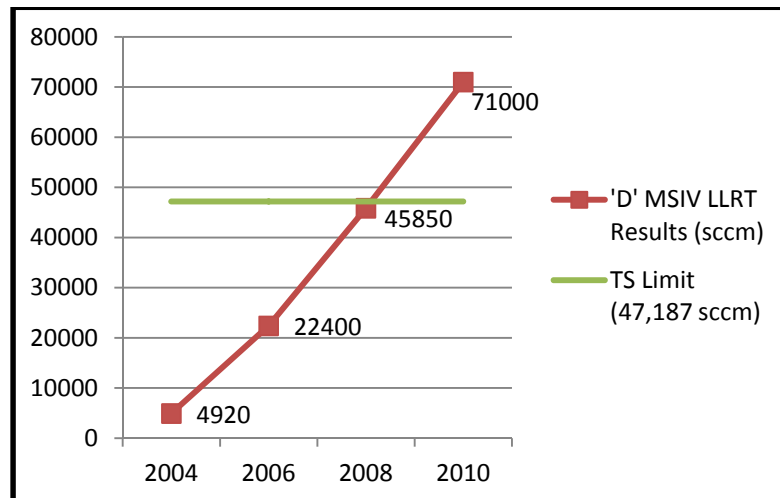
A Level 2 ACE (CR 1554813) was performed to evaluate the LLRT failure and determined that excessive leakage of the ‘D’ outboard MSIV was “due to inadequate maintenance of the MSIV seating surfaces” performed in 2010. Specifically, as discussed in NCV 05000387/2012003-002 above, the ACE identified that the maintenance instructions, MT-083-011, “MSIV Disassembly, Inspection and Reassembly (Longnose Poppet),” were inadequate and resulted in improper boring bar set up and machining of the seating surfaces. This maintenance directly led to the excessive leakage observed on April 8, 2012.

During additional reviews of valve performance, the inspectors identified that this was the second consecutive outage that HV141F028D had failed its as-found LLRT. Specifically, in 2010, the as-found LLRT would not pressurize. A Level 3 ACE (CR 1242099) determined the cause of that LLRT failure was failure to perform maintenance on the valve in the previous outage (2008) due to an adverse trend in leakage. Despite the 2008 as-found LLRT leakage value being ~97 percent of the TS limit and the trend showing strong evidence that the subsequent LLRT would exceed the TS limit, no valve maintenance was performed to restore margin.
