UNITED STATES
NUCLEAR REGULATORY COMMISSION
OFFICE OF NUCLEAR REACTOR REGULATION
WASHINGTON, D.C. 20555

April 7, 2005

NRC INFORMATION NOTICE 2005-09: INDICATIONS IN THERMALLY TREATED ALLOY
600 STEAM GENERATOR TUBES AND TUBE-
TO-TUBESHEET WELDS

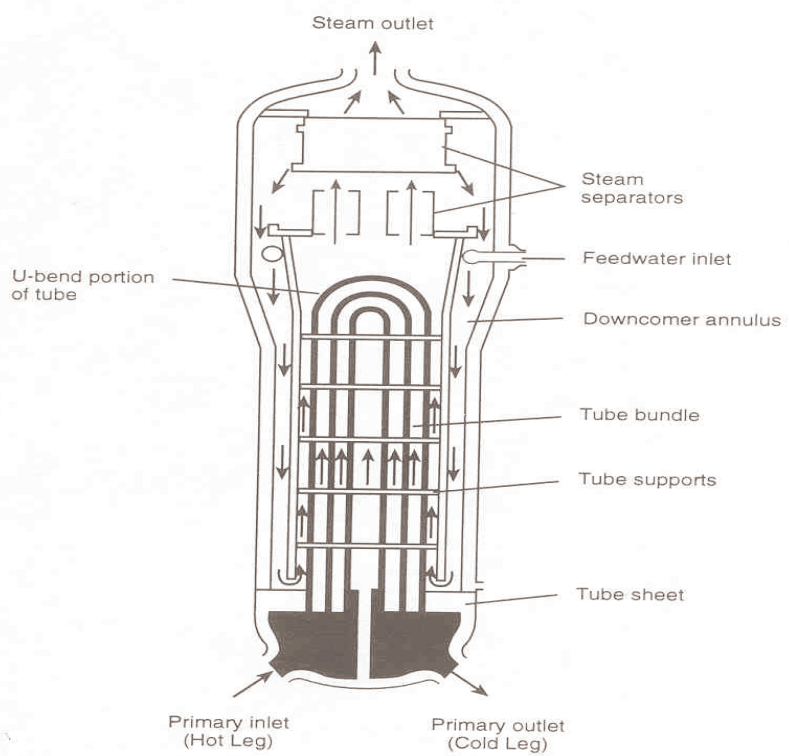
Figure 1

Catawba Nuclear Station, Unit 2, has four Westinghouse Model D5 recirculating steam generators. Each steam generator has approximately 4,600 tubes fabricated from thermally treated Alloy 600 (Figure 1). During fabrication of the steam generators, a portion of the U-shaped tubes are inserted into a thick plate called a tubesheet. The tubesheet is approximately 21 inches thick and has two holes for each tube (one hole on the hot-leg side of the steam generator and one hole on the cold-leg side). The lower end of the tubes were tack-expanded into the tubesheet for approximately 0.70 inch (Figure 2). This tack expansion is performed to facilitate welding of the tube to the primary side of the tubesheet. In the case of Catawba Unit 2, this region is frequently referred to as the tack roll region since the tack expansion was accomplished by mechanically rolling the tube into the tubesheet. The tack expansion forms a temporary expansion transition (i.e., a roll transition in the case of Catawba). Following welding, the tubes were hydraulically expanded for the full depth of the tubesheet. The transition from the expanded portion of tube within the tubesheet to the unexpanded portion of the tube at the top of the tubesheet is referred to as the expansion transition region of the tube.

PWR Recirculating Steam Generator

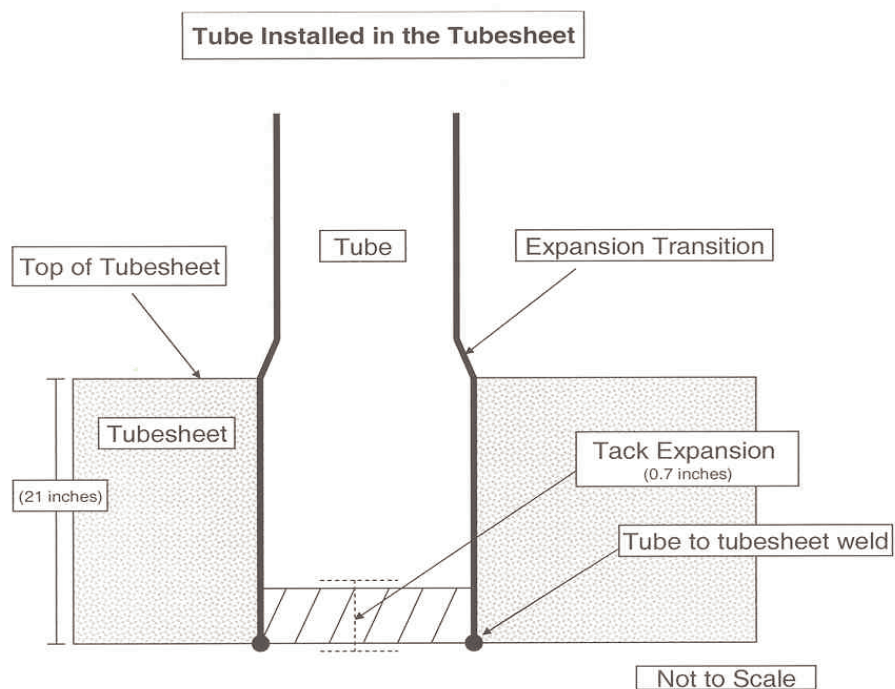
Figure 2

During these additional rotating probe examinations, no additional indications were found in the overexpanded (bulged) regions; however, several indications were found at the tube ends (tube-to-tubesheet weld) and one indication was found in the tack expansion region. At the tube ends, the licensee identified approximately 12 indications in steam generators A, B, and D. These indications were in the tube-to-tubesheet weld and were not visible during visual inspections of the weld. The indication in the tack expansion (the region of the tube expanded into the tubesheet to facilitate welding) was approximately 0.70 inch above the tube-to-tubesheet weld and was circumferentially oriented. It was estimated to be 330 degrees in circumferential extent and 100 percent through-wall.

In steam generator B, 9 tubes were found to have indications in the tack roll region. These indications were circumferentially oriented and consisted of either single or multiple cracks. No indications were found in the tack roll region in steam generators A, C, or D. In the tube-to-tubesheet weld region, 188 tubes in steam generator B, 1 tube in steam generator A, and 7 tubes in steam generator D contained indications in the tube-to-tubesheet weld. No indications were found in the tube-to-tubesheet weld region in steam generator C. Six tubes in steam generator B were identified with tube end (i.e., tube-to-tubesheet weld) indications that extended into the tube material. The indications in these tubes were axially and circumferentially oriented and consisted of either single or multiple cracks.

The licensee plugged the tube with the circumferential indications in the overexpanded region and the tubes with indications in the tack roll region. In addition, the licensee plugged the six tubes with indications in the weld region that extended into the tube material.
