Consolidated Edison Company of New York, Inc.
Indian Point 2 Station
Broadway & Bleakley Avenue
Buchanan, New York 10511

Re: Indian Point Unit No. 2
Docket No. 50-247

Subject : Root Cause Evaluation For Steam Generator Tube Rupture Event of February 15, 2000

Root Cause Evaluation For Steam Generator Tube Rupture Event of February 15, 2000

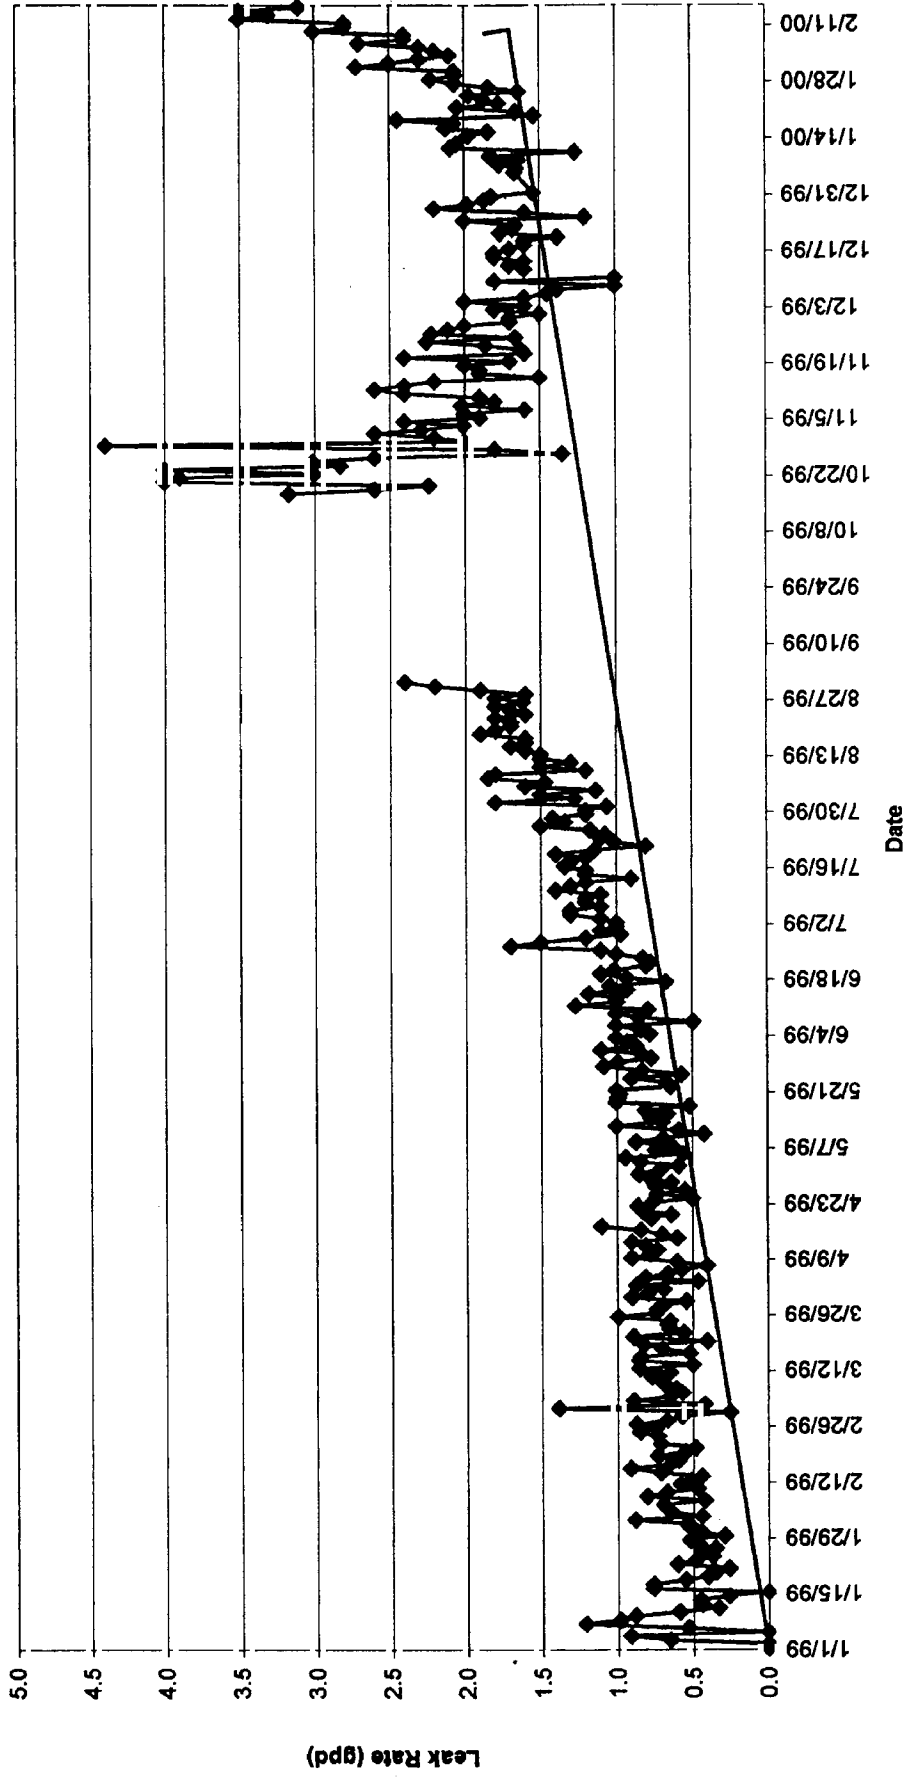
Figure 2 Indian Point 2 Leak Rate History

Although the N-16 monitor alarm signaled the leak, the recorder was out of operation at the time of the alarm. Consequently, the short-term leak rate data just prior to the shutdown are not available. However, the longer-term leak rate over a period of a year (1999) is available and shown in Figure 2. The trend of the long-term leak rate, although not conclusively verifying the postulated mechanism of coalescence of cracks, is consistent with that hypothesis. The low leakage indicated on Figure 2 may have been due to R2C5 or may have resulted from other sources in the SG, such as tube plugs.

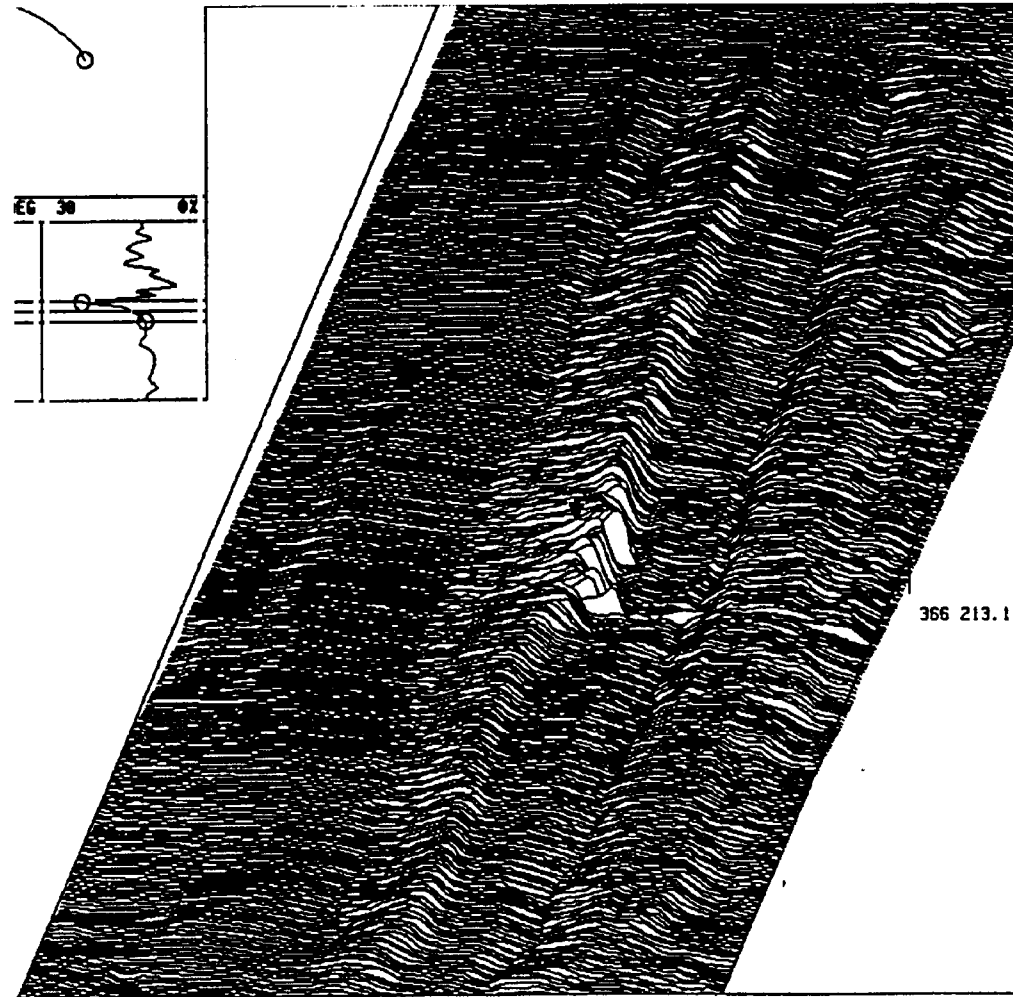
Figure 3
C-Scan of R2C5; 1997 Data

Subsequent to the identification of R2C5 in steam generator 24 as the tube responsible for the leakage event on February 15, 2000, a re-review was conducted of the 1997 eddy current data for that tube. Initial review of the 1997 data supported the NDD findings. The R2C5 data from the 1997 inspection were also reviewed by several experienced, qualified data analysts and industry experts who concurred with this conclusion. The signal included an anomaly in the data that, upon further detailed analysis

of the signal, proved to be an indication of a flaw that developed into the leak. However, background noise was apparent on the Plus Point C-scan plot due to tube geometry and the presence of deposits (Figure 3). The irregularities (offsets) in the ridges shown on Figure 3 can occur as a result of the probe rattling in the tube. The noise levels seen in Figure 3 would not typically permit the signal to be identified as an indication. This conclusion was consistent with that reached in the 1997 interpretation of the data.

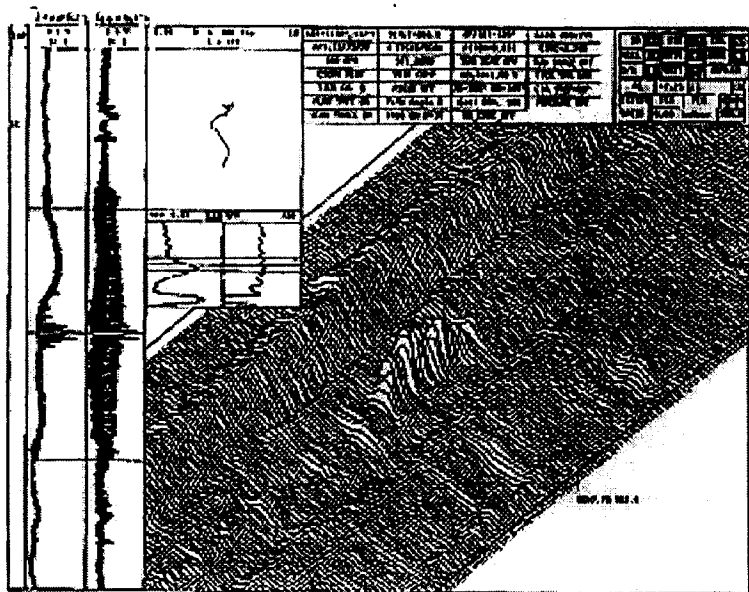
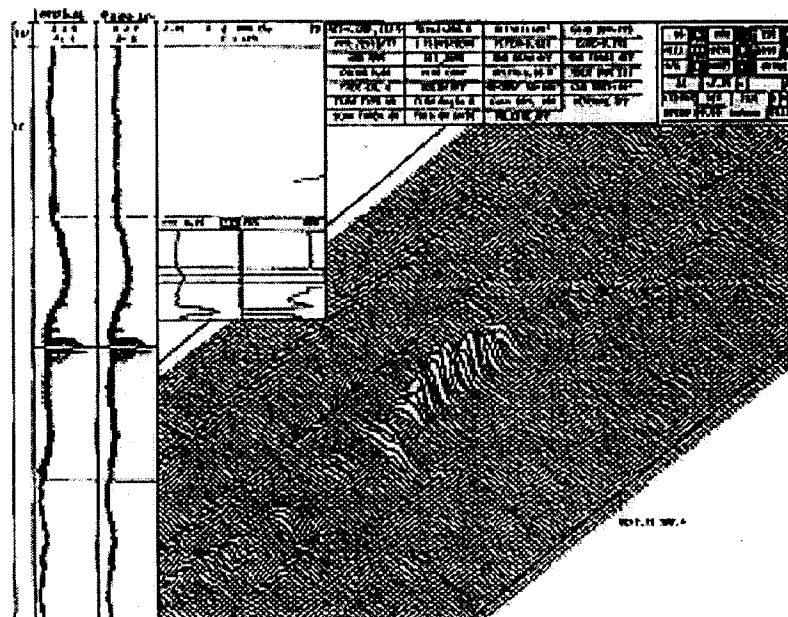
Figure 4
Comparison of Signal and Noise for Mid-Range and High Frequency Plus Point Probe

Mid-Range +Point
R2C69
2000 Data

High Frequency +Point
R2C69
2000 Data

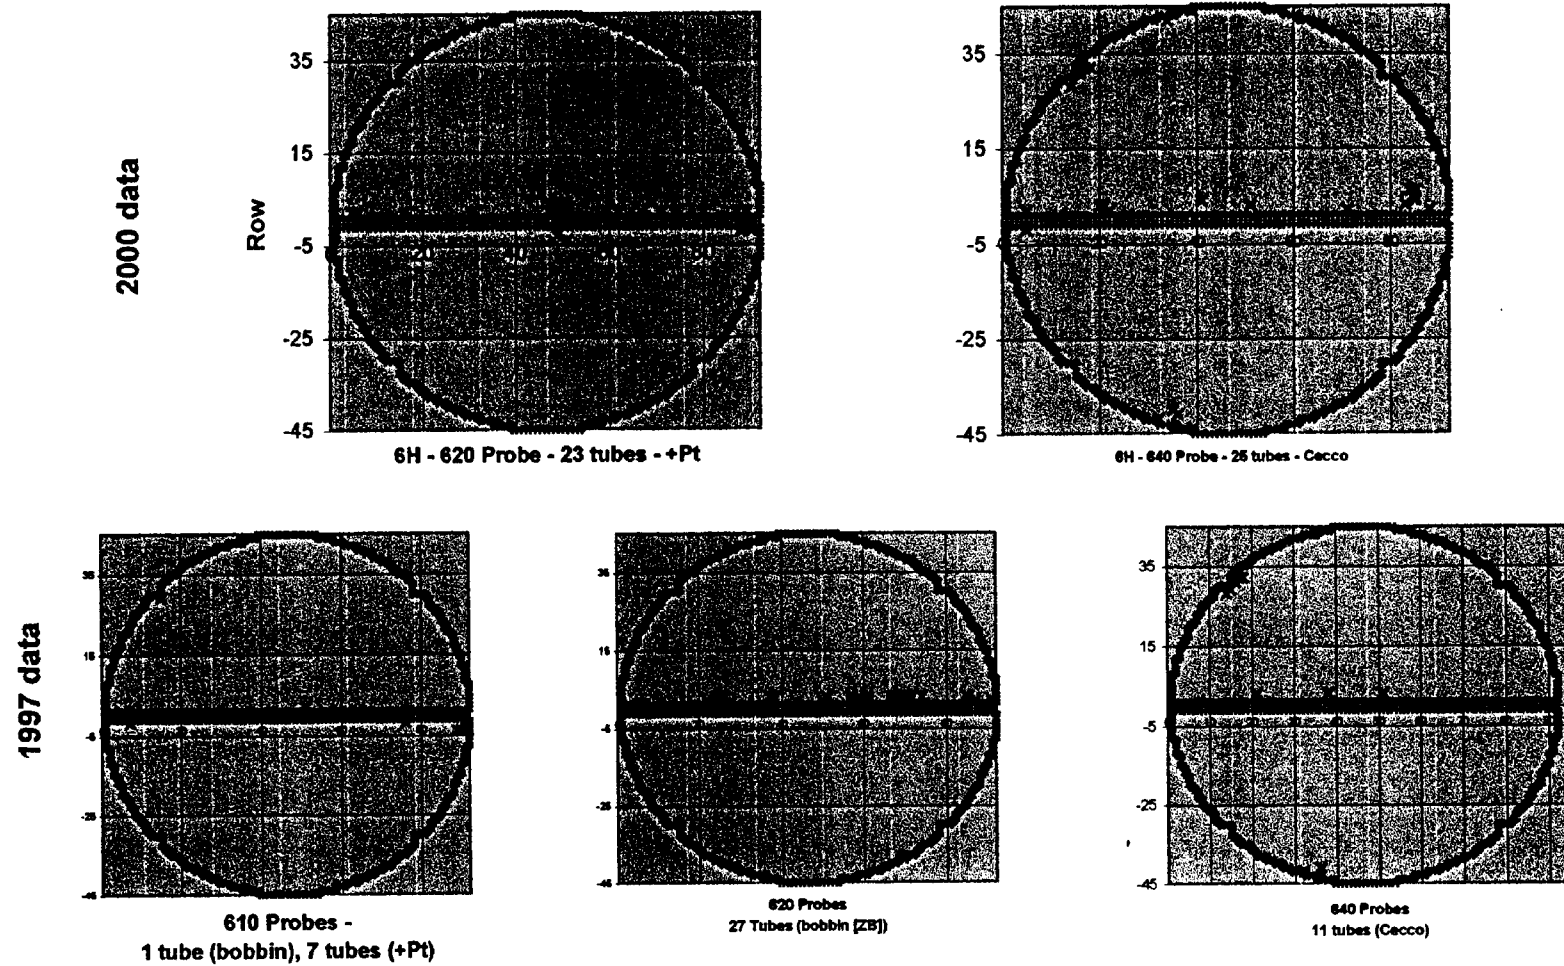
Figure 5
SG 24, TSP6 Probe Restrictions; 1997 Data Compared to 2000 Data

These observations are consistent with a general conclusion that the denting process is continuing at a slow rate. The rate of denting progression cannot be quantified from the increased number of restrictions since there is no available correlation between restrictions and denting. Also, variations between inspections on probe restrictions can occur due to differences in probe types, probe pushers and tolerances on probe length and diameter. However, the restriction study leads to the qualitative conclusion that, if additional restrictions are observed for the same probe type, it is reasonable to conclude that denting is continuing.

Indian Point 2 S/G 24 Composite Restriction Map

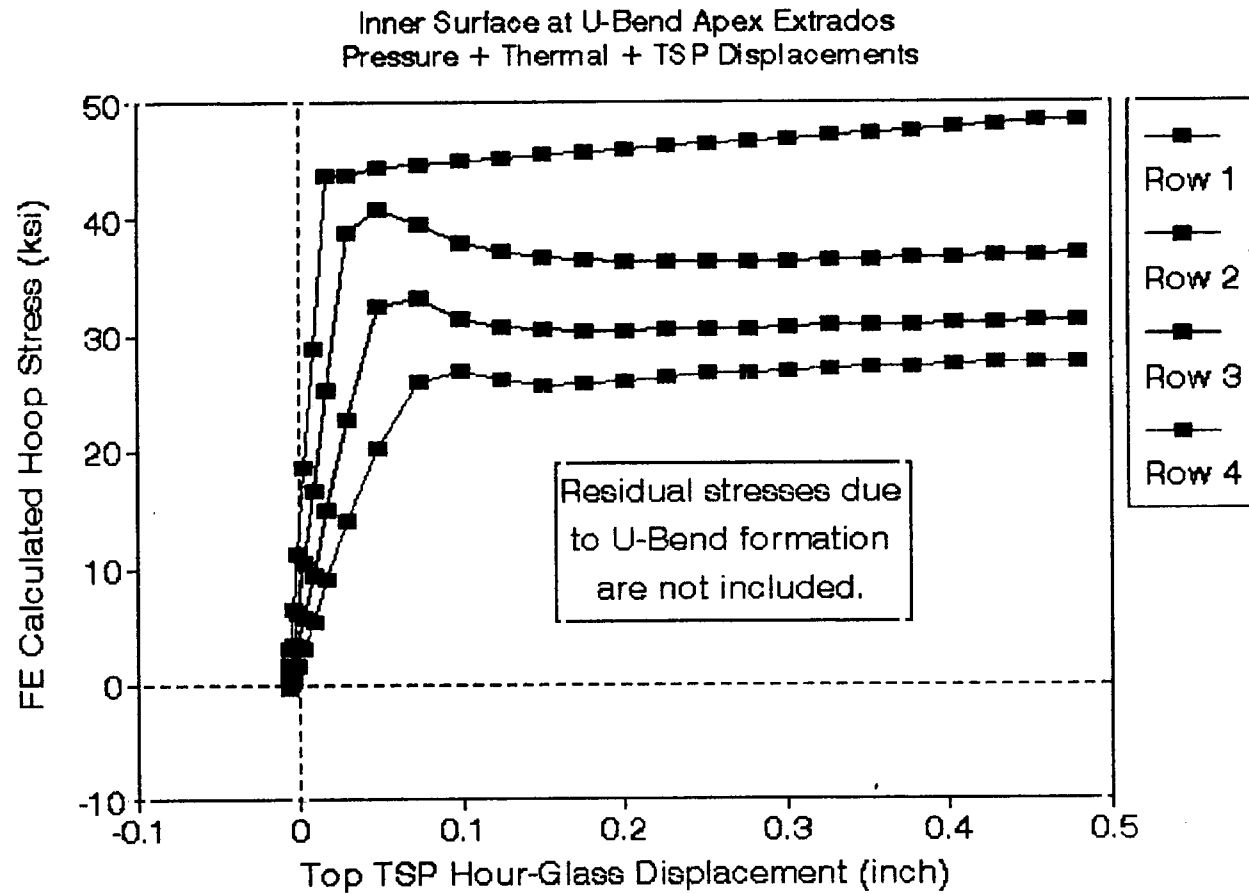
Figure 6

Stress analysis of the low row u-bends, R2, R3 and R4, was initiated with the objective to evaluate the sensitivity of the tube stresses to pinching of the straight legs resulting from hourglassing of the TSP flowslots. An analysis was performed, as described below, that assumed no residual stresses resulting from the bending process. A second analysis, to be included as part of the Condition Monitoring and Operational Assessment Report, seeks to establish the residual stress condition due to bending and ovalization on the tubes prior to imposing various leg spacing boundary conditions. The objective of the analyses is to evaluate if the predicted stresses are consistent with the observed cracking, i.e., PWSCC, and its location at the apex of the U-bend. Further, it is the objective of these analyses to estimate the comparative stresses and, therefore, sensitivity to cracking of the row 2, row 3 and row 4 tubes for the condition monitoring and operational assessments.

The results of this analysis support the observation that the leak is due to PWSCC at the apex of the tube, since the point of maximum predicted stress is at the inside surface of the tube wall at the extrados of the tube at the apex of the tube. The preliminary stress results also indicate that the row 3 tubes are expected to be less susceptible to PWSCC due to the larger TSP displacement required to reach the maximum stress condition and due to the lower stress in the row 3 tubes compared to the row 2 tubes.

**Finite Element Model Calculated Hoop Stresses
vs Reduction in Straight Leg Spacing from Nominal Dimension**

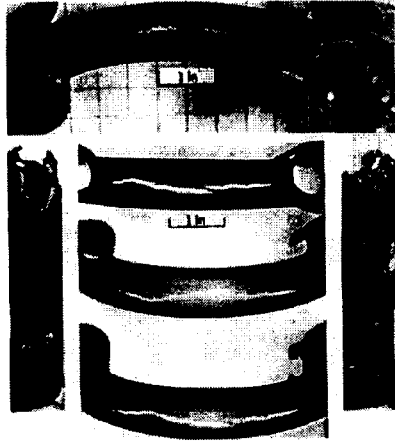
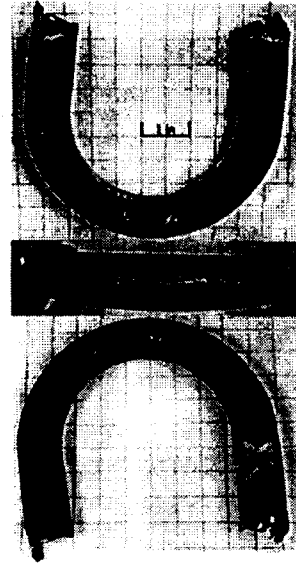
Figure 7. Apex crack location, on row 1 U-bend, which leaked in September 1976.

The rapid leakage event is characterized by the Surry 2, row 1 U-Bend tube rupture event of September 15, 1976, (Figure 7), which is described in NUREG/CR-6365⁷. The NRC estimate of leakage for this event was 330 gpm, in contrast to the 80 gpm reported by the plant operator. The source of the leak was attributed to high stresses from dent related hourglassing of the top TSP flow slots and the resultant strain placed on the U-bend. Stress corrosion cracking had occurred from the primary side at both the top and bottom (extrados and intrados) of the U-bend (Figure 8). The leak occurred at the top (extrados). The sudden, high leak rate occurred because an approximately four-inch long crack network had formed over the entire top of the U-bend. The leakage from this network was low because the individual through-wall sections of the crack were each relatively short, and, although several through-wall sections may have been leaking, the combined leak rate was still very small. The essentially parallel cracks however, overlapped each other and were separated by ligaments of sound metal that continued to decrease in cross section as the cracks grew in length and branched into a three-dimensional network. This resulted in the burst resistance of the network decreasing without a substantial increase in the leak rate. At the time that the network could no longer contain the normal pressure differential, the crack network opened over about a four-inch length, resulting in the large increase in leak rate.

Radiography Reveals Both
Intrados and Extrados Cracking
in Surry 2 U-Bend

Fig. 12. Surry 2, A(EI-C7), as-received. Intrados view (top), cold-ink view (middle left), hot-ink view (middle right), and three full-section radiographs (center).

Fig. 13. Surry 2, A(EI-C7), as-received. Center picture is of extrados of U-bend.

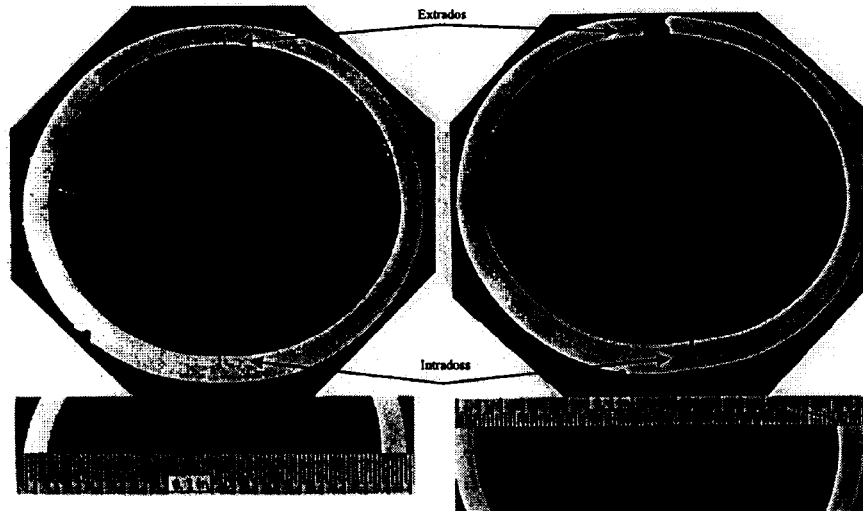
Figure 8. Cross section of row 1 U-bends for columns 6 and 7 illustrates the PWSCC crack networks on the extrados and intrados.

As a result of the leakage at Surry 2, in 1976, the leaker of R1C7, SG A, was removed along with the six tubes preceding it and the subsequent two tubes. The examination of these row 1 tubes showed that the seven adjacent to the flow slot had all experienced PWSCC. Physical measurements showed that 'pinching' of the U-bend legs had occurred, contributing to the ovalization of the tubing in the U-bend region⁹.

Metallographic Examination Confirms PWSCC
For Both U-Bend Cracking Locations

Fig. 25. Surry 2, A(EI-C8), midbend ring sample 2 for ovality and wall thickness measurements. Extrados is at top. (Notch is for identification.)

Fig. 26. Surry 2, A(EI-C7), midbend ring for ovality and wall thickness measurements. Extrados (with operation) is at top (with crack area).

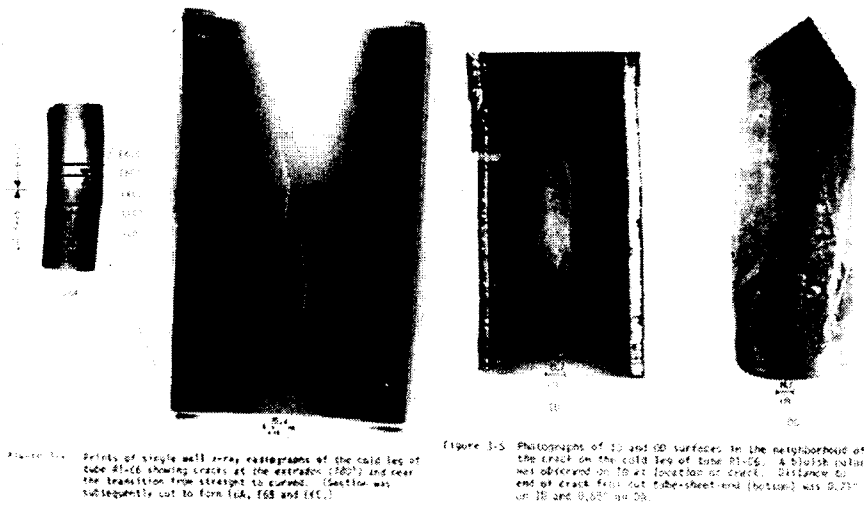
Figure 10. Radiographs, to the left of the figure, show the overall tangent point region and crack network. The visual appearance of the crack is shown to the right.

The slowly progressing leak rate leakage is typified by the degradation observed at the Trojan power plant (Figure 10). In this case, the row 1 stress corrosion cracking occurred at the tangent point on one side of the U-Bend. This tangent point was irregular, as a result of the bending process and apparently, high residual stresses in the irregular geometry, contributed to the onset of PWSCC. Because of the local geometry, the cracks do not extend for a great distance and there is reduced potential for large,

R1 U-Bend Cracking At Trojan Occurred at the Extrados Tangent Point Location

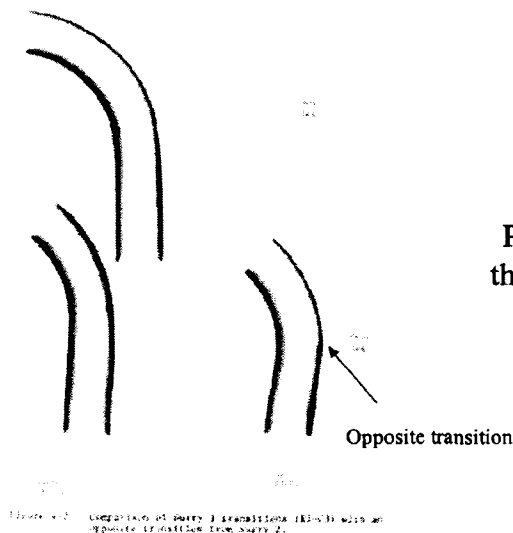
Figure 11. The radiographs to the left show the smooth tangent point transitions of a row 1 U-bend from Surry 1. The hot leg is shown above the cold leg. To the right is a radiograph of the irregular tangent point transition from a row 1 U-bend of Surry 2

As part of this tube examination effort, additional examination was made of some U-bend samples previously removed from Surry 1 and 2 and Turkey Point 4. These comparisons showed that the Surry 1 and Turkey Point 4 U-bends had only smooth transitions on both sides and no cracking was observed at the tangent locations. Surry 2 U-bends displayed both the smooth and opposite tangent point transitions and one of the locations evaluated displayed a PWSCC crack (Figure 11). This was on R1C7, the same tube with the apex location leak.

**Tangent Point U-Bend
PWSCC is Influenced by
the Shape of the Transition**
