North Anna 8/23/11 Seismic Event

NUHOMS® HD and ISFSI Pad 2 Overview

July 2012

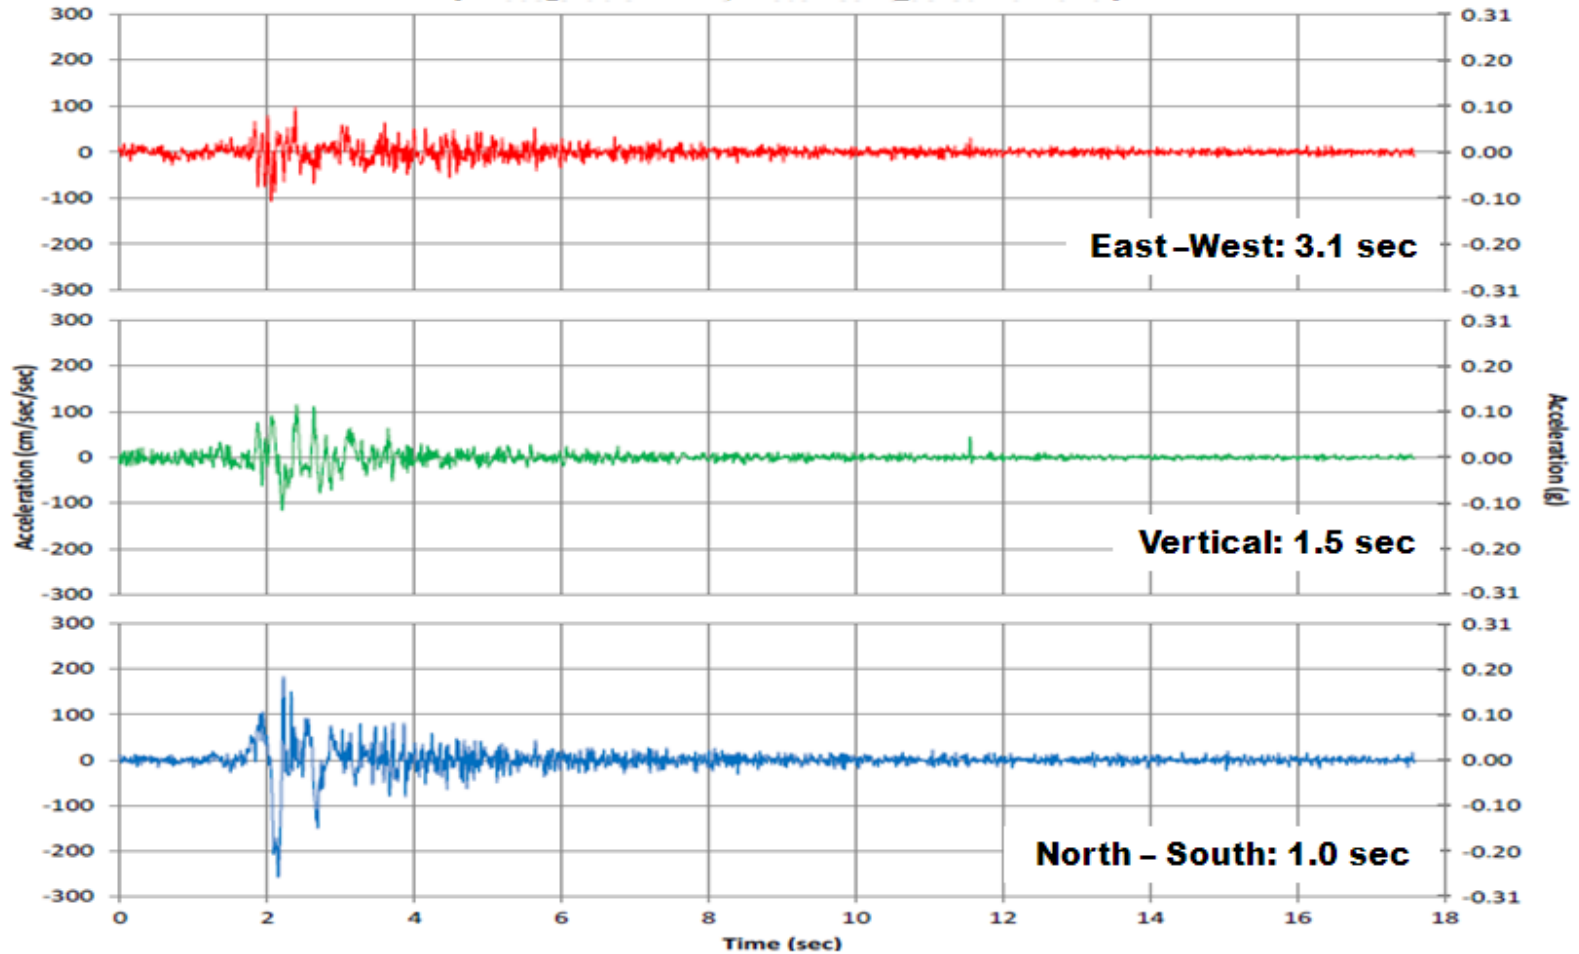
Acceleration Time Histories

- **5.8 magnitude earthquake**
- **Peak Ground Acceleration**
 - measured at Unit 1 basemat
 - 0.26 g north-south
 - 0.11 g east-west
 - 0.12 g vertical
- **Strong motion duration 3.1 seconds**

Containment Basemat (elevation 216')

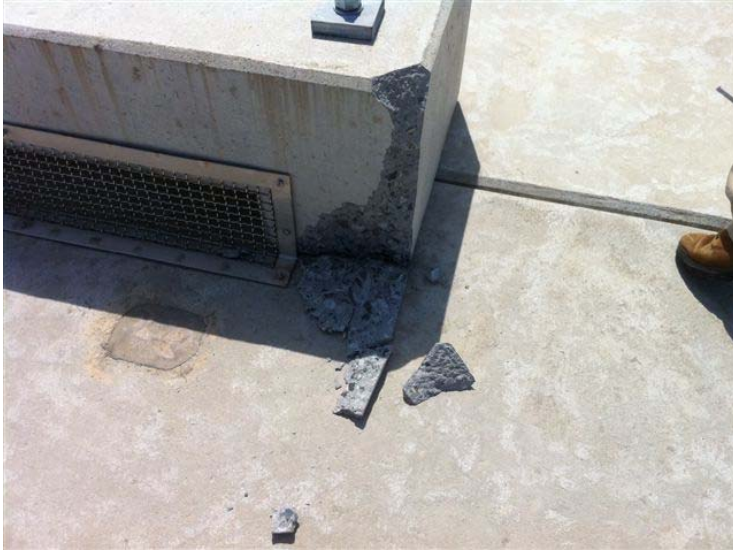
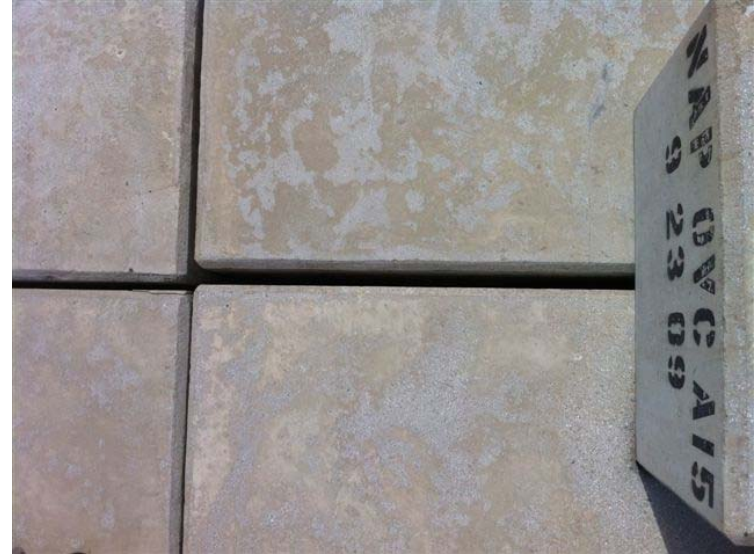
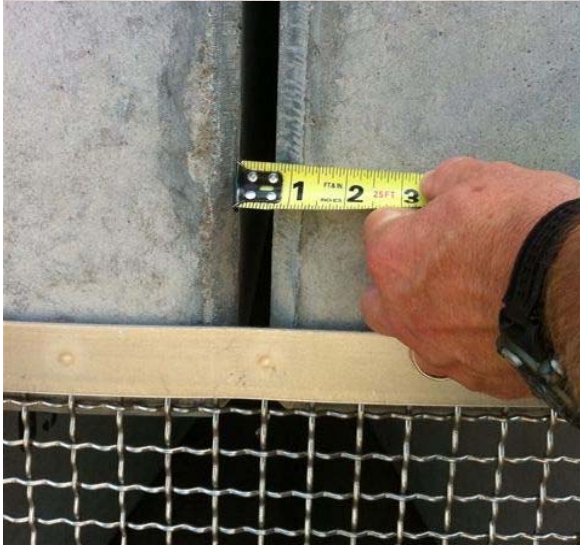
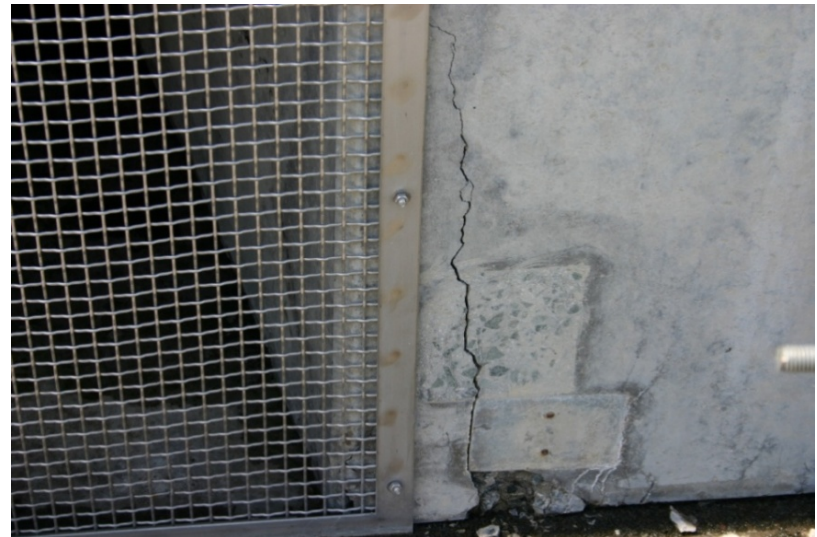
Initial Inspection Observations

- **Gaps between some base or roof components**
- **Cosmetic concrete damage**
 - on inlet vent between loaded HSM-H 1 and 3
 - on several empty HSM-H outlet vents, including associated displacement of screen
- **Some HSM-H fasteners no longer “snug-tight”**
 - could be turned by hand (ex: roof vent cover bolts)
- **Minor surface cracks in Pad 2 (pre-existing)**

- **All Concrete Repairs Completed**
- **All Fasteners Checked & Retightened**
- **All Module Alignments Re-established**
- **Delta Temperature Surveillances Normal (No Blockage)**
- **Dose Surveys Consistent with Pre-Event Measurement**
- **Recertification of HSM-H array in progress with TN**

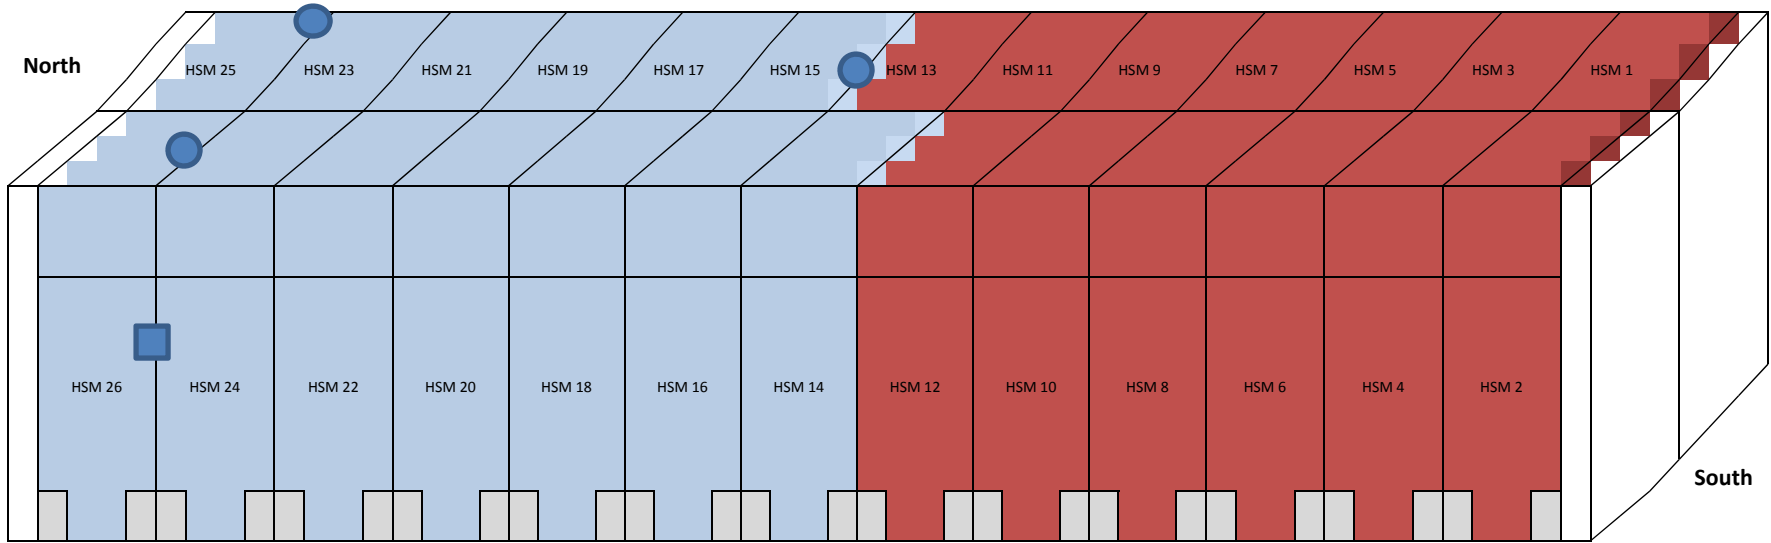
NUHOMS® HSM-H Gap Inspections Measured Gap Results

- One base-to-base gap of 1.0 inch with no contact (between empty HSM-H 24 & 26)
- Other base-to-base gaps 0.75 inch or less (typically < 0.5 inch and appear to contact)
- Three roof-to-roof gaps > 0.75 inch (maximum 1.25 inch gap between empty HSM-H 24 & 26)

HSM-H base-to-base gap > 0.75 inches
(maximum gap = 1.0 inch)

HSM-H roof-to-roof gap > 0.75 inches
(maximum gap = 1.25 inches)
