**UNITED STATES
NUCLEAR REGULATORY COMMISSION**

August 30, 2012

LICENSEE: Entergy Nuclear Operations, Inc.
FACILITY: Palisades Nuclear Plant
SUBJECT: SUMMARY OF THE AUGUST 24 AND AUGUST 28, 2012, MEETINGS
REGARDING PALISADES NUCLEAR PLANT CONTROL ROD DRIVE
MECHANISM (CRDM) 24

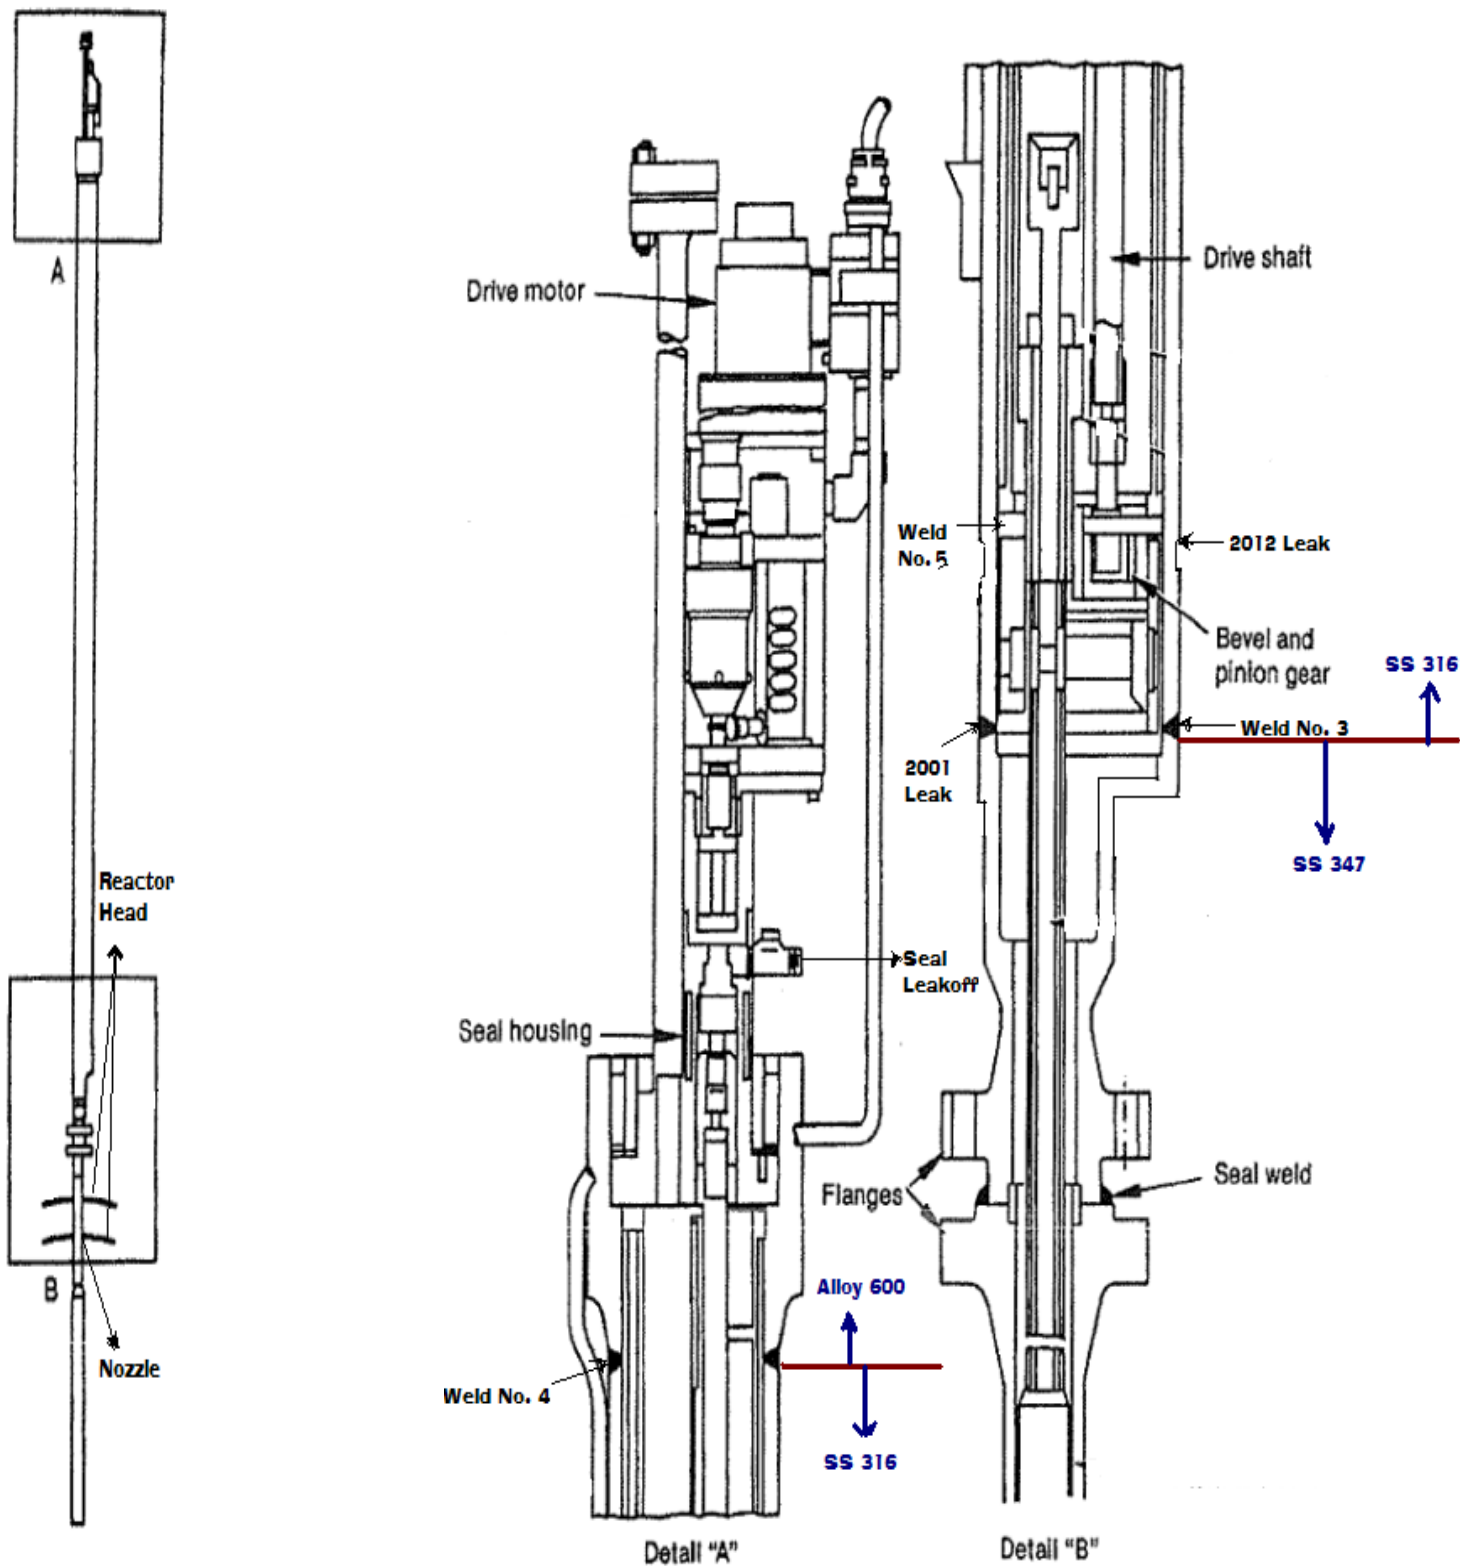
Palisades Rack and Pinion CRDM

The licensee shut down the plant on August 12, 2012, due to unidentified leakage exceeding 0.3 gallons per minute. After the shut down, the licensee identified the CRDM 24 upper housing as the source of the leakage with a pinhole leak of 1/8"x1/16" rough dimensions and located approximately 2 feet above the reactor head. This was pressure boundary leakage. The licensee indicated that they performed detailed boric acid walkdowns, performed visual inspections of all the CRDMs, and performed post walkdowns of all the CRDMs. The licensee stated that, through the use of manual ultrasonic testing (UT), they identified an axial crack emanating from an onlay weld (weld no. 5) which is located inside the upper housing on CRDM 24. The location of this crack is different from the previous CRDM 21 fault from 2001 in that it is

not from a butt weld. During their extent of condition evaluation, the licensee assumed that all the CRDM housings were subjected to a similar environment and that they were all susceptible to stress corrosion cracking. The licensee stated that the primary stress in the area of the failure was hoop stress. Hoop stress leads to axial cracks. Due to the lower axial stresses in the area, circumferential cracking was not expected. In addition, the onlay area where the fault was identified was close to a witness point, a machined area used to make accurate measurements, resulting in a slightly reduced wall thickness of the CRDM housing for an axial length of approximately 1 - 1.5 inches. The licensee also acknowledged that the area of the CRDM 24 fault was a higher stress area and was a heat affected zone of weld no. 5.

Based on the location of the fault and destructive analysis of CRDM 24, the licensee concluded that CRDM 24 experienced a failure due to TGSCC. The licensee described the extent of condition examination. The licensee reported that the ASME Code In Service Inspection (ISI) requirements did not apply in this case as the weld in question (weld no. 5) was not a pressure retaining weld addressed by the Code. This weld was an overlay located inside the housing. However, they applied the guidance in the ASME Code to inspect 10 percent of the CRDM housings. They stated that although less than five CRDMs (10 percent) were required to be inspected per the ASME Code, they were conservative in selecting eight peripheral CRDMs for additional inspections. Based on their knowledge of the history related to previous CRDM failures (most failures in both the upper housing and seal housing occurred on the peripheral), they selected CRDM 25 (which experienced a seal housing leak), CRDM 22 (which experienced a seal housing crack), CRDM 21 (which experienced the upper housing crack in 2001), CRDM 2 and 26 (which experienced a seal housing leak) and CRDMs 23, 27, and 28.

The licensee stated that the thru wall leak identified on CRDM 24 was related to a sub-surface defect in the onlay area with the flaw growing over six refueling cycles. The NRC stated that, for TGSCC to start, it was likely to be on the surface versus below the surface (as pockets will accumulate the impurities in oxygenated atmosphere) and that the flaw could be growing in a time period that was less than six refueling cycles because of the temperature changes experienced by the CRDMs when the plant heated up or cooled down. The NRC added that the licensee would have to show that the CRDMs were unaffected by the temperature cycles that were experienced in between refueling cycles. In addition, the NRC asked the licensee if they had a crack growth analysis prior to entering Mode 4 to ensure that the crack will not progress to a thru wall leak during plant operations. The licensee indicated one was complete or almost complete. The SIT had not seen this analysis.
