**UNITED STATES
NUCLEAR REGULATORY COMMISSION**

August 30, 2012

LICENSEE: Entergy Nuclear Operations, Inc.
FACILITY: Palisades Nuclear Plant
SUBJECT: SUMMARY OF THE AUGUST 24 AND AUGUST 28, 2012, MEETINGS
REGARDING PALISADES NUCLEAR PLANT CONTROL ROD DRIVE
MECHANISM (CRDM) 24

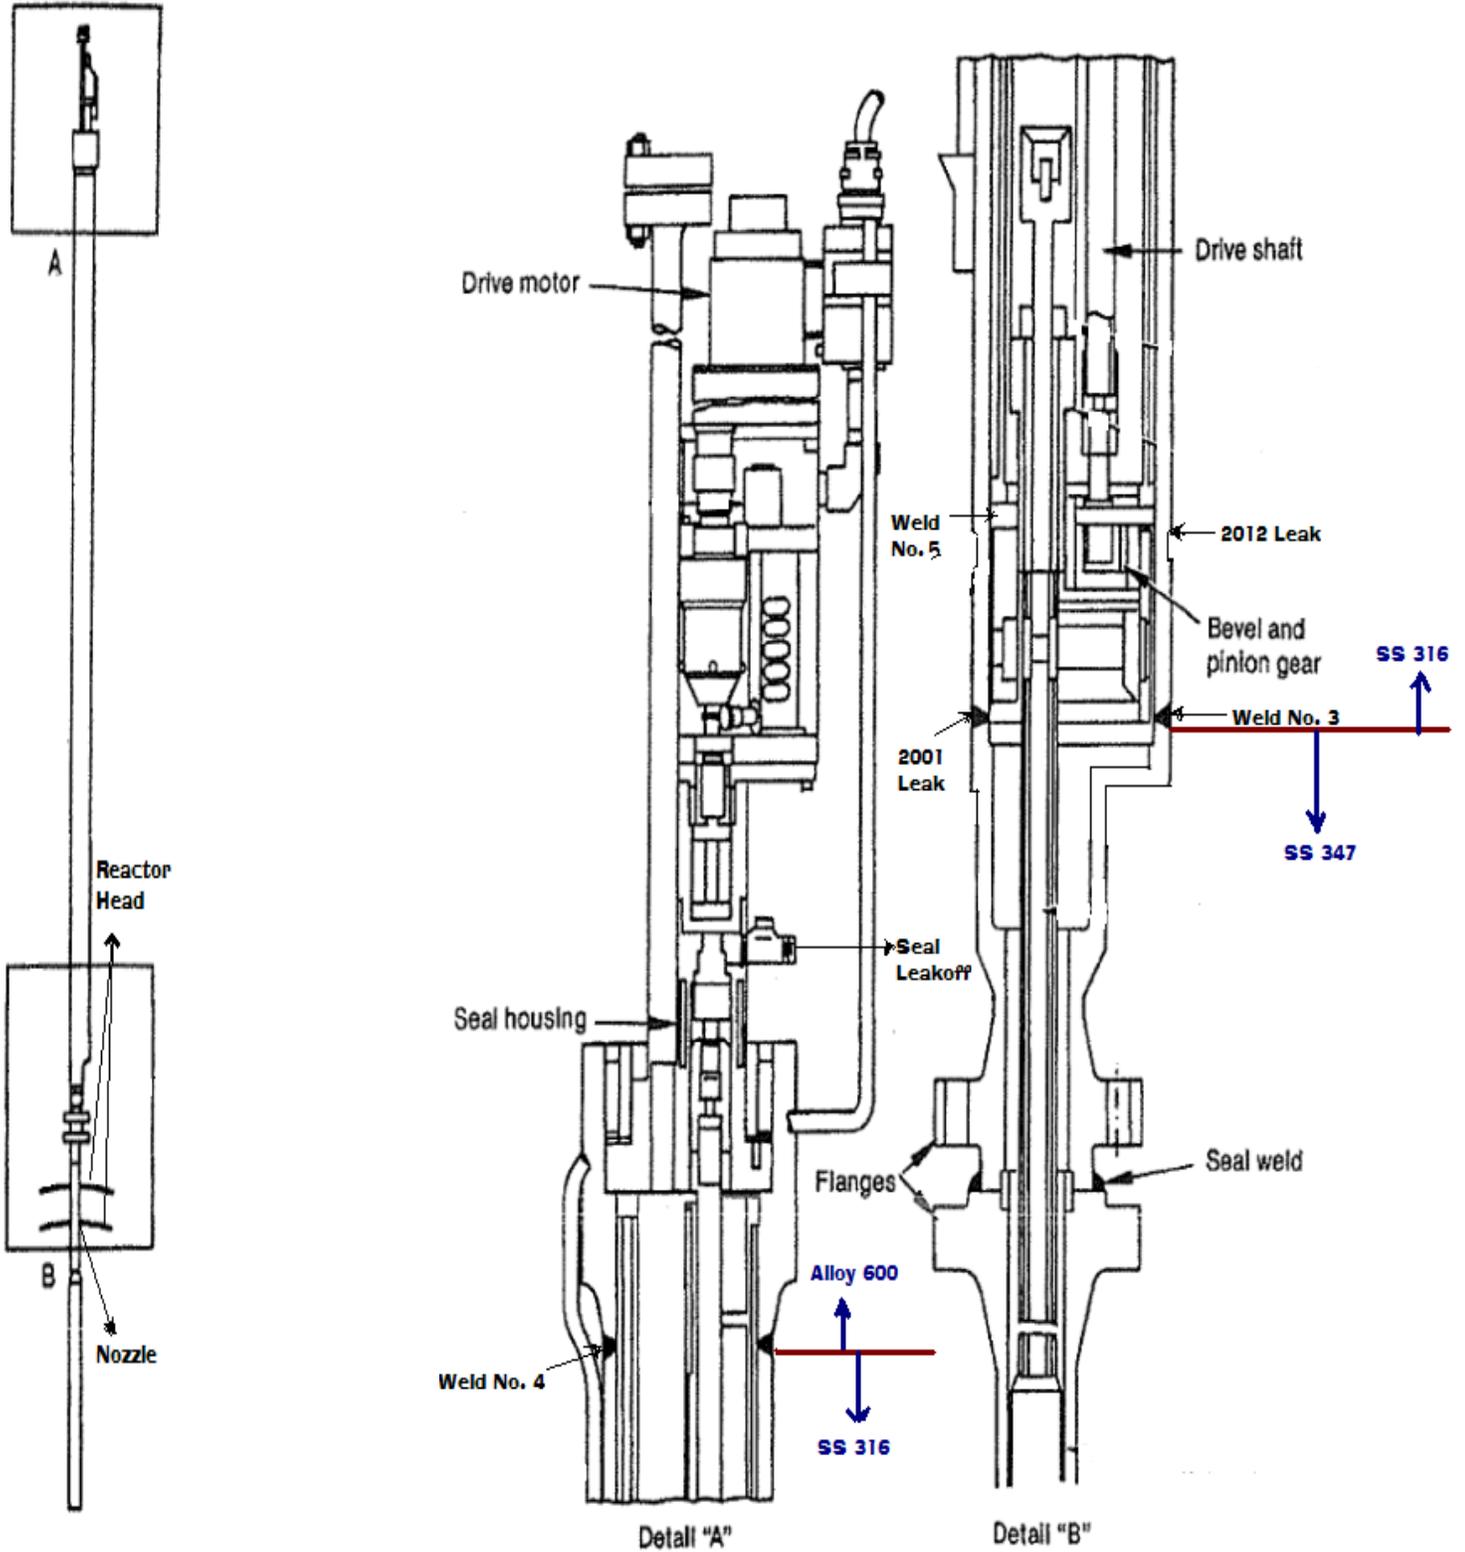
Palisades Rack and Pinion CRDM

The licensee shut down the plant on August 12, 2012, due to unidentified leakage exceeding 0.3 gallons per minute. After the shut down, the licensee identified the CRDM 24 upper housing as the source of the leakage with a pinhole leak of 1/8"x1/16" rough dimensions and located approximately 2 feet above the reactor head. This was pressure boundary leakage. The licensee indicated that they performed detailed boric acid walkdowns, performed visual inspections of all the CRDMs, and performed post walkdowns of all the CRDMs. The licensee stated that, through the use of manual ultrasonic testing (UT), they identified an axial crack emanating from an onlay weld (weld no. 5) which is located inside the upper housing on CRDM 24. The location of this crack is different from the previous CRDM 21 fault from 2001 in that it is

not from a butt weld. During their extent of condition evaluation, the licensee assumed that all the CRDM housings were subjected to a similar environment and that they were all susceptible to stress corrosion cracking. The licensee stated that the primary stress in the area of the failure was hoop stress. Hoop stress leads to axial cracks. Due to the lower axial stresses in the area, circumferential cracking was not expected. In addition, the onlay area where the fault was identified was close to a witness point, a machined area used to make accurate measurements, resulting in a slightly reduced wall thickness of the CRDM housing for an axial length of approximately 1 - 1.5 inches. The licensee also acknowledged that the area of the CRDM 24 fault was a higher stress area and was a heat affected zone of weld no. 5.
