Re: Turkey Point Unit 3
Docket No. 50-250
Reportable Event: 2012-002-00
Non-Compliance with Technical Specification 3.4.9.3 due to Manual Isolation Valve
Found in Incorrect TS Configuration

LICENSEE EVENT REPORT (LER)

1. FACILITY NAME									2. DOCKET NUMBER	3. PAGE																											
Turkey Point Unit 3									05000250	1 of 5																											
4. TITLE																																					
Non-compliance with TS 3.4.9.3 due to Manual Isolation Valve Found in Incorrect TS Configuration

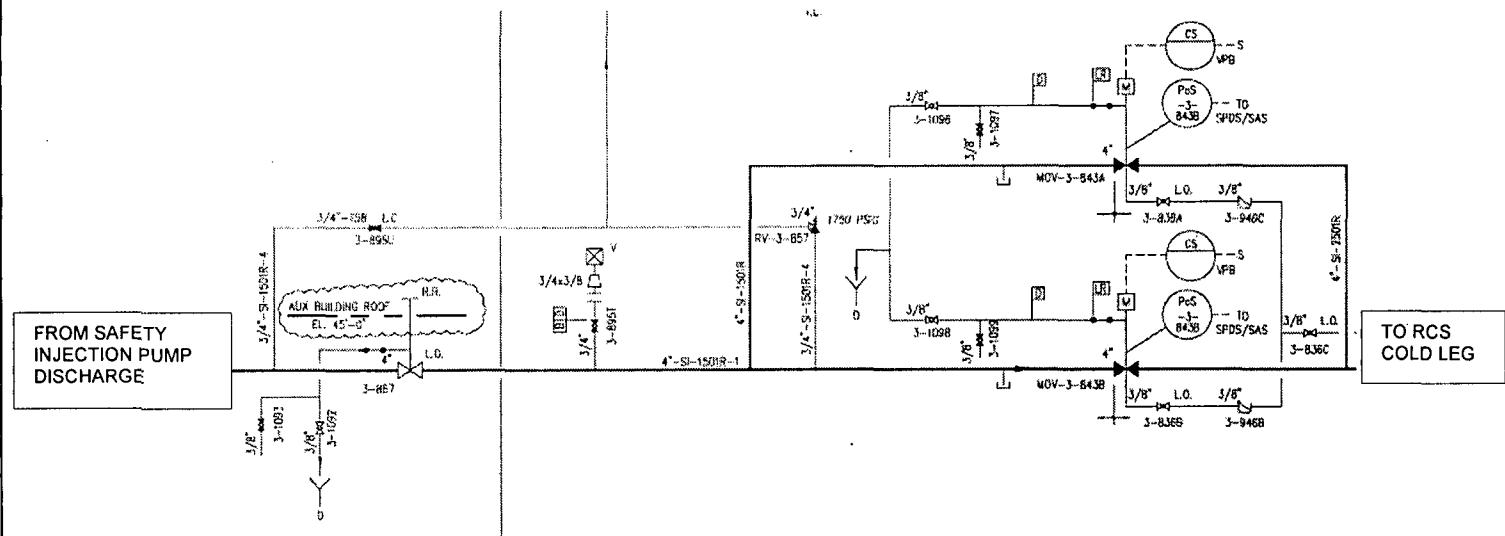
The HHSI system is designed to supply borated water to the RCS system to make up for any loss of inventory and to maintain core cooling during a Loss of Coolant Accident (LOCA). Safety Injection boundary isolation valve, 3-867 is downstream of the HHSI pumps. Valve 3-867 is located in the Containment Spray Pump room with a reach rod handwheel located on the Auxiliary Building roof. The HHSI Cold Leg Injection Isolation valves, MOV-3-843A/B, are located downstream of 3-867 in a parallel arrangement and actuate open upon a Safety Injection signal. During Modes 1-3, valve 3-867 is locked open and MOV-3-843A/B are closed with their associated power supply breakers energized. While shutdown in Modes 4-6, MOV-3-843A/B are required to be closed with the breakers de-energized or 3-867 is required to be locked closed in order to prevent pressurized thermal shock in the event of an inadvertent safety injection and subsequent over- pressurization of the RCS. The following schematic represents the configuration for the manual isolation valve 3-867, and the HHSI Cold Leg Injection Isolation valves MOV-3-843A/B:
