L-2012-334
10 CFR § 50.73

Re: Turkey Point Unit 3
Docket No. 50-250
Reportable Event: 2012-002-00
Non-Compliance with Technical Specification 3.4.9.3 due to Manual Isolation Valve
Found in Incorrect TS Configuration

4. TITLE
Non-compliance with TS 3.4.9.3 due to Manual Isolation Valve Found in Incorrect TS Configuration

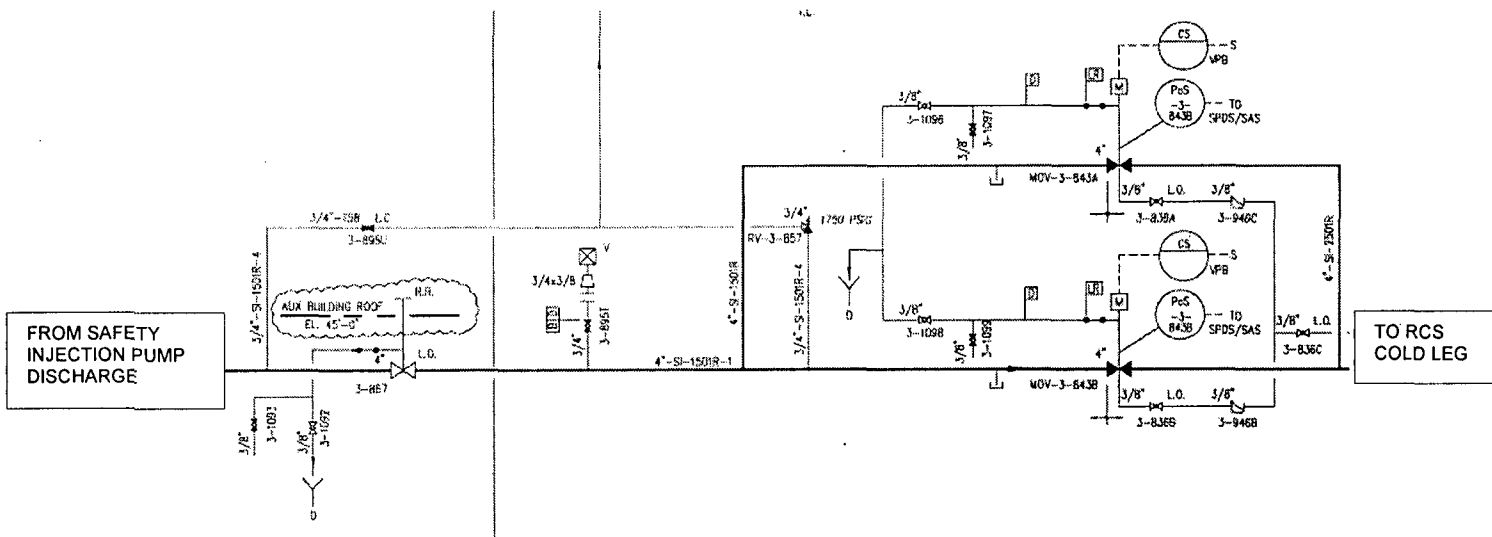
The HHSI system is designed to supply borated water to the RCS system to make up for any loss of inventory and to maintain core cooling during a Loss of Coolant Accident (LOCA). Safety Injection boundary isolation valve, 3-867 is downstream of the HHSI pumps. Valve 3-867 is located in the Containment Spray Pump room with a reach rod handwheel located on the Auxiliary Building roof. The HHSI Cold Leg Injection Isolation valves, MOV-3-843A/B, are located downstream of 3-867 in a parallel arrangement and actuate open upon a Safety Injection signal. During Modes 1-3, valve 3-867 is locked open and MOV-3-843A/B are closed with their associated power supply breakers energized. While shutdown in Modes 4-6, MOV-3-843A/B are required to be closed with the breakers de-energized or 3-867 is required to be locked closed in order to prevent pressurized thermal shock in the event of an inadvertent safety injection and subsequent over-pressurization of the RCS. The following schematic represents the configuration for the manual isolation valve 3-867, and the HHSI Cold Leg Injection Isolation valves MOV-3-843A/B:
