Dresden Nuclear Power Station

Subject: Licensee Event Report 249/2012-001-00, Unexpected Isolation of the Isolation
Condenser Due to Test Switch Failure

LICENSEE EVENT REPORT (LER)

4. TITLE
Unexpected Isolation of the Isolation Condenser Due to Test Switch Failure

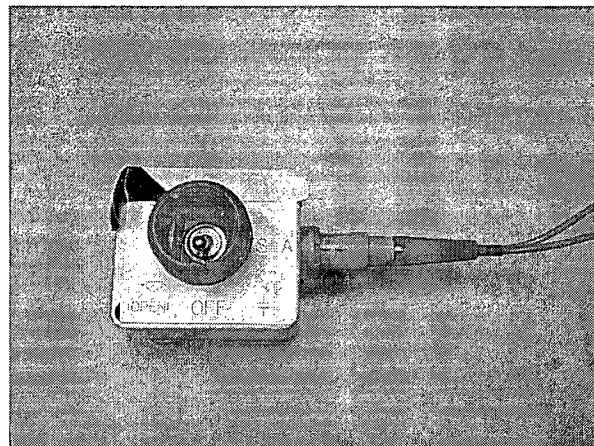
Test Toggle Switch

Following the unexpected isolation, walkdowns were performed to verify that the proper configuration had been used. No anomalies were identified. Voltage at the termination points of TS-A was tested and confirmed that the installed TTS had failed to maintain electrical continuity.

The suspect TTS was sent for failure analysis. The failure analysis indicated that the most probable cause was grease on the TTS internal stationary contacts. The TTSs were assembled by plant instrument maintenance personnel between 1998 and 2000. Even though the TTS test leads are periodically replaced, there have been no preventative maintenance activities to identify age-related degradation with regard to TTS internal operations.

All TTSs were replaced. A preventative maintenance activity is being generated to inspect or refurbish all TTSs assembled by the instrument maintenance personnel on a periodic basis.
