**Dresden Nuclear Power Station**

Subject: Licensee Event Report 249/2012-001-00, Unexpected Isolation of the Isolation  
Condenser Due to Test Switch Failure

**4. TITLE**  
Unexpected Isolation of the Isolation Condenser Due to Test Switch Failure

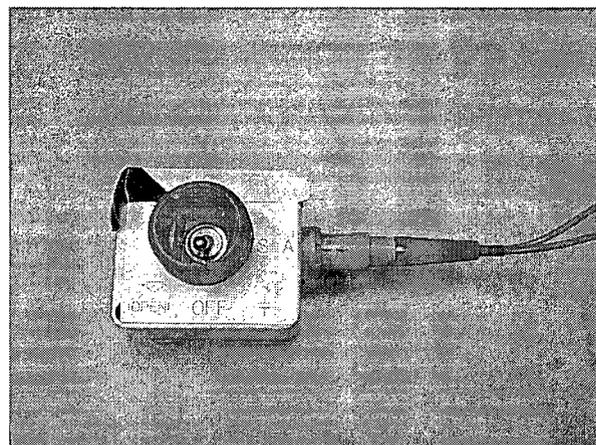
Test Toggle Switch

Using plant procedures, maintenance personnel commenced testing of differential pressure indicating switch 3-1350A, Isolation Condenser high steam flow. The toggle switches for TTS TS-A and TS-AA were placed in the "ON" positions. At approximately 0236 hours, a high flow signal was simulated and the 0595-115A relay de-energized as expected. However, the main control room received an unexpected annunciator indicating an isolation condenser line break due to trip logic relay 0595-116A also de-energizing as relay 0595-115A changed state. This occurrence indicated that TS-A, which had been installed in parallel to contacts 3 and 4 of relay 0595-115A, had not maintained electrical continuity.

Following the unexpected isolation, walkdowns were performed to verify that the proper configuration had been used. No anomalies were identified. Voltage at the termination points of TS-A was tested and confirmed that the installed TTS had failed to maintain electrical continuity.

The suspect TTS was sent for failure analysis. The failure analysis indicated that the most probable cause was grease on the TTS internal stationary contacts. The TTSs were assembled by plant instrument maintenance personnel between 1998 and 2000. Even though the TTS test leads are periodically replaced, there have been no preventative maintenance activities to identify age-related degradation with regard to TTS internal operations.

All TTSs were replaced. A preventative maintenance activity is being generated to inspect or refurbish all TTSs assembled by the instrument maintenance personnel on a periodic basis.
