SUBJECT: DAVIS-BESSE NUCLEAR POWER STATION - INSPECTION TO EVALUATE IN THE CHANGES IN THE REVISED ROOT CAUSE ANALYSIS REPORT FOR CRACKING IN REINFORCED CONCRETE SHIELD BUILDING OF THE CONTAINMENT SYSTEM 05000346/2012010(DRS)

Report No: 05000346/2012010(DRS)

Facility: Davis-Besse Nuclear Power Station

ATTACHMENT 2 – PHOTOS AND DIAGRAMS

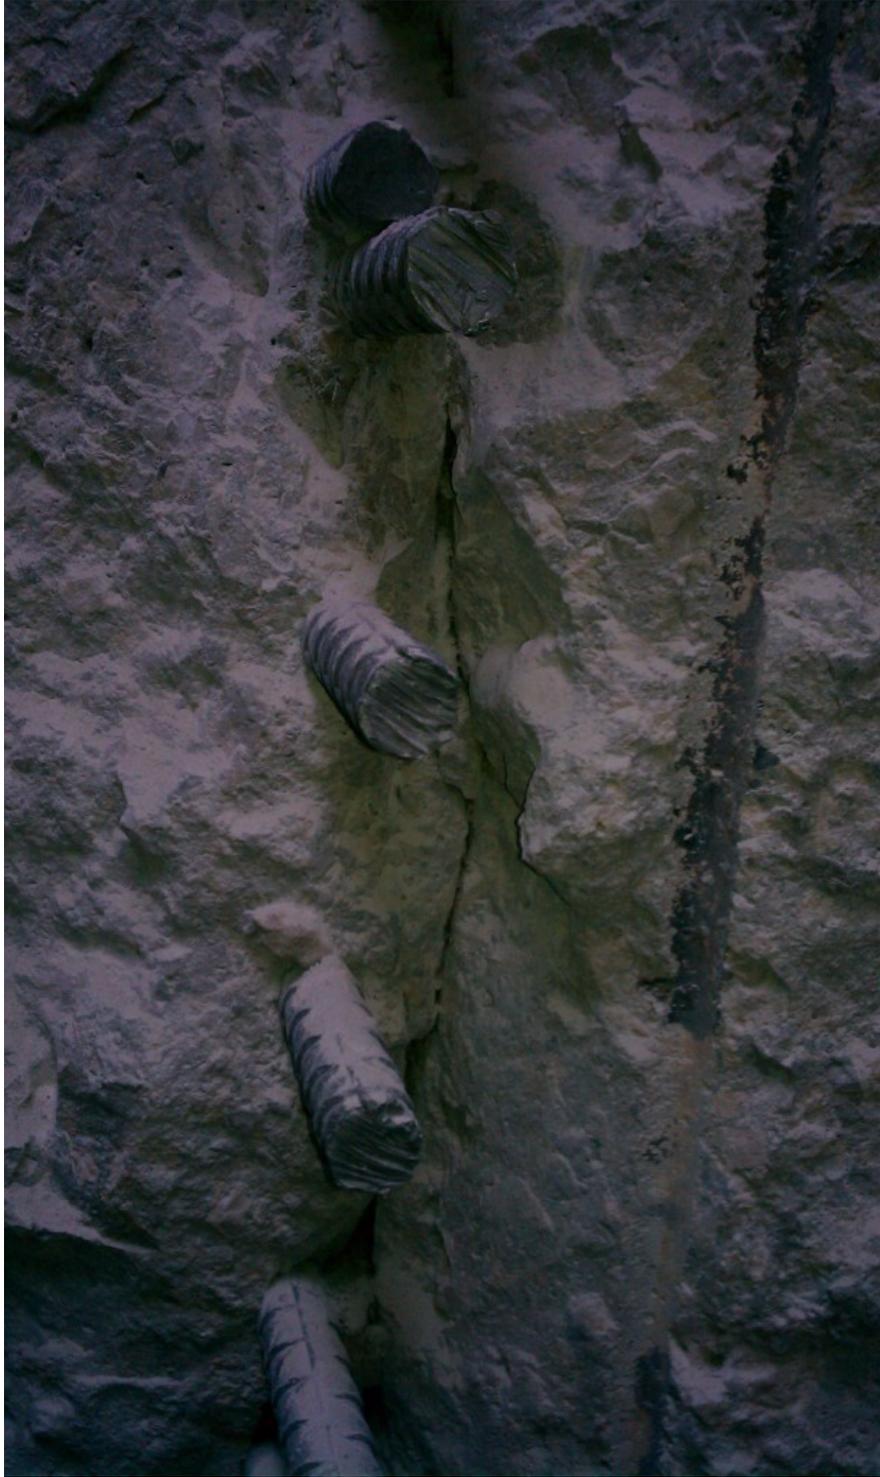
Picture No. 3 - Davis-Besse Shield Building Laminar Subsurface Cracking

During construction of the SB access opening in the 17-mid-cycle outage, the licensee discovered subsurface cracking located near the outer rebar mat, which extended into areas of the SB that has not been modified since original construction. The licensee attempted to remove the cracks discovered during the hydrodemolition process (Attachment 2, Picture 3) using a manual chipping process. Using this method, the crack indications along the left and bottom edges essentially disappeared, but the crack at the top of the opening did not disappear. The licensee investigated and confirmed the extent of subsurface laminar cracking through the use of Impulse Response Testing and Core Boring Samples (CBS) taken from the SB. Specifically, laminar subsurface concrete cracks were identified along the outer rebar mat in the SB flute shoulders, at the top of the SB near the junction with the roof, and at the SB main steam line penetrations. The licensee was able to demonstrate that the SB remained structurally adequate for the controlling load cases and remained capable of performing its safety functions.

(Note: initial condition after hydrodemolition to create an opening in the shield building and is included to show the relative location of subsurface laminar cracking. Based upon core bore samples, the crack condition (e.g., crack width) shown does not represent the laminar crack conditions in the sections of the shield building unaffected by the hydrodemolition process.)
