Donald C. Cook Nuclear Plant Unit 2  
2012 STEAM GENERATOR TUBE INSPECTION REPORT

### Unit 2 2012 Steam Generator Tube Inspection Report

In April of 2012, steam generator (SG) inservice inspections were conducted on Donald C. Cook Nuclear Plant (CNP) Unit 2. In accordance with the reporting requirements of CNP Technical Specification (TS) 5.6.7, the results of the inspection are provided herein.

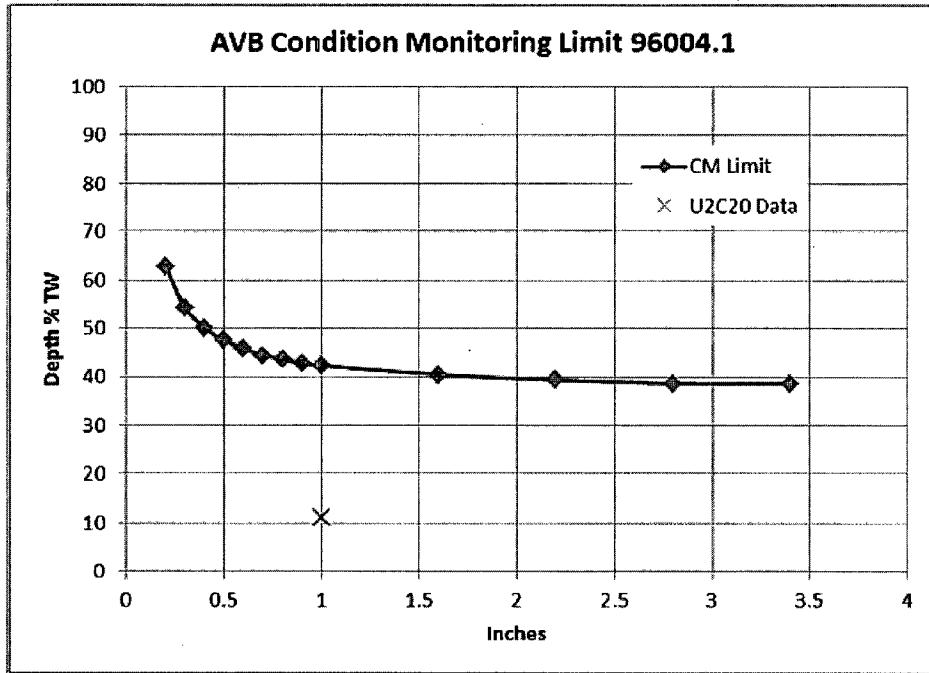
### AVERAGE DEPTH ANTI-VIBRATION BAR WEAR CONDITION MONITORING LIMIT

A single AVB wear indication was reported in the SGs. The indication was located in SG 23 on the third AVB (upper most AVB on the hot leg side of the SGs) and had a reported depth of 11%. The indication represents the only AVB related wear indication reported on the Unit 2 SGs since they became operational. The affected tube was left in service.

Degradation specific condition monitoring limits were applied to the indications in the remaining tubes for each degradation mode (anti-vibration and tube support wear). As shown in the figures below, no degradation exceeded the technical specification repair limit of 40 %TW or the condition monitoring limits.

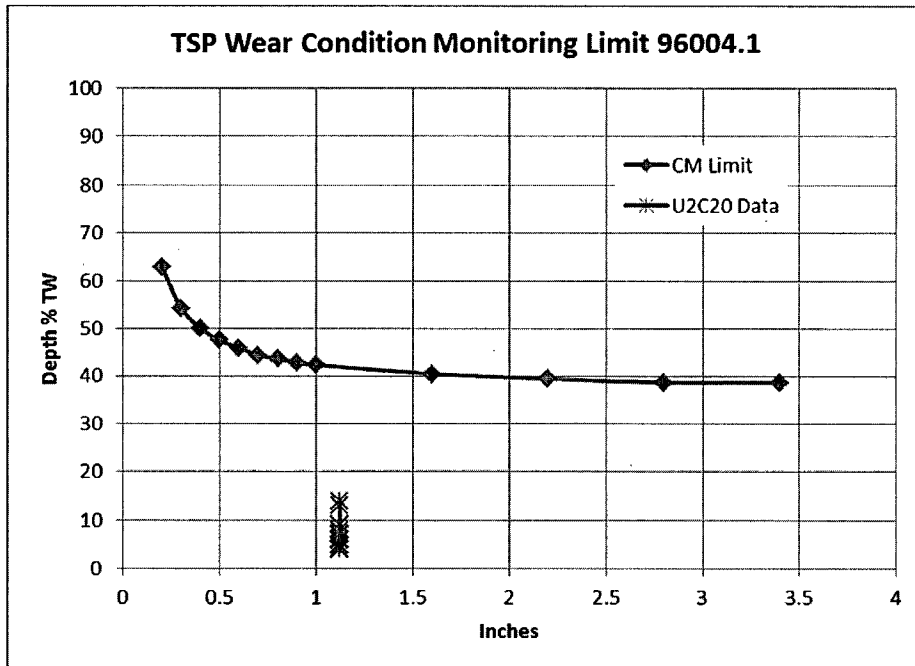
### AVERAGE DEPTH TUBE SUPPORT PLATE WEAR CONDITION MONITORING LIMIT

TSP wear showed a mild increase in the number of indications reported in U2C20 over the previous inspection (2007). The 2007 inspection examined a nominal 58% of the tubes and recorded seven total TSP indications with a maximum depth of 12%.

During the 100% examination in 2012, 40 TSP wear indications were reported. As shown in the response to report item "D", the maximum depth of the TSP wear was 14 %TW (same affected tube as reported in 2007 with a 12% indication). None of the associated tubes were removed from service.
