**SUBJECT: PALISADES NUCLEAR PLANT - NRC SPECIAL INSPECTION TEAM (SIT)
REPORT 05000255/2012012**

Report No.: 05000255/2012012

Facility: Palisades Nuclear Plant

Palisades Control Rod Drive Mechanism Housing Through Wall Crack

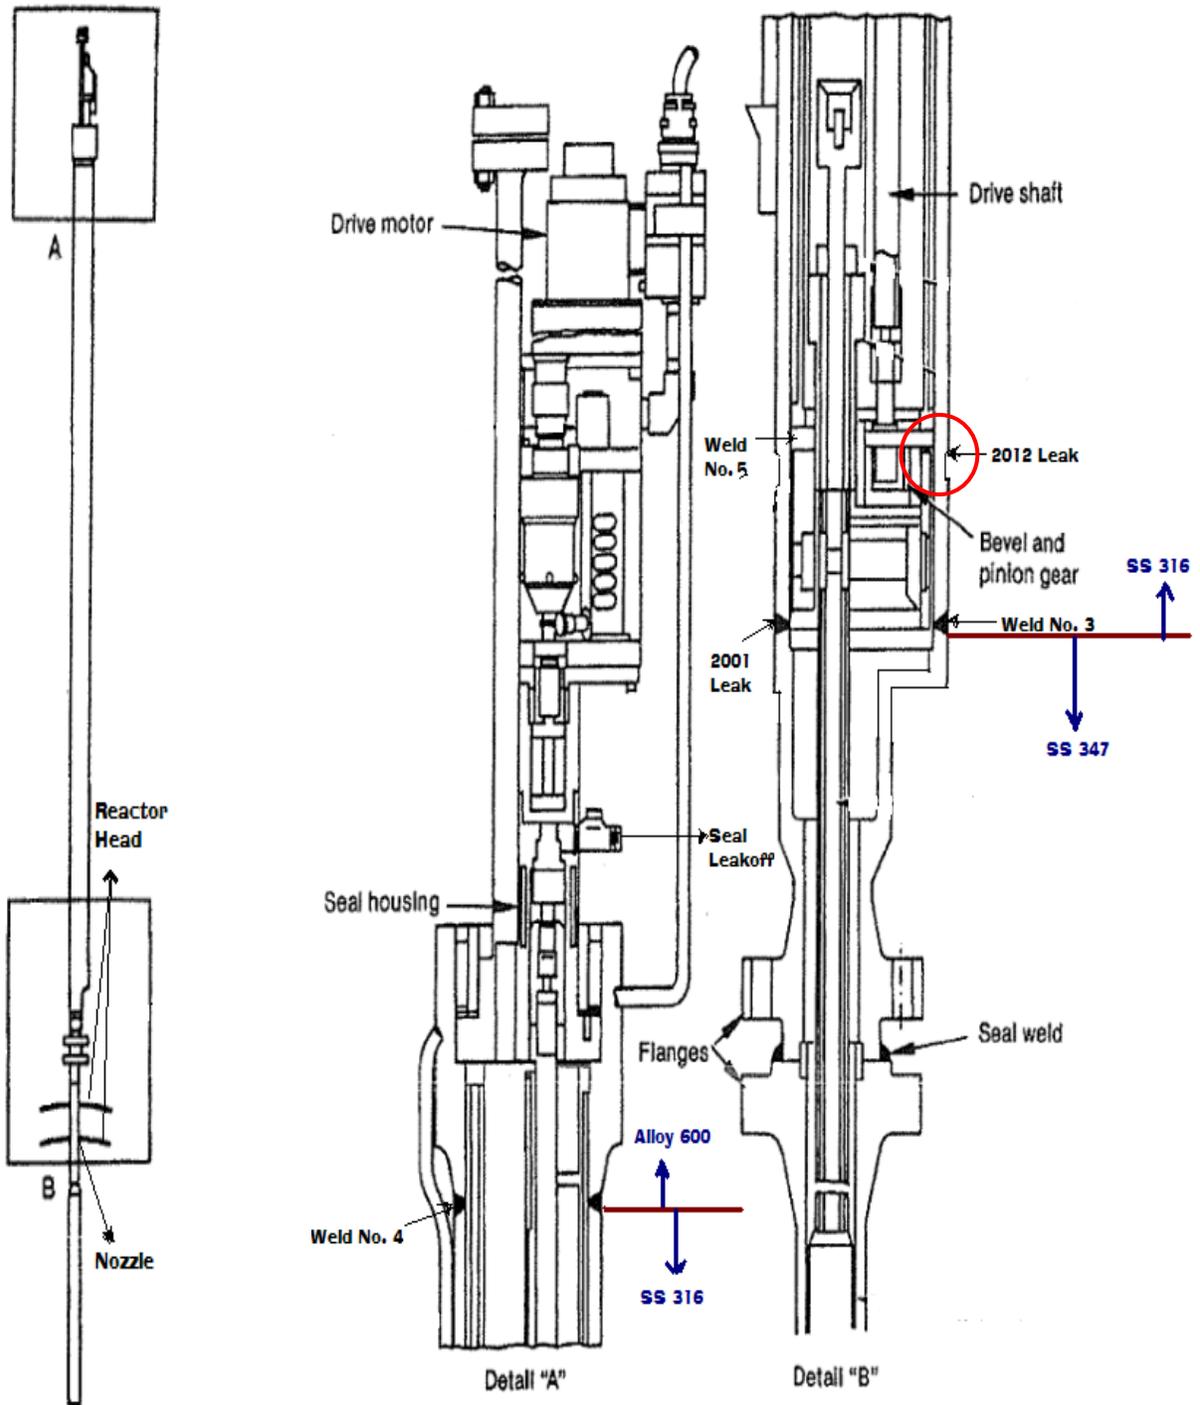
Palisades Rack and Pinion CRDM

The leak was present in the lower witness band of the Type 316L stainless steel pipe section of the upper housing of CRDM-24 located above Weld No.3 (see attachment 4). Weld No.3 was a butt weld (structural weld) that joined the pipe section and the lower flange assembly of the upper housing assembly. The through-wall leak location was at the upper radius of the witness band opposite the lower taper of the internal weld build up area (non-structural weld No.5) and was axially oriented (see attachment 5). A witness band is a precisely machined area on the exterior of the pipe section used during the fabrication process as a reference for critical dimensions. A laboratory evaluation determined that the cracking in the housing of CRDM-24 was transgranular stress corrosion cracking (TGSCC) initiating from a flaw location on the inner wall, propagating outward to the outer wall. Three concurrent conditions are necessary for TGSCC to occur – namely an accumulation of tensile stresses greater than some minimum, a material that is susceptible to the cracking phenomenon, and an environment that supports cracking. An NRC inspector observed the testing done at this laboratory. In the laboratory, using a dye penetrant test, nine axial cracks were found including the crack that went through-wall. Testing done on eight additional housings (installed on the vessel head), in the same location as the cracks found on CRDM-24, found no cracks.
