Subject: 10CFR21 Reporting of Defects and Non-Compliance -
Engine Systems, Inc. Report No. 10CFR21-0106, Rev. 0

EMD (Detroit Switch) Temperature Switch – Potential Missing Set Screw

Report No. 10CFR21-0106

SYSTEM: Emergency Diesel Generator

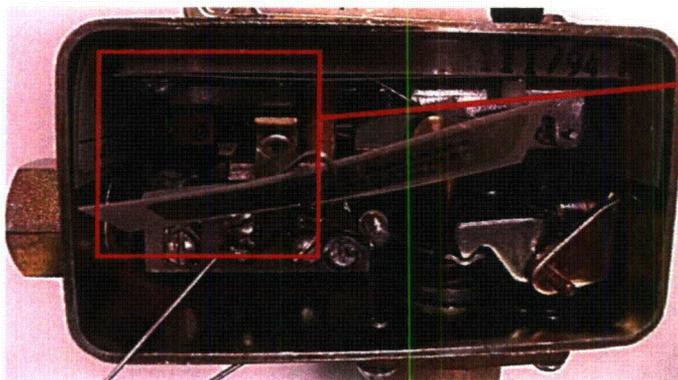
The set screw found in the temperature test fixture oil bath is 1/8" long with #6-32 threads. This is the same length, thread size and style as the set screw used in EMD/Detroit temperature switches to lock the differential adjustment screw.

TYPICAL EMD/DETROIT TEMP SWITCH
(shown with cover removed)

All affected users should inspect the suspect switches (see Table 1) for presence of the set screw at their earliest convenience. If the set screw is missing, the temperature switch should be returned to ESI for rework.

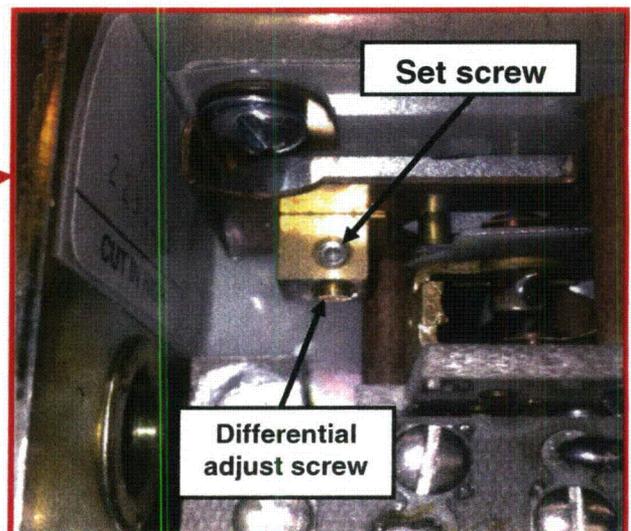
SET SCREW LOCATION

1. Loosen the screw located in the center of the temperature switch cover.
2. Remove the cover, the mounting screw and cover gasket will remain attached to the cover.
3. Look behind the insulator to access the differential adjust screw.
4. Verify that set screw is installed.
 - a. If installed, re-install the cover; temperature switch is acceptable.
 - b. If not installed, return the temperature switch to ESI for rework.
