**UNITED STATES
NUCLEAR REGULATORY COMMISSION**

October 26, 2012

LICENSEE: Entergy Nuclear Operations, Inc.
FACILITY: Palisades Nuclear Plant
SUBJECT: SUMMARY OF THE OCTOBER 12, 2012, AND OCTOBER 18, 2012,
MEETINGS REGARDING PALISADES NUCLEAR PLANT CONTROL
ROD DRIVE MECHANISM (CRDM) 24 AND CRDM 25

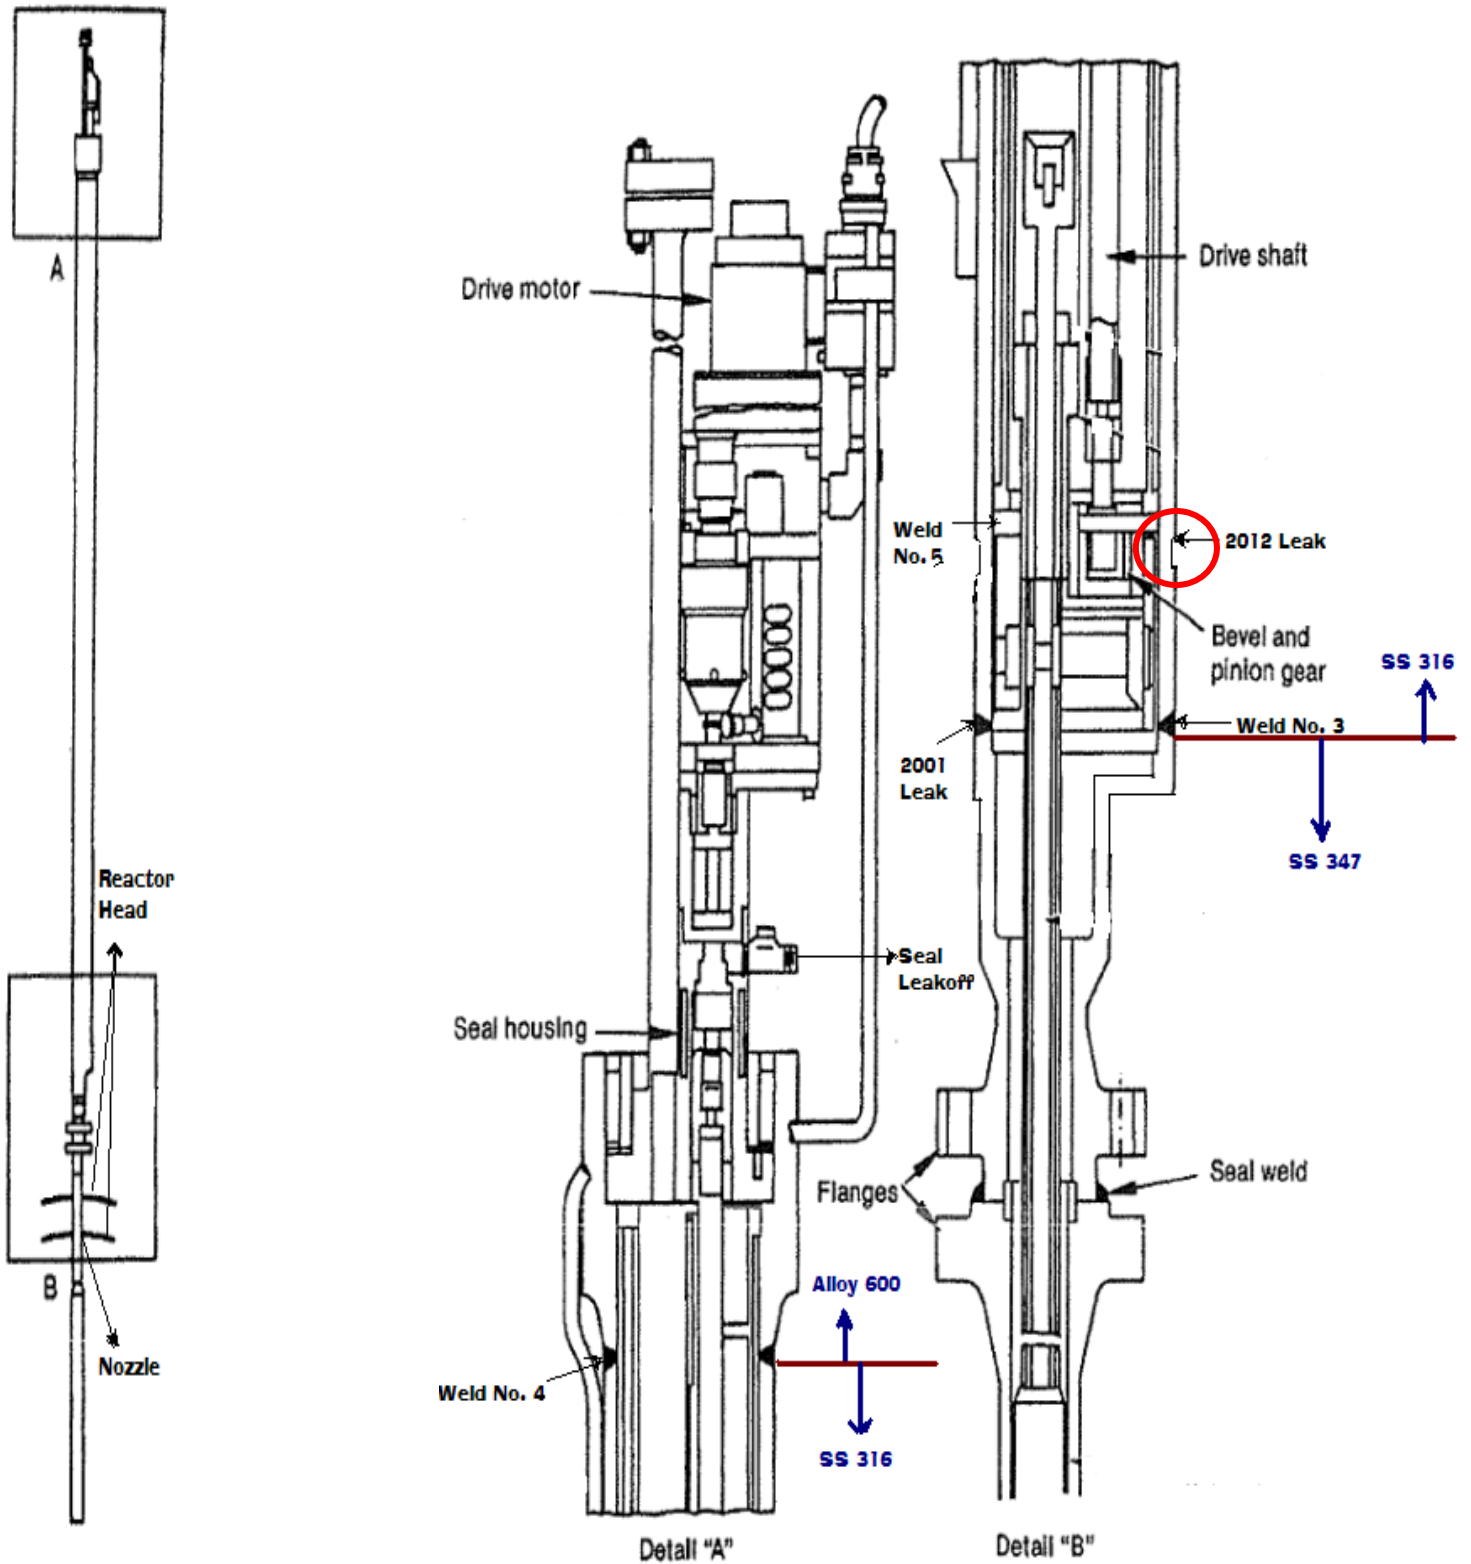
Palisades Rack and Pinion CRDM

1. The witness mark appears to be non-concentric with the CRDM housing tube;
2. Weld No. 5 appears concentric with the witness mark and therefore, non-concentric with the tube;
3. The observed cracks are located in two areas. These areas are approximately 120 degrees from each other;
4. A rub mark is present on Weld No. 5. This rub mark is approximately 120 degrees from each area of cracking. The presence of the rub mark may indicate contact between the CRDM and the CRDM housing at Weld No. 5.
5. In 2001, when the CRDM 24 housing was originally installed, it was necessary to drill out (make oversize) two bolt holes in the flange connecting the CRDM housing to the flange due to misalignment between the holes in the CRDM housing flange and the head flange.

When combined, these observations may demonstrate causes and/or effects which could create stresses in Weld No. 5 which would result in the observed cracking.
