SUBJECT: Proposed Alternative – Request for Relief from Immediate ASME
Code Flaw Repair of Service Water System Manual Valve MV-SW136

Palisades Nuclear Plant
Docket 50-255
License No. DPR-20

PROPOSED ALTERNATIVE in Accordance with 10 CFR 50.55a(a)(3)(ii) Hardship or Unusual Difficulty Without Compensating Increase in Level of Quality and Safety

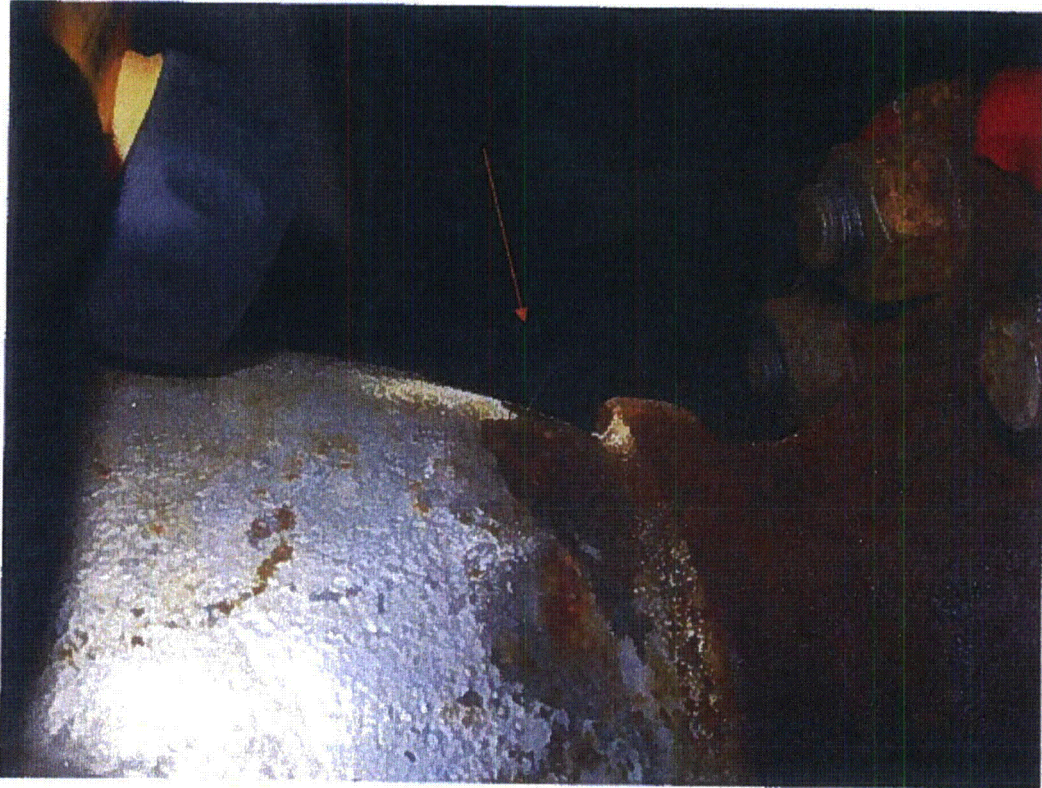
Figure 1: Photograph of Leak at MV-SW136 Valve

Initial volumetric ultrasonic testing (UT) of the body of valve MV-SW136 was performed. The body of the valve is made of cast steel with a measured nominal thickness of 0.5 inches. The pin hole leak is located approximately one inch from the toe of the flange weld, near the valve outlet. Ultrasonic testing on a 0.5 inch by 0.5 inch grid was completed by ultrasonic testing in the area surrounding the pin hole leak and the minimum wall thickness identified was 0.214 inch at the location of the pin hole.

The pin hole leak is approximately one inch from the toe of the flange weld. A 0.5 inch by 0.5 inch grid was completed by the inspector and a minimum wall thickness identified via UT was 0.214 inch at the location of the pin hole. (Reference 15, Attachment 3).

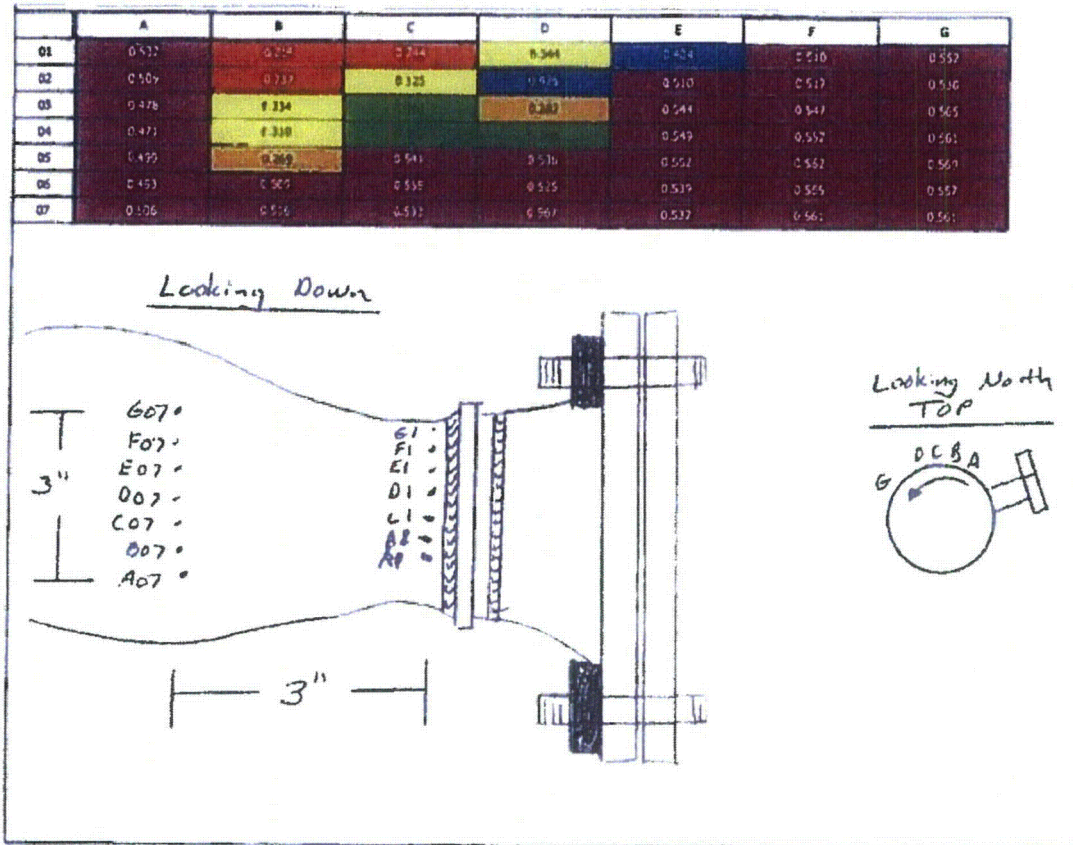
Figure 2: UT Examination Results for Outlet Side of MV-SW136 Valve

- $t_p = 0.125$ " which corresponds to the predicted end-of-evaluation period minimum thickness
- $t_{meas} = 0.214$ " which corresponds to the minimum measured thickness, and
- $t_{avg} = 0.35$ " which corresponds to the mean thickness in the thinned region

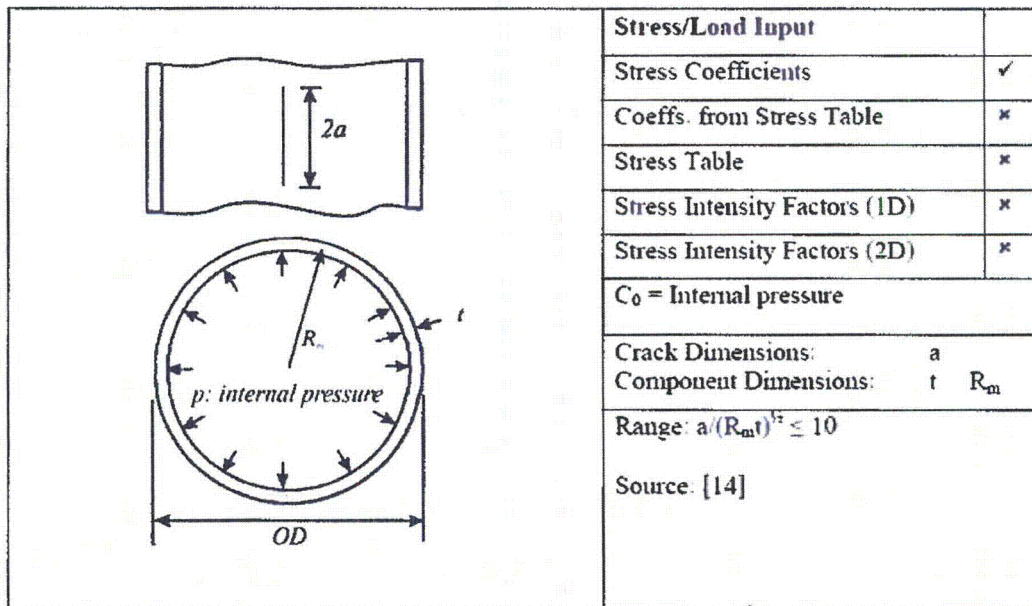
Figure 3: Fracture Mechanics Model for Axial Through-Wall Flaw

Crack Model: 310 - Through-Wall Axial Crack in Pressurized Cylinder

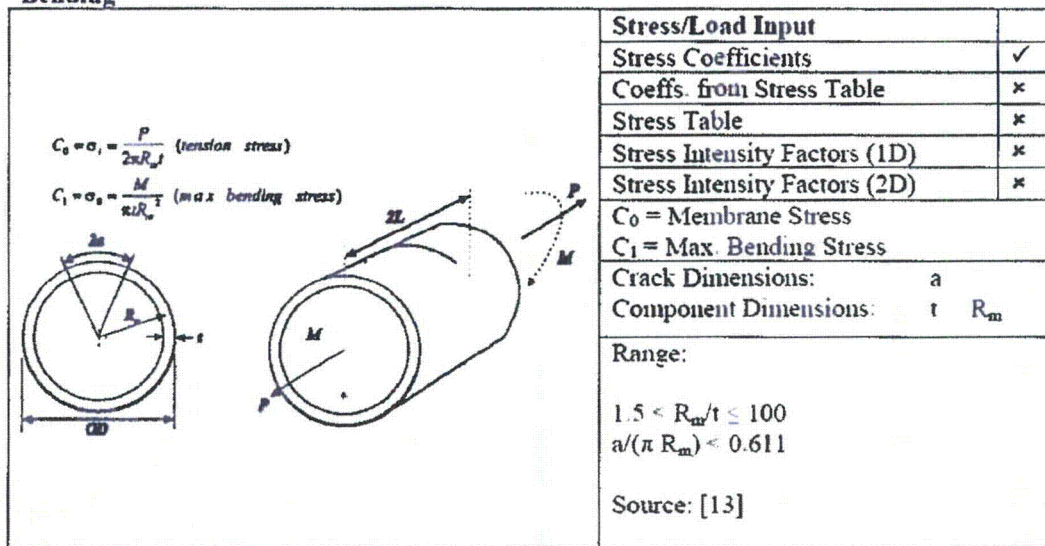
Figure 4: Fracture Mechanics Model for Circumferential Through-Wall Flaw

Crack Model: 311 - Through-Wall Circumferential Crack in Cylinder Under Tension And Bending

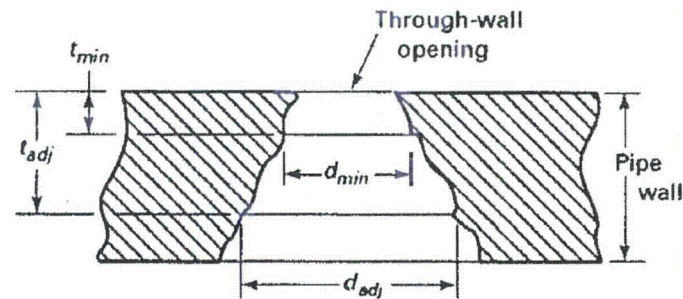
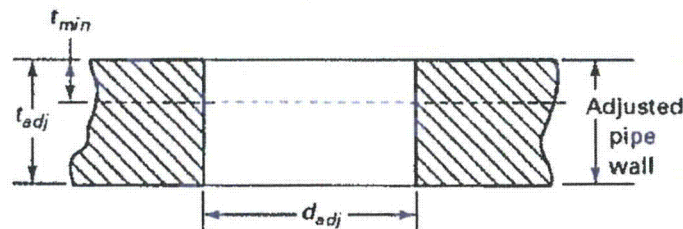
Figure 5: Illustration of Branch Reinforcement Approach

The value of t_{adj} may be conservatively taken as 0.315" – the minimum thickness measurement from Table 3 surrounding the localized thinned region (i.e., the valve body is assumed uniformly thinned at 0.315" surrounding the localized thinned region). Solving for N-513-3 Equation 8 gives the following limit on d_{adj} :

$$d_{adj} \leq 18.7"$$

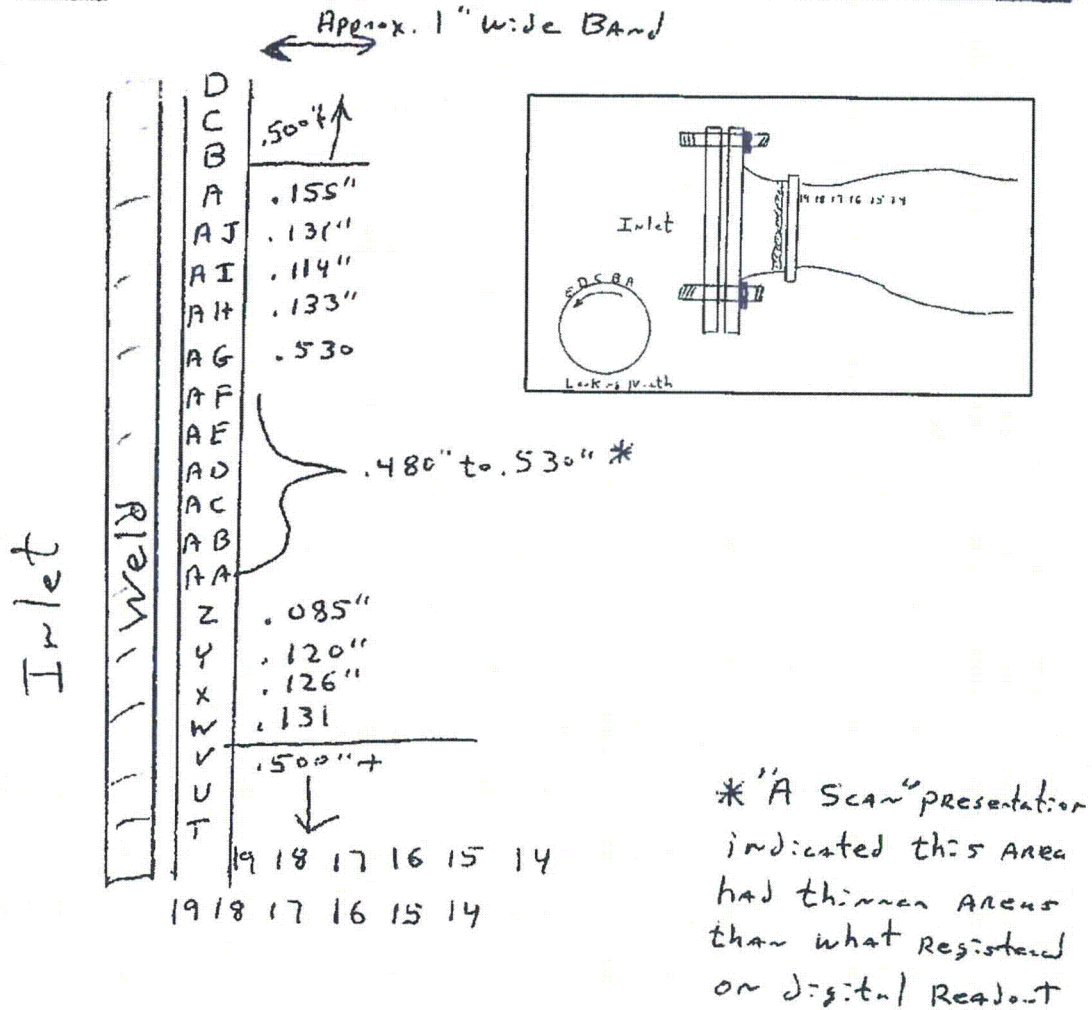
Figure 1: UT Examination Results for MV-SW136 Valve Inlet [3]

Additional UT of the valve, covering the circumference of the valve body, was performed. Wall thinning was identified at two additional locations, near the inlet of the valve body. The thickness of the first area ranged from 0.114 inch to 0.155 inch, and the thickness of the second area ranged from 0.085 inch to 0.131 inch. There was no leakage observed at either of these locations. The as-found thickness of the valve body at these two locations is greater than the required minimum wall thickness.

The thinnest wall location is 0.085" at the inlet of the valve body at approximately the 4 o'clock position. There is no through wall leak at this location, nor the A-AH thinned location. (Reference 28, Attachment 4)

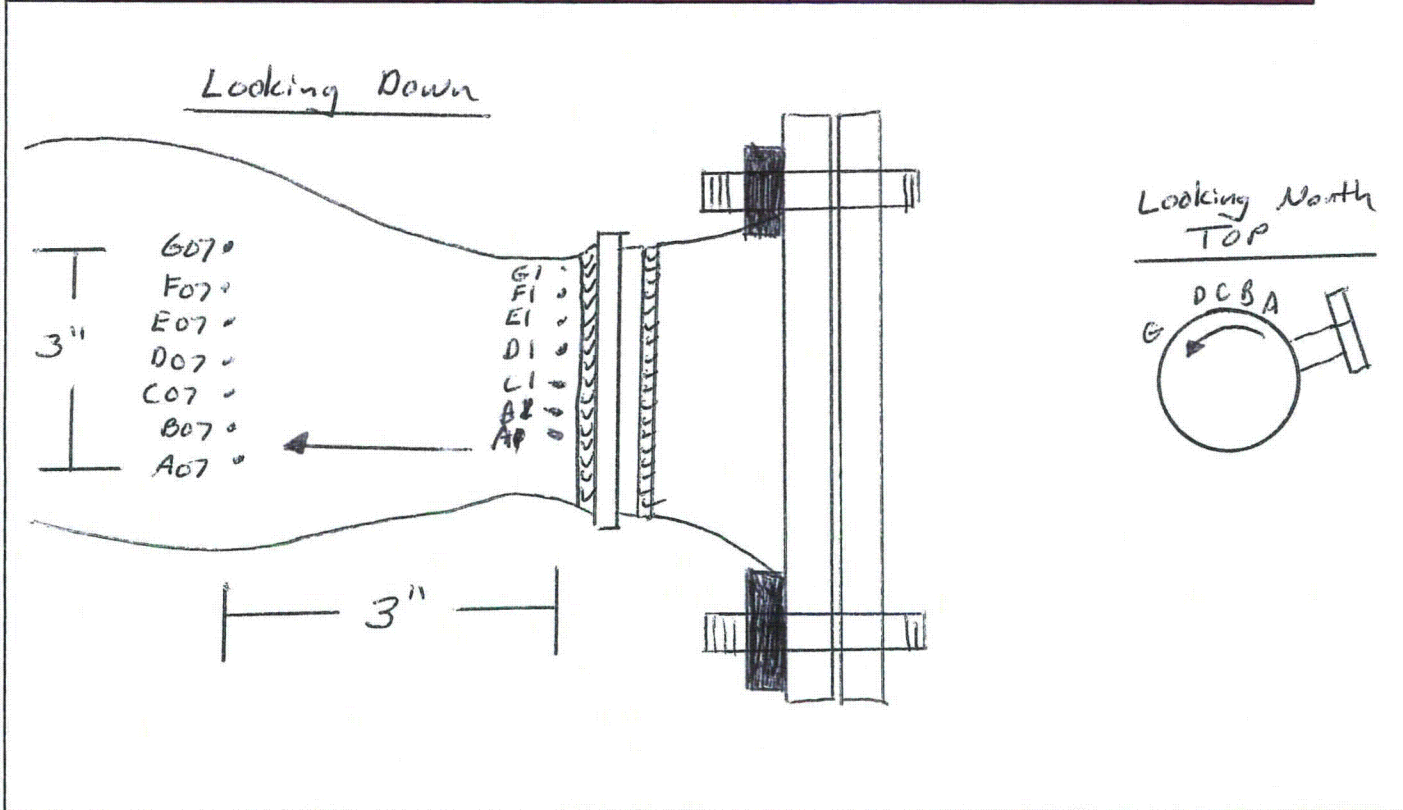
Maximum	0.569
Minimum	0.214
Average	0.473

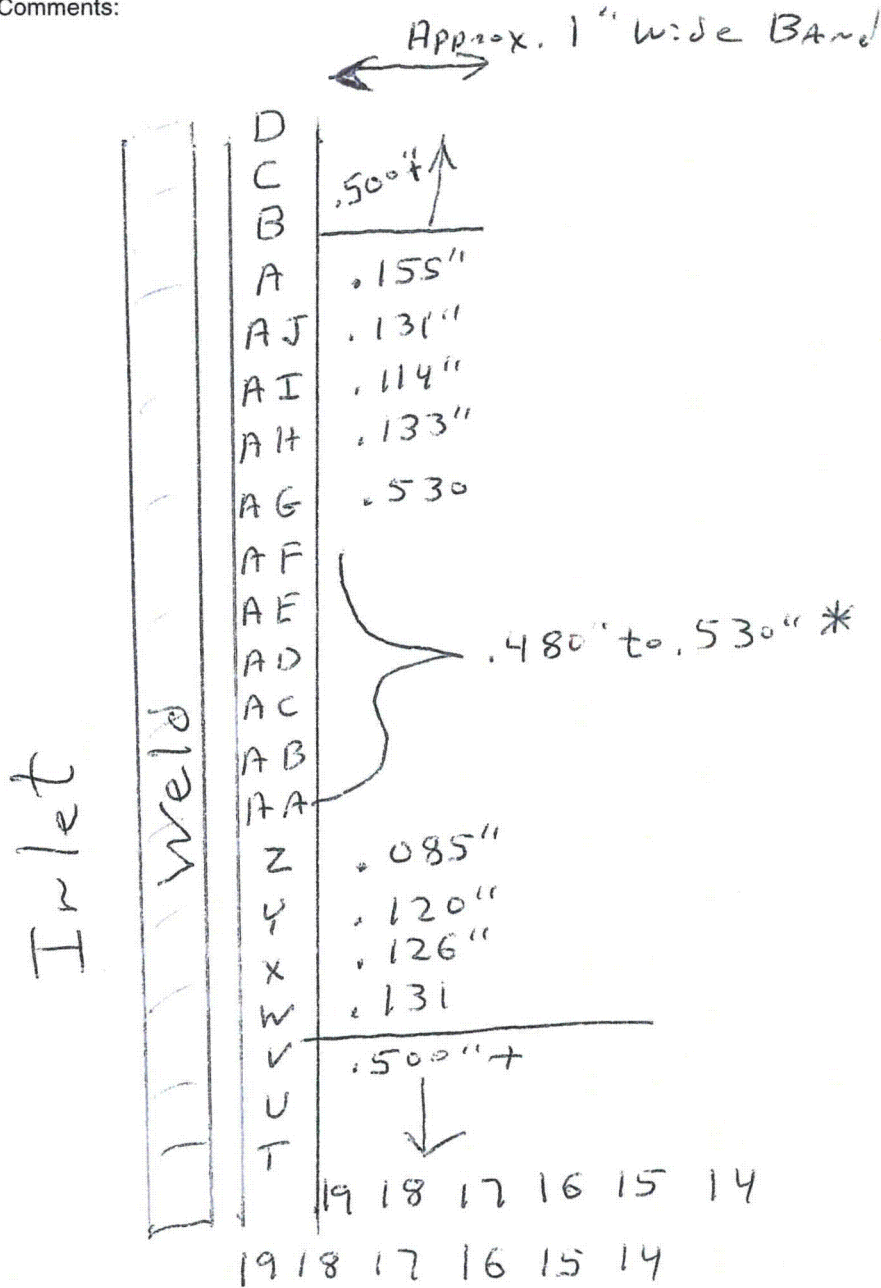
* "A Scan" presentation indicated this area had thinner areas than what registered on digital readout
