UNITED STATES
NUCLEAR REGULATORY COMMISSION
REGION IV
1600 EAST LAMAR BLVD
ARLINGTON, TEXAS 76011-4511

SUBJECT: SAN ONOFRE NUCLEAR GENERATING STATION – NRC AUGMENTED
INSPECTION TEAM FOLLOW-UP REPORT 05000361/2012010 AND
05000362/2012010

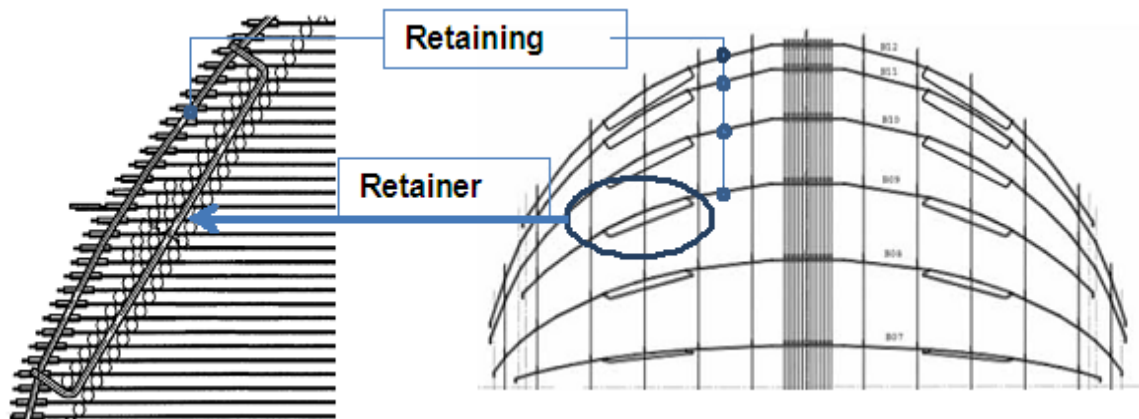
As shown in the figure below, the retainer bars are internal parts of the steam generator anti-vibration bar assembly that are attached to a series of retaining bars to capture a small group of tubes with the purpose of restraining movement of the anti-vibration bar assembly during manufacturing, upending during installation; and a main steam line break design basis event. The anti-vibration bar assembly was designed to float in between the tubes and be held in place by friction. There are 24 total retainer bars of two different diameter sizes in each steam generator. There are two groups of twelve bars where each group has six large and six small diameter bars. The different sized bars were needed to accommodate the different size of tube gaps in different areas of the bundle. Only tubes adjacent to the smaller diameter bars experienced wear indications. The retainer bars capture two short rows of tubes, which physically stop anti-vibration bar movement into or out of the tube bundle. Only those tubes immediately adjacent to both sides of the retainer bars (23 inside and 24 outside) were affected or potentially affected by vibration wear between the retainer bar and tubes. The first captured row was not affected by the retainer bar vibration.

The first indication of tube wear due to retainer bar vibration was identified on February 5, 2012, as part of the planned in-service eddy current examinations of the Unit 2 steam generator tubes. The Unit 2 in-service eddy current examinations were in progress at the time that the Unit 3 primary-to-secondary leak was identified on January 31, 2012. The licensee performed eddy current examinations in the Unit 2 and Unit 3 replacement steam generators to identify the extent of the condition. The eddy current examinations identified six tubes with wear indications in Unit 2 as a result of retainer bar vibration. The total number of tube-to-retainer-bar wear indications in Unit 2 was seven since one tube had more than one indication. Out of the six tubes with indications, four tubes had indications greater than 35 percent through wall degradation. In Unit 3, the licensee identified four tubes with one tube-to-retainer-bar wear indication each. Three of the four tubes had indications greater than 35 percent through wall degradation. For Unit 2, the maximum through wall degradation was determined to be 90 percent in tube 2E-089 R119 C133. This tube was in-situ pressure tested and it maintained pressure with zero leakage during the testing and therefore met the technical specification requirements for tube integrity.

The Cause Evaluation Report NN 201843216 identified that the mechanistic root cause of the tube-to-retainer-bar wear was due to inadequate design of the smaller diameter retainer bars in that the bar size (diameter and length) was insufficient to prevent excessive flow-induced vibration. The retainer bars were designed and fabricated with longer and smaller-diameter than previous designs, which resulted in a lower natural frequency when compared with previous configurations, increasing the susceptibility to flow-induced vibration. This resulted in tube wear from vibration contact between the retainer bars and tubes inside the steam generators. The vibration source was characterized as turbulent two-phase flow across the retainer bars.

was considered to be the most probable cause of the vibration in the smaller diameter retainer bars, based on flow forces near the retainer bars, combined with the rather low natural frequency of the retainer bar. The evaluation concluded that the cross-flow velocities in the replacement steam generators could result in large vibration amplitude of the smaller diameter retainer bars.
