UNITED STATES
NUCLEAR REGULATORY COMMISSION
OFFICE OF NUCLEAR MATERIAL
SAFETY AND SAFEGUARDS
WASHINGTON, DC 20555-0001

April 16, 2013

NRC INFORMATION NOTICE 2013-07: PREMATURE DEGRADATION OF SPENT FUEL
STORAGE CASK STRUCTURES AND
COMPONENTS FROM ENVIRONMENTAL
MOISTURE

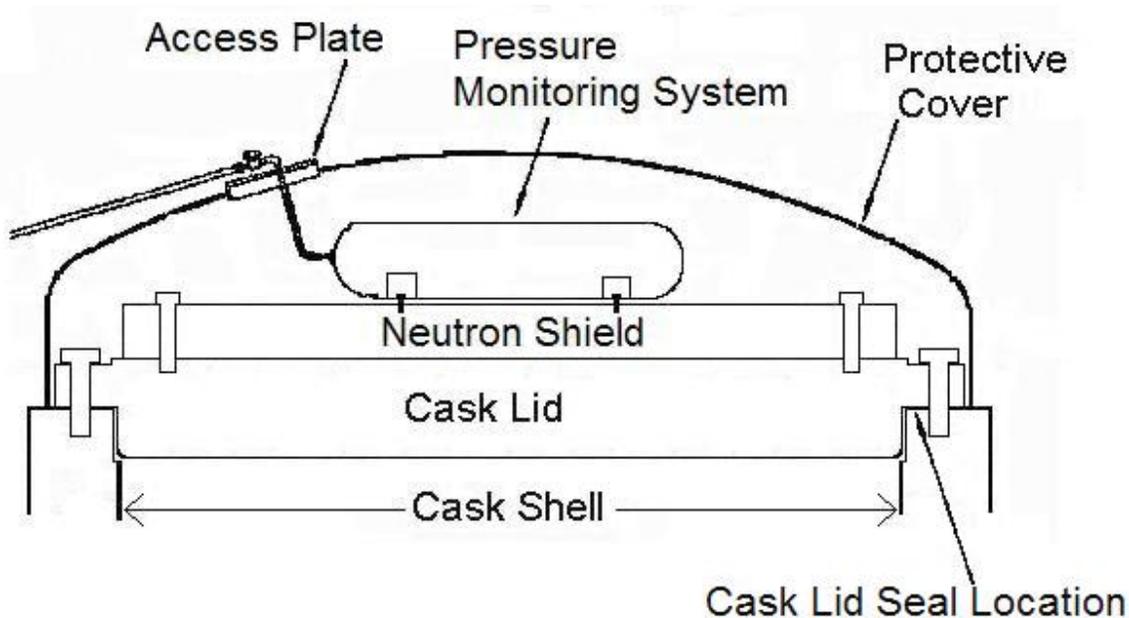
Figure 1

spent fuel assemblies to the spent fuel pool to perform additional inspections on the cask lid and seals. The initial evaluation revealed corrosion of the outer portion of the cask lid seal, lower than expected torque on some of the main lid bolts, and corrosion on the threads of the lid bolts. The inner portion of the cask lid seal remained intact; therefore, the cask's primary confinement was not compromised.

A root cause evaluation concluded that the seal leakage was caused by corrosion of the outer portion of the cask lid seal from water infiltration through the access plate in the protective cover. The water infiltration caused galvanic corrosion of the outer portion of the cask lid seal due to the presence of moisture at the interface of the aluminum-clad cask lid seal and the stainless steel clad cask body sealing surface. The presence of the moisture at the interface of the two dissimilar metals set up a galvanic cell that caused the aluminum to corrode and allowed helium to leak through the outer portion of the cask lid seal. The root cause evaluation further stated that the helium leak was attributed to inadequate sealing of the access plate in the protective cover and a lack of any verification of the integrity of the water-tight cover. The primary corrective actions developed by the cask vendor and the licensee involved improving the access plate design and developing a method for verifying protective cover seal integrity. Additional corrective actions, which were incorporated into operating procedures immediately after the event, included a change to the lid bolt torquing process and ensuring access plate gaskets and O-rings were inspected at installation.
