Limerick Generating Station, Units 1 and 2
Facility Operating License Nos. NPF-39 and NPF-85
NRC Docket Nos. 50-352 and 50-353

Subject: Exelon Generation Company, LLC's 180-day Response to NRC Request for Information Pursuant to 10 CFR 50.54(f) Regarding the Flooding Aspects of Recommendation 2.3 of the Near-Term Task Force Review of Insights from the Fukushima Dai-ichi Accident

**Flooding Walkdown Report In Response To The 50.54(f) Information
Request Regarding Near-Term Task Force
Recommendation 2.3: Flooding for the
Limerick Generating Station, Units 1 and 2**

LIMERICK GENERATING STATION
3146 Sanatoga Road
Pottstown, PA 19464
Facility Operating License No. NPF-39 and NPF-85
NRC Docket No. 50-352 and 50-353

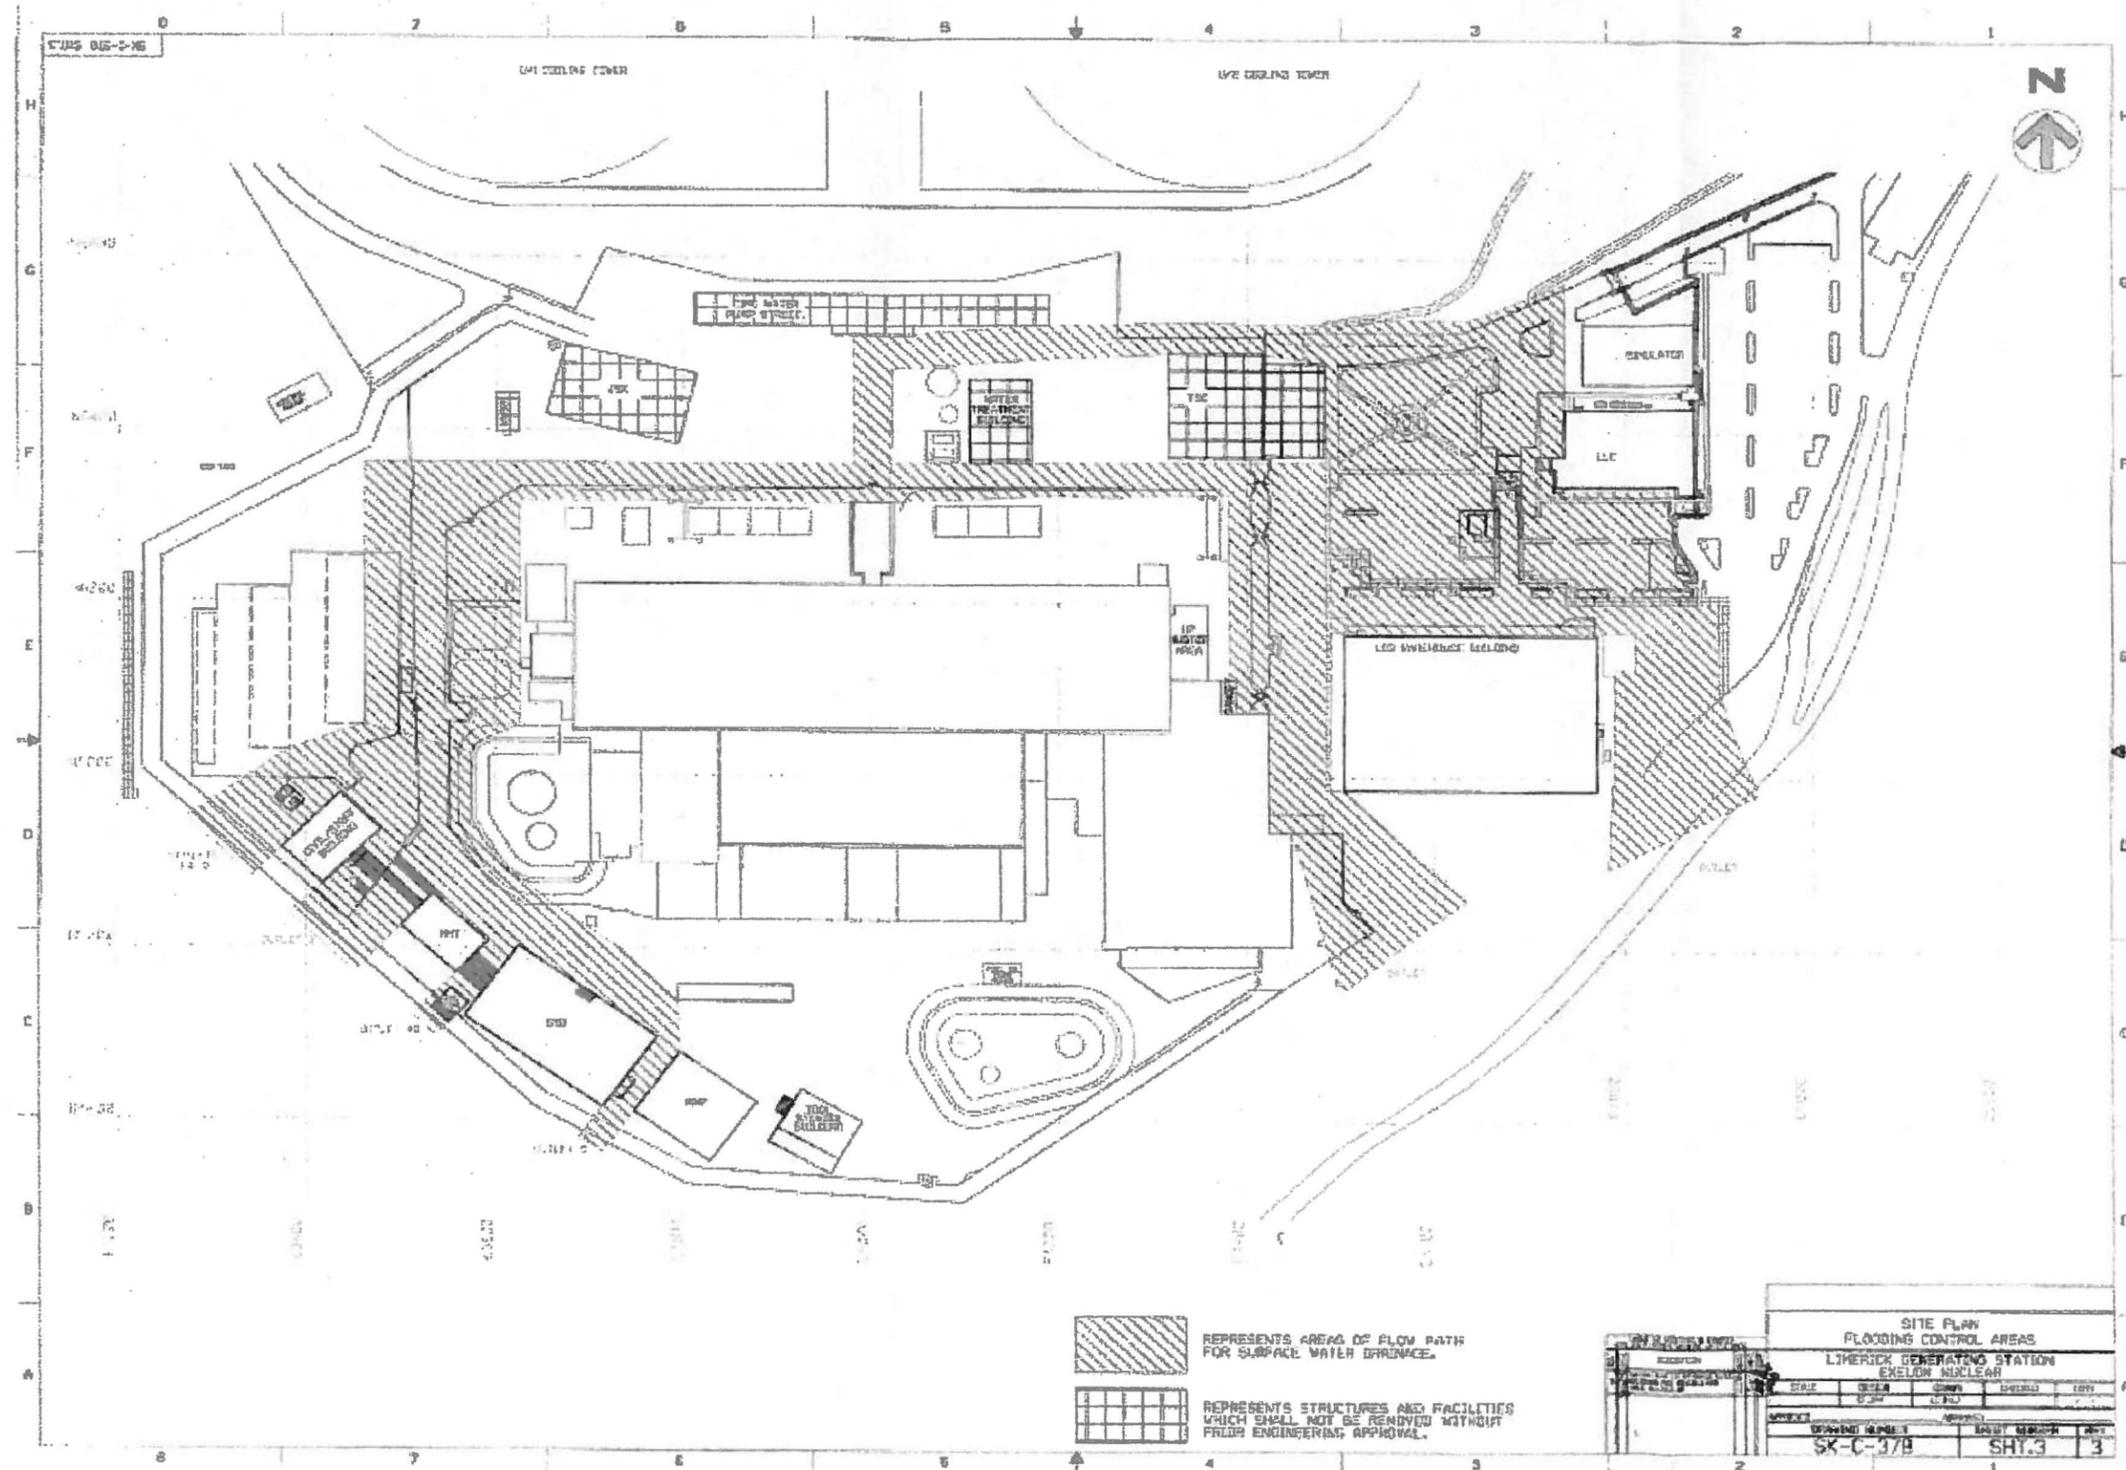
Figure 1

The main flow path around the power block is divided into four drainage areas (DA-3, DA-4, DA-5 and DA-6). All of these areas were included as a feature in the walk-downs, and were evaluated in terms of how they are controlled relative to the assumed flood analysis. The finished floor elevation of relevant safety-related structures at the power plant complex area (power block) is elevation 217'. Drainage is generally away from the structures. The present site drainage condition was determined from the Limerick Site Master Plan and subsequent walk downs.

SITE PLAN FLOODING CONTROL AREAS

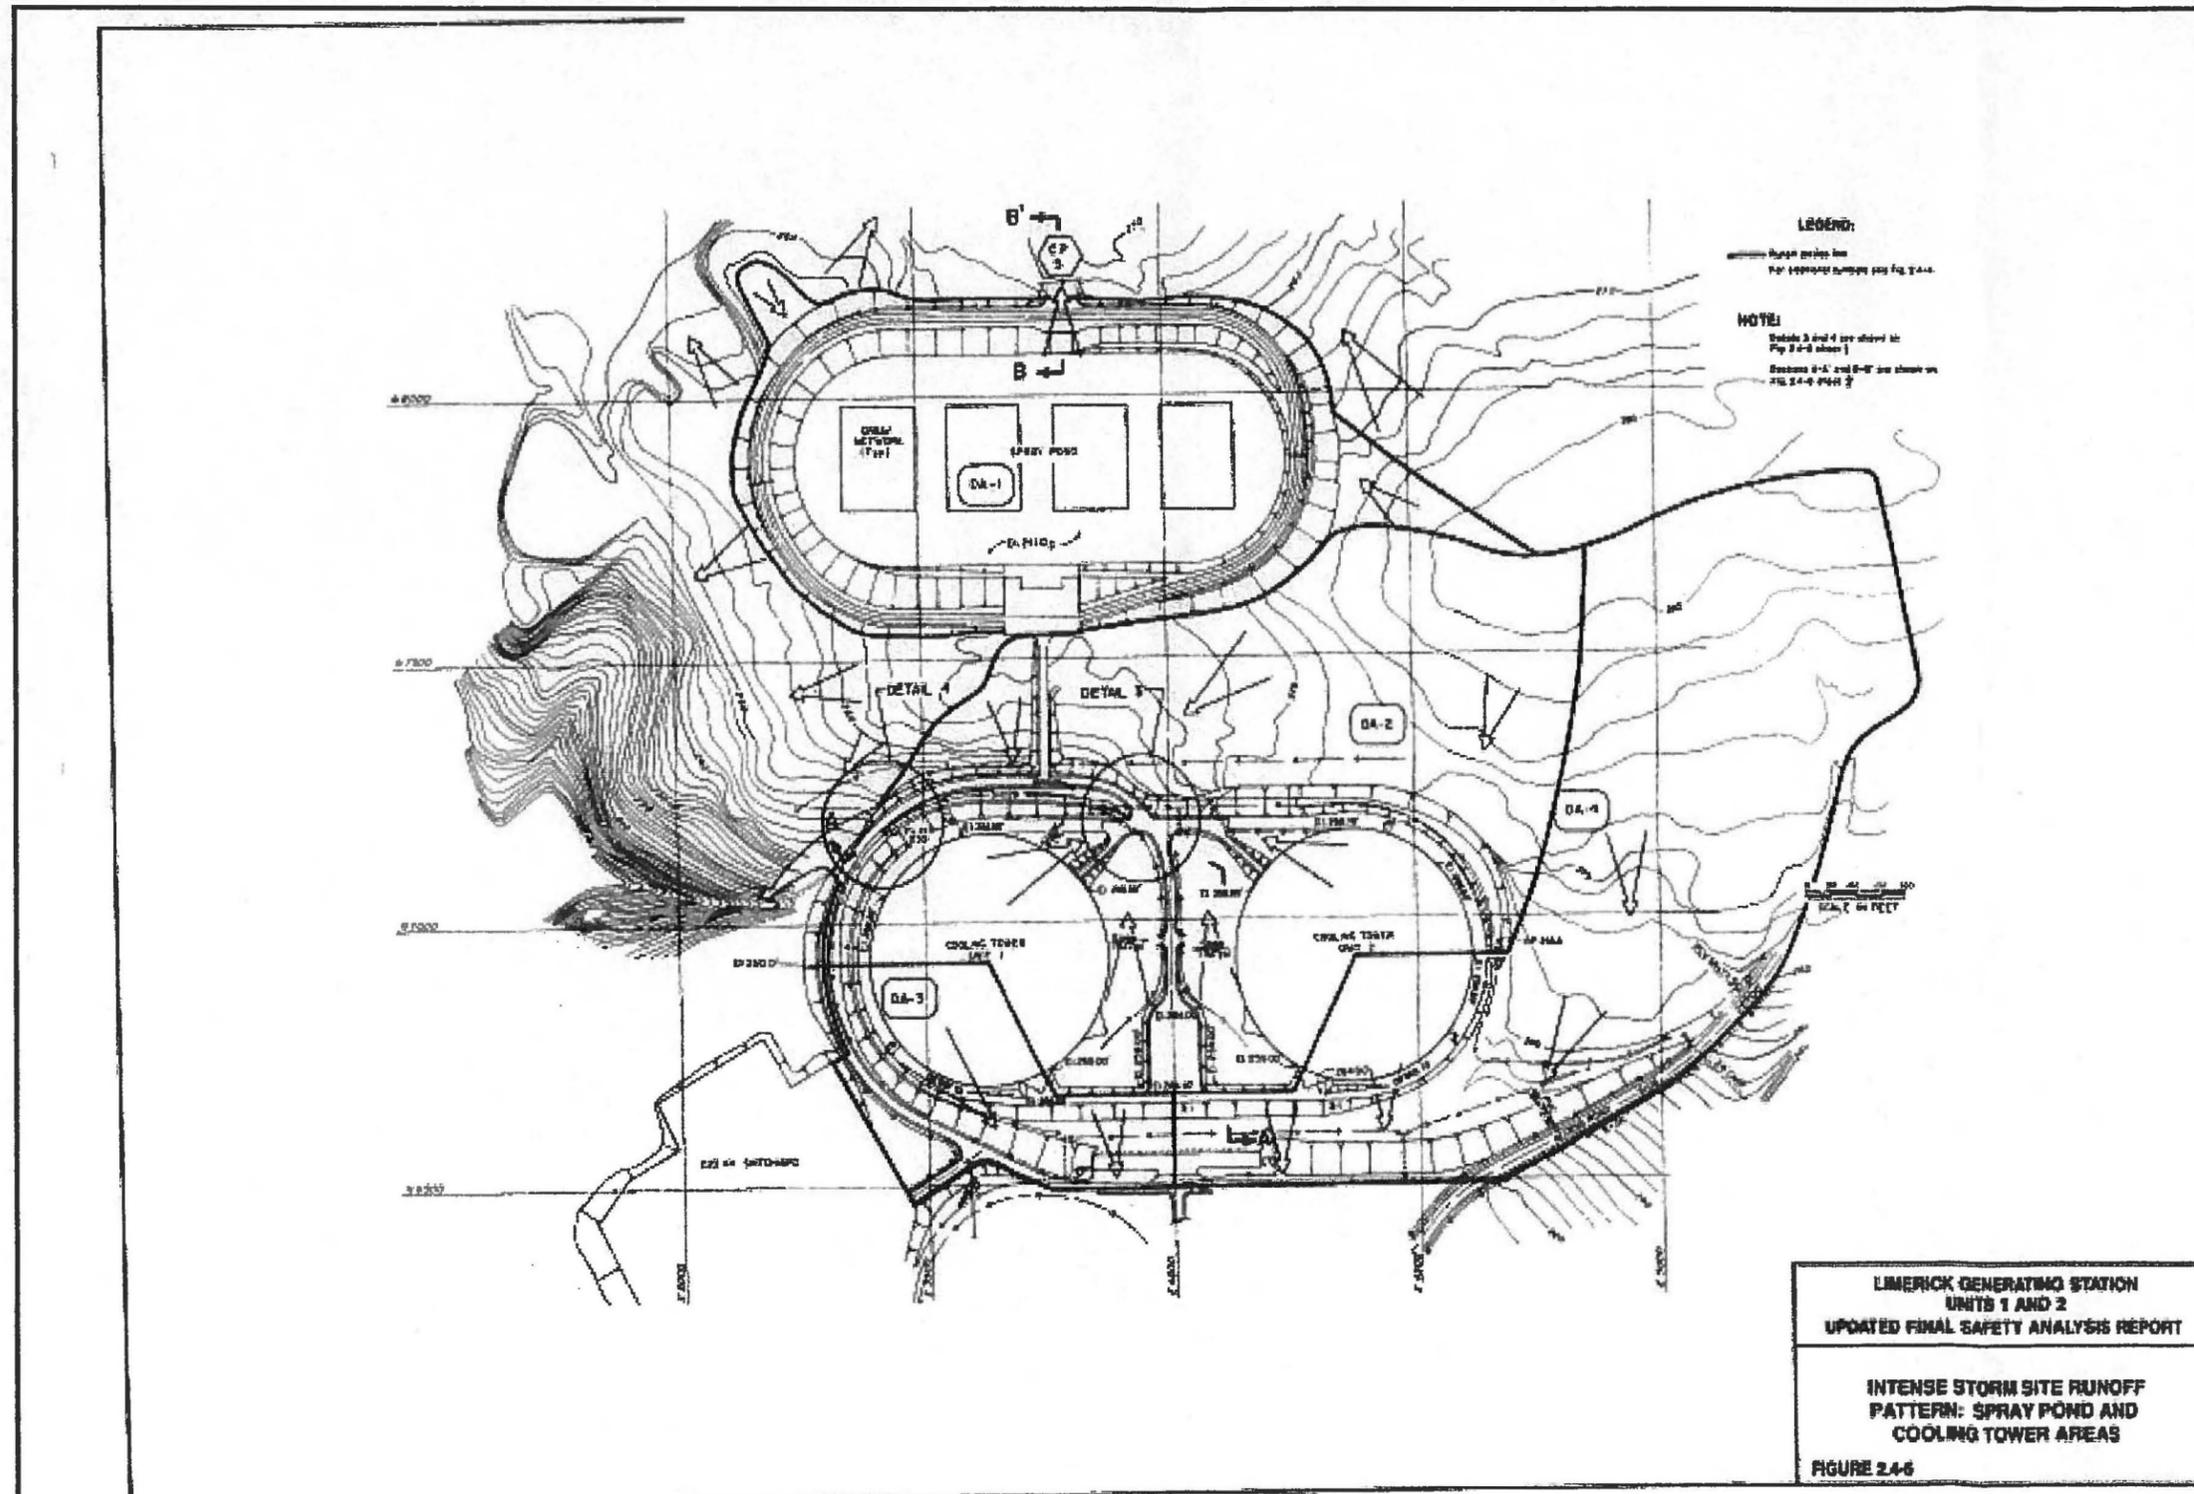
Figure 2

As with the northern side tank failures, the walkdown of the flood flow path to assess topography and blockage will be conducted. The walk down activities also addressed the spray pond drainage area (DA-1) depicted in Figure 2. This feature includes the cut slope areas draining toward the pond as well as two small pieces of natural topography that drain toward the cut slope. Drainage is the pond itself, which has a normal operating level of 251' and a 60 foot wide spillway set at elevation 252'. The activities associated with this effort is simply to walkdown the pond and the spillway to assess the condition of the rip rap installed around the pond to handle wind induced wave actions and confirm that the spill way is clear and in good condition.
