Seismic Walkdown Checklist (SWC) SWEL1- 089

Equipment ID No. EJ-1051 Equip. Class¹ 20, INSTRUMENTATION AND CONTROL PANELS

Equipment Description AUX FEEDWATER CONTROLS

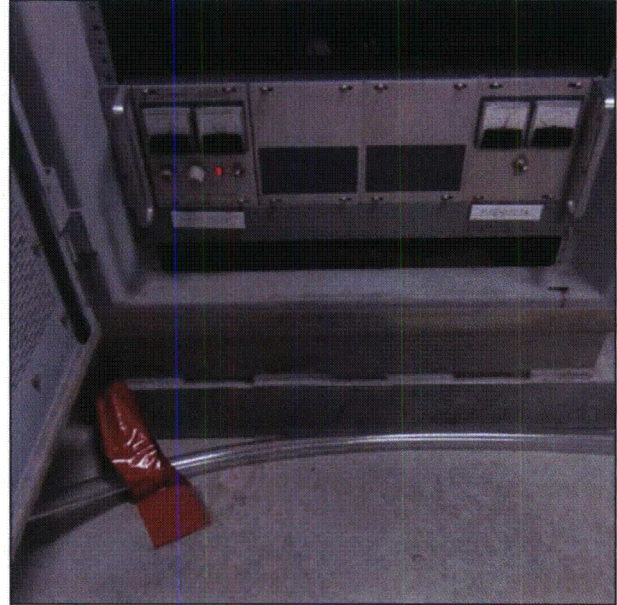
2. Is the anchorage free of bent, broken, missing or loose hardware? Y N U N/A
The equipment anchorage consists of 4" intermittent fillet welds to structural steel angles which are embedded in a concrete pedestal on the concrete floor.

Note: Equipment anchorage consisting of intermittent fillet welds to embedded steel.

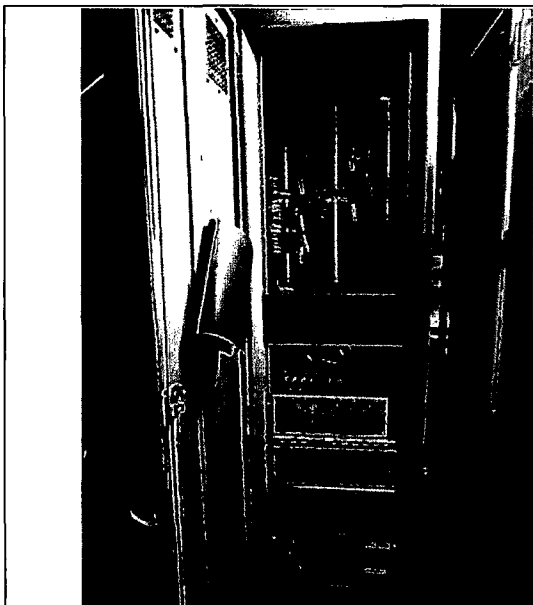
7. Are soft targets free from impact by nearby equipment or structures?
*A book is hanging from the inside of the cabinet which could potentially
interact with interior wiring and components. Further evaluation is
required and licensing basis evaluation, LB-19, has been created. CR-
PLP-2012-06754 has been created to remove item.* Y N U N/A

Note: *Inside of equipment and book/manual noted on inside of door providing a possible seismic interaction with interior wiring and components.*

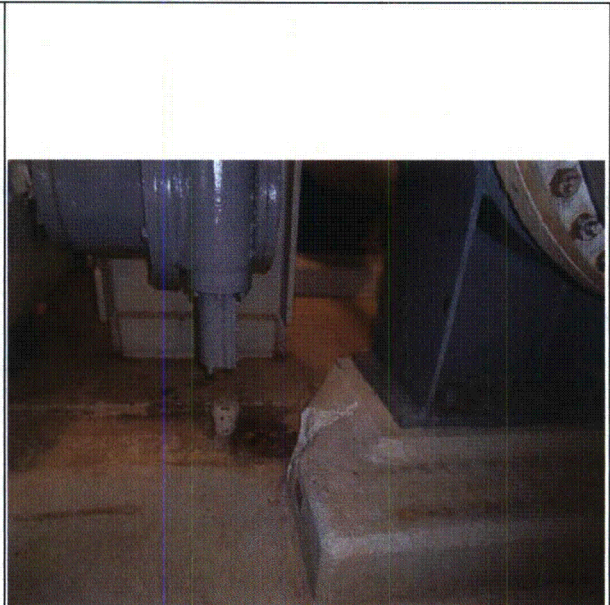
Note: *Concrete Chip*

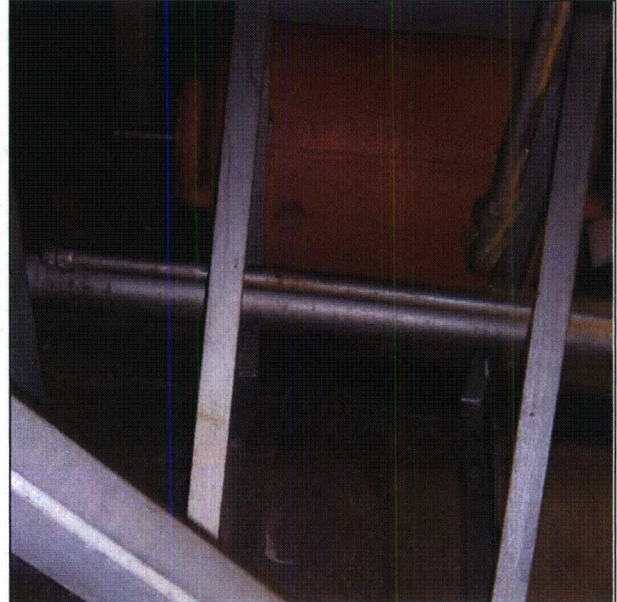
Note: *Holes in top of bracket.*

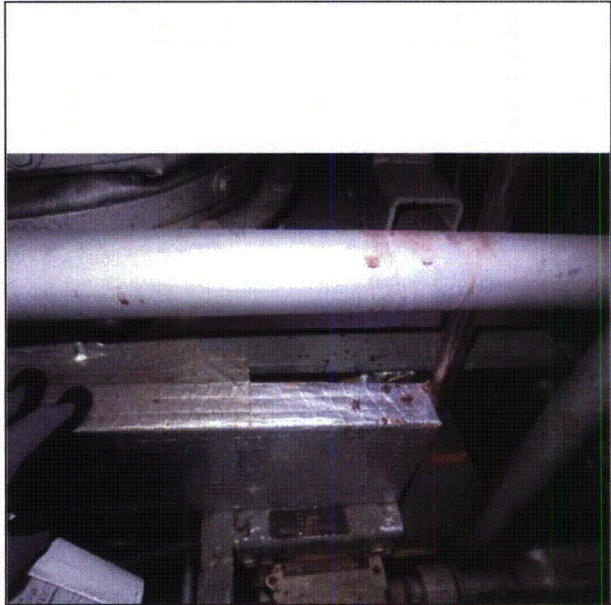
Note: *Insulation separated from damper unit.*

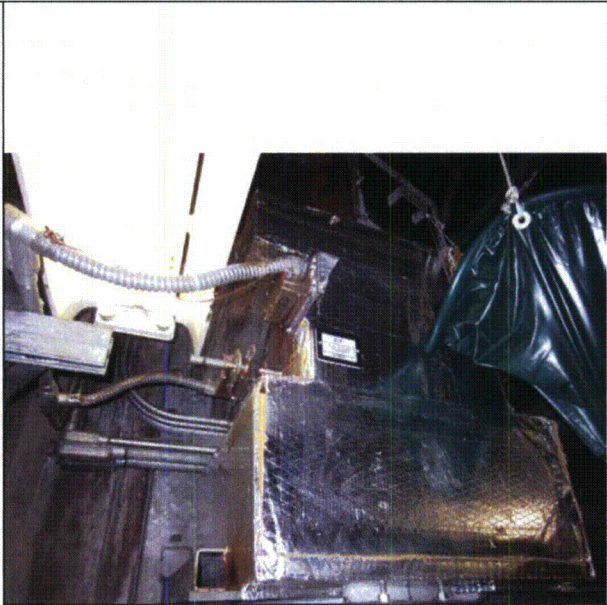
Note: *Drip funnel overhead.*

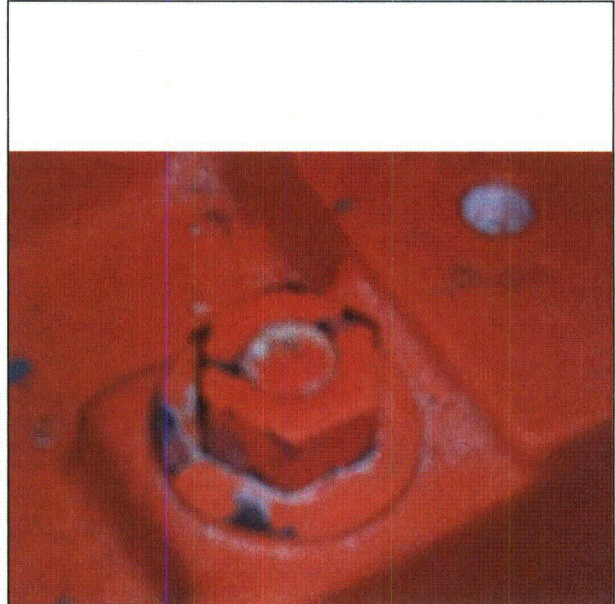
Note: *Bolt with limited engagement with nut*

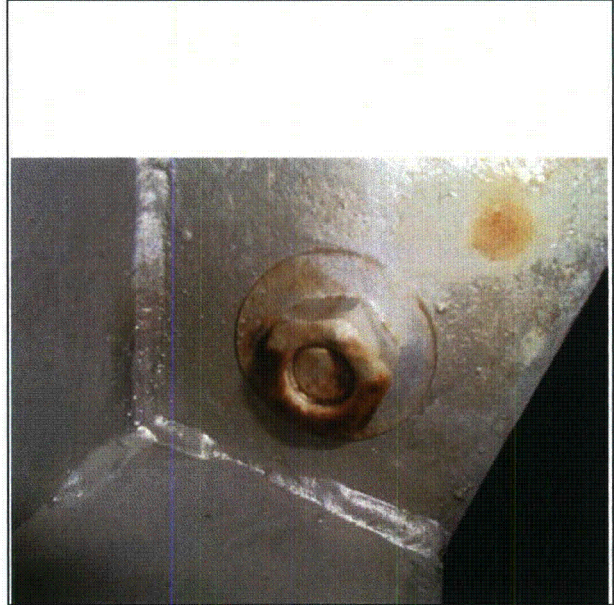
Note: Rusted bolt lacking full thread engagement (bottom view).

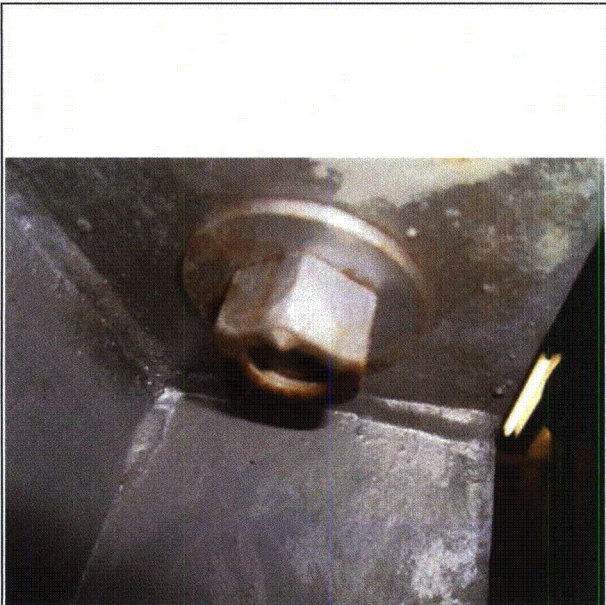
Note: *Rusted Bolt with lack of thread engagement (side view).*

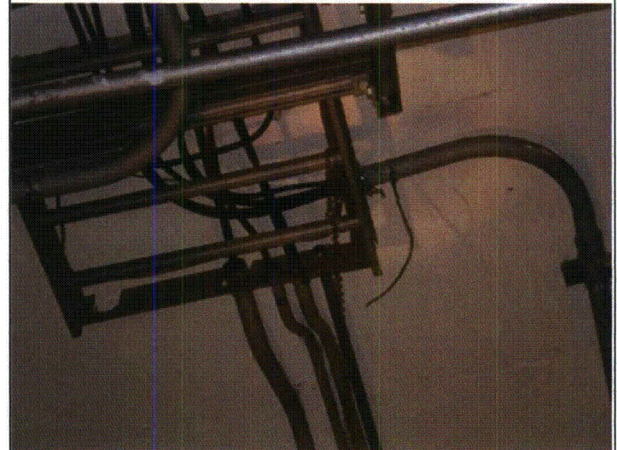
Note: *Loose Uncrimped S-Hook Hanging From Cable Tray*

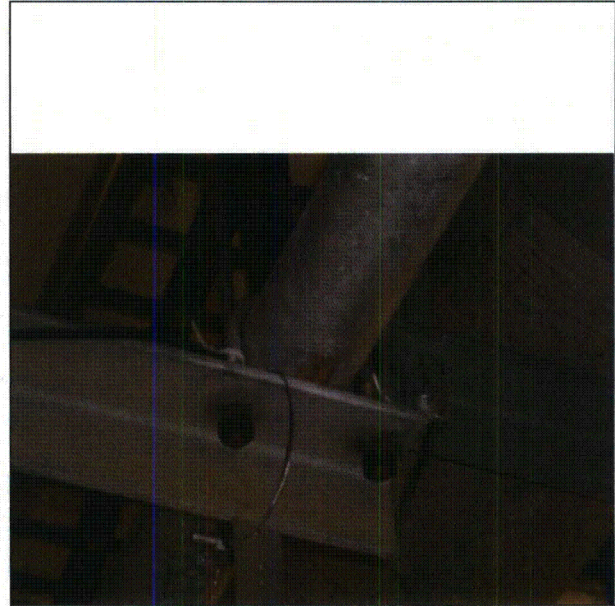
Note: Pipe Lifted Off Support

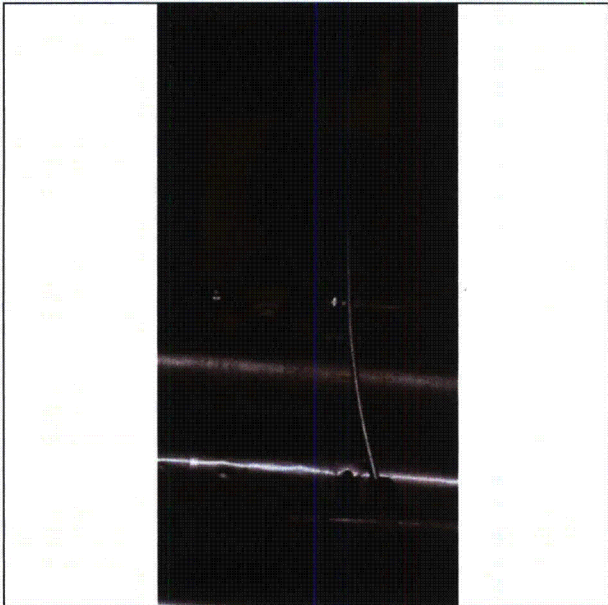
Note: Bent Hanger Rod with Sliding Clamp

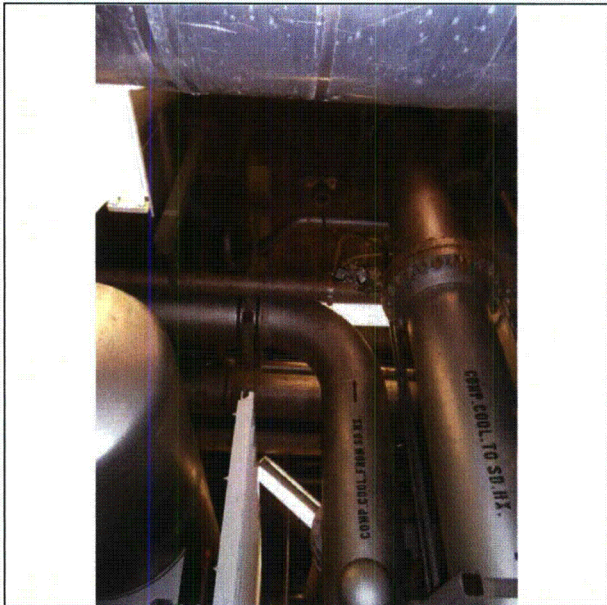
Note: Pipe Hanger Supported by Spring Cannister Bent Around Pipe (Overview)

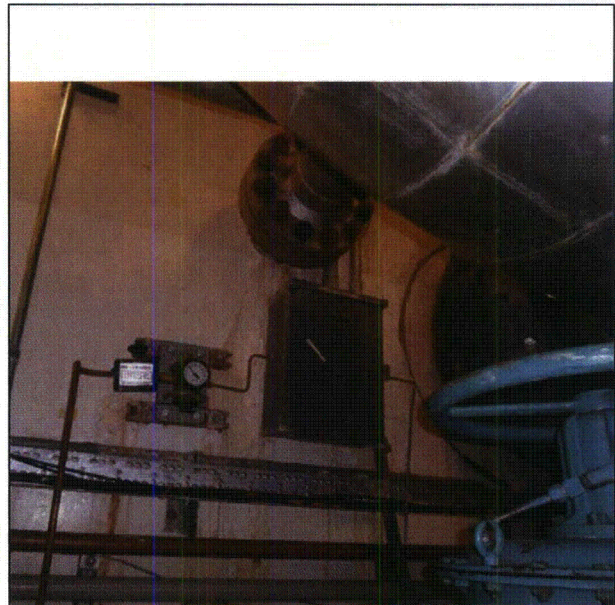
Note: Degraded Wall Due to Water Damage

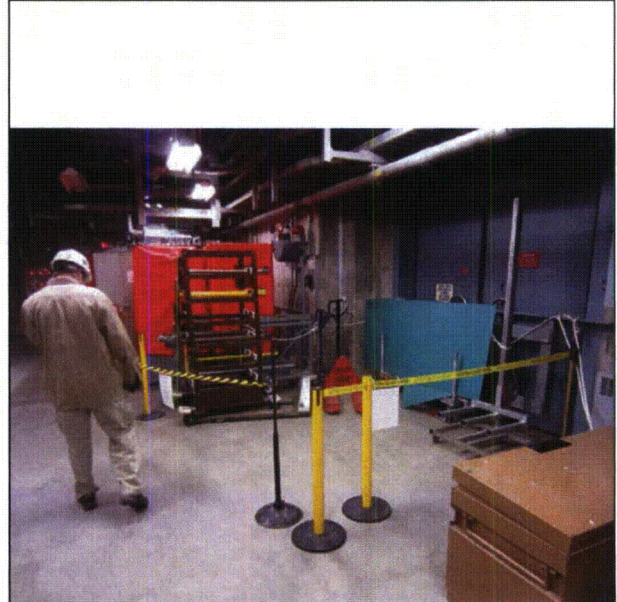
Note: Staged equipment.

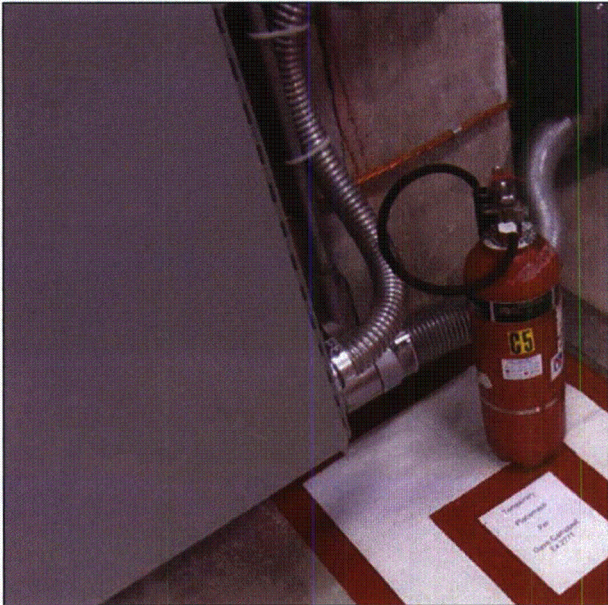
Note: Fire extinguisher near wall, unrestrained.

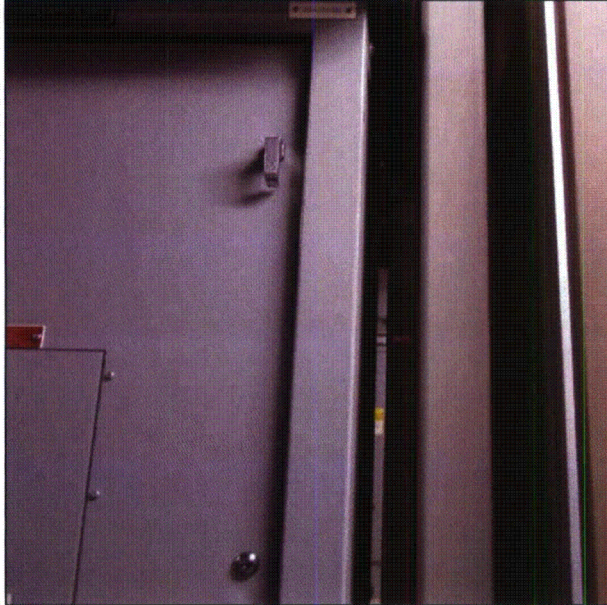
Note: Example of 2 inch gap between Cabinet and other Items
