## Entergy Operations, Indian Point Energy Center

# Root Cause Analysis Report

CST Underground Recirc Line Leak

CR-IP2-2009-00666

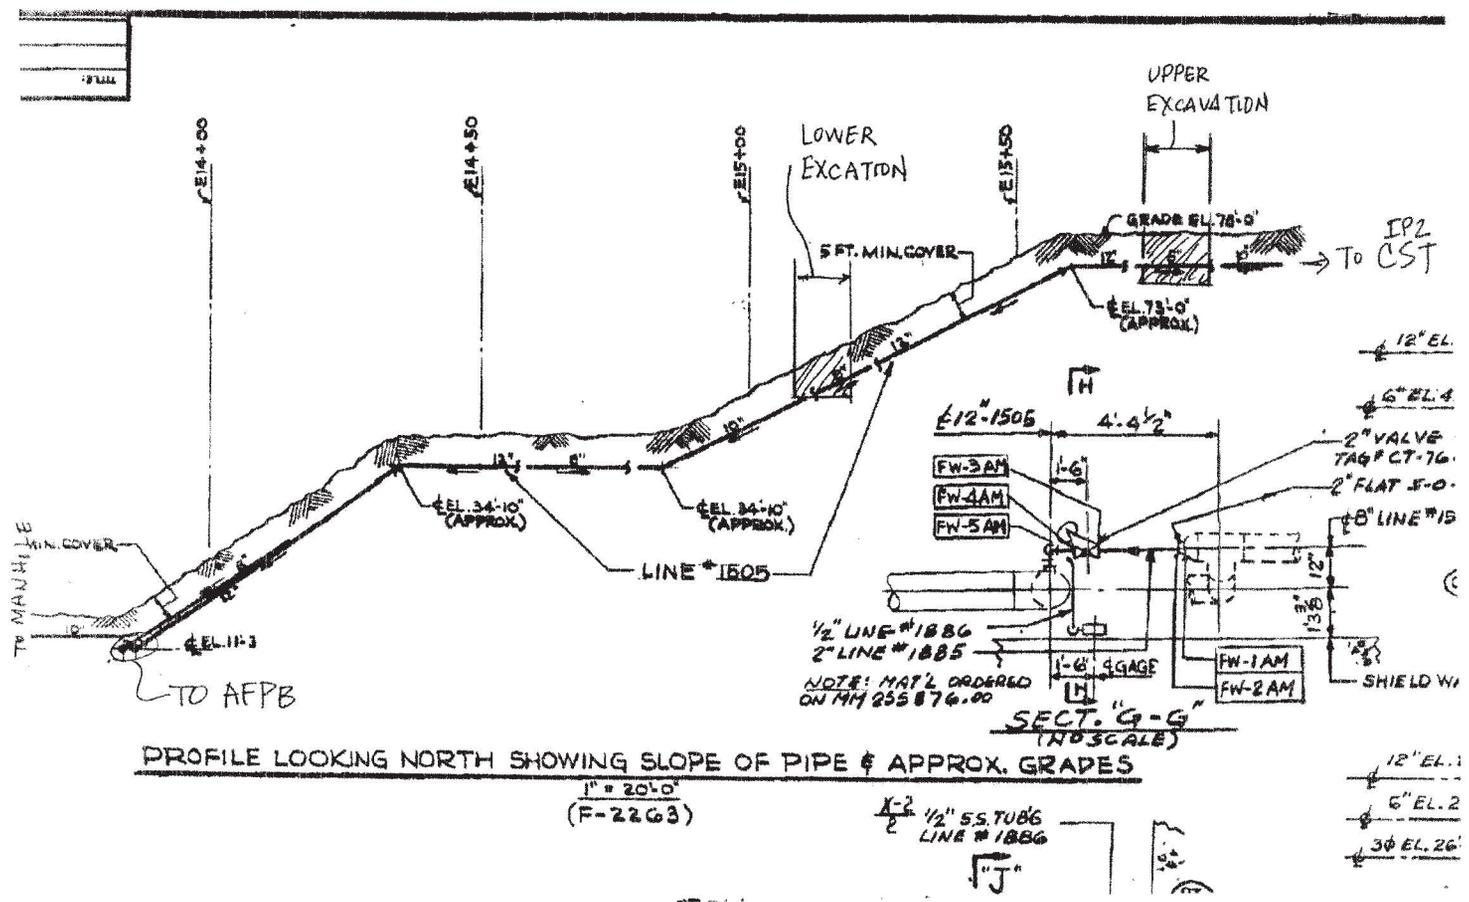
Upper and lower holes were excavated. An inspection in the upper hole identified five areas which required coating repair. UT thickness measurements were also performed on those areas where the base metal was exposed and these inspections confirmed that the pipe thickness remains at nominal thickness (i.e. within the manufacturer's tolerance). All of these activities were performed under WO 164495.

The visual inspection of these pipes at the lower excavation revealed that they were in generally good condition, with the coating intact and in acceptable condition. A minor coating repair was required at one location on 8" Line 1509 and the 10" overflow line required repair at the top portion of the pipe at the crests of the corrugations, possibly indicative of coating damage during the digging. Based on the results of these pipe visual inspections (at the upper and lower holes), and the coating repairs performed, there was no evidence of any significant pipe degradation that would warrant the re-inspection of these pipes at the same locations. Future inspection of these lines will be performed at different location(s) along their length. The scheduling of the future inspections will be controlled under the IPEC Buried Pipe Program. Specifically for the CST lines, CA-5 of CR IP2-2008-04754 reads, "Given the results of the leak in the AFP Building, determine if the scope and/or frequency of future buried condensate lines should be modified. This should cover both IP2 and IP3." See elevation drawing on the next page.

LINES INSPECTED  
12" LINE 1505  
8" LINE 1509  
10" OVERFLOW LINE (CORRUGATED METAL PIPE)

PROFILE LOOKING NORTH SHOWING SLOPE OF PIPE & APPROX. GRADES
