United States Nuclear Regulatory Commission Official Hearing Exhibit	
In the Matter of:	Entergy Nuclear Operations, Inc. (Indian Point Nuclear Generating Units 2 and 3)

<b>ASLBP #:</b> 07-858-03-LR-BD01
	<b>Docket #:</b> 05000247   05000286
	<b>Exhibit #:</b> NYS000202-00-BD01
	<b>Admitted:</b> 10/15/2012
	<b>Rejected:</b>
<b>Other:</b>	<b>Identified:</b> 10/15/2012
	<b>Withdrawn:</b>
	<b>Stricken:</b>

Significance Level 2 Report

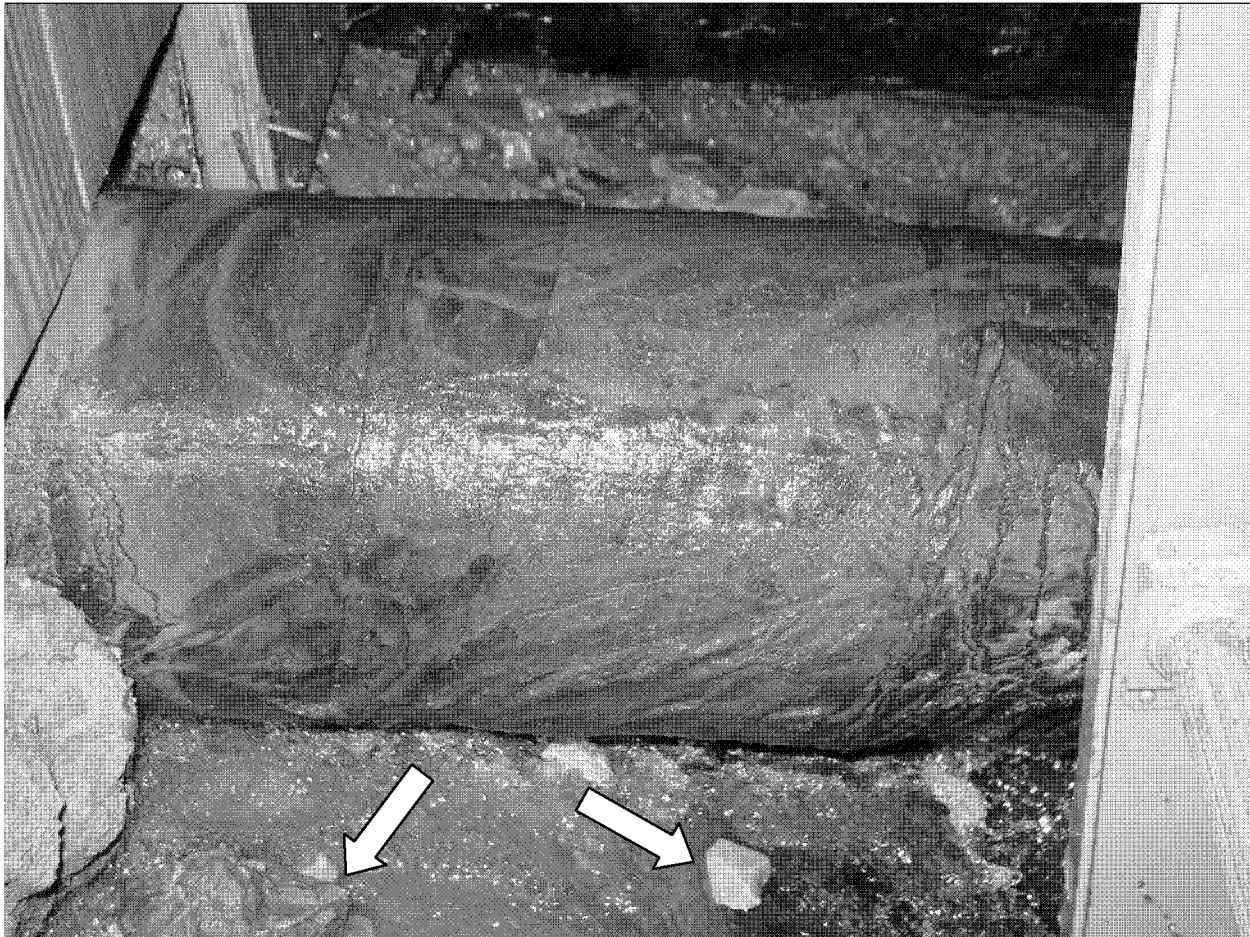
**Figure 1- View of pipe coating as observed in the excavation by Entergy Staff**

This photograph was provided to SI by Entergy staff. It was taken before the pipe sample was removed. Note wrinkling of the coating typical of soil stress. (Soil stress refers to distortion of external pipe coatings of this type. The distortion is typically caused by relative movement of the pipe and soil resulting from pipe expansion and contraction, soil settlement, or other events.) Arrows point to examples of angular rocks in the backfill.

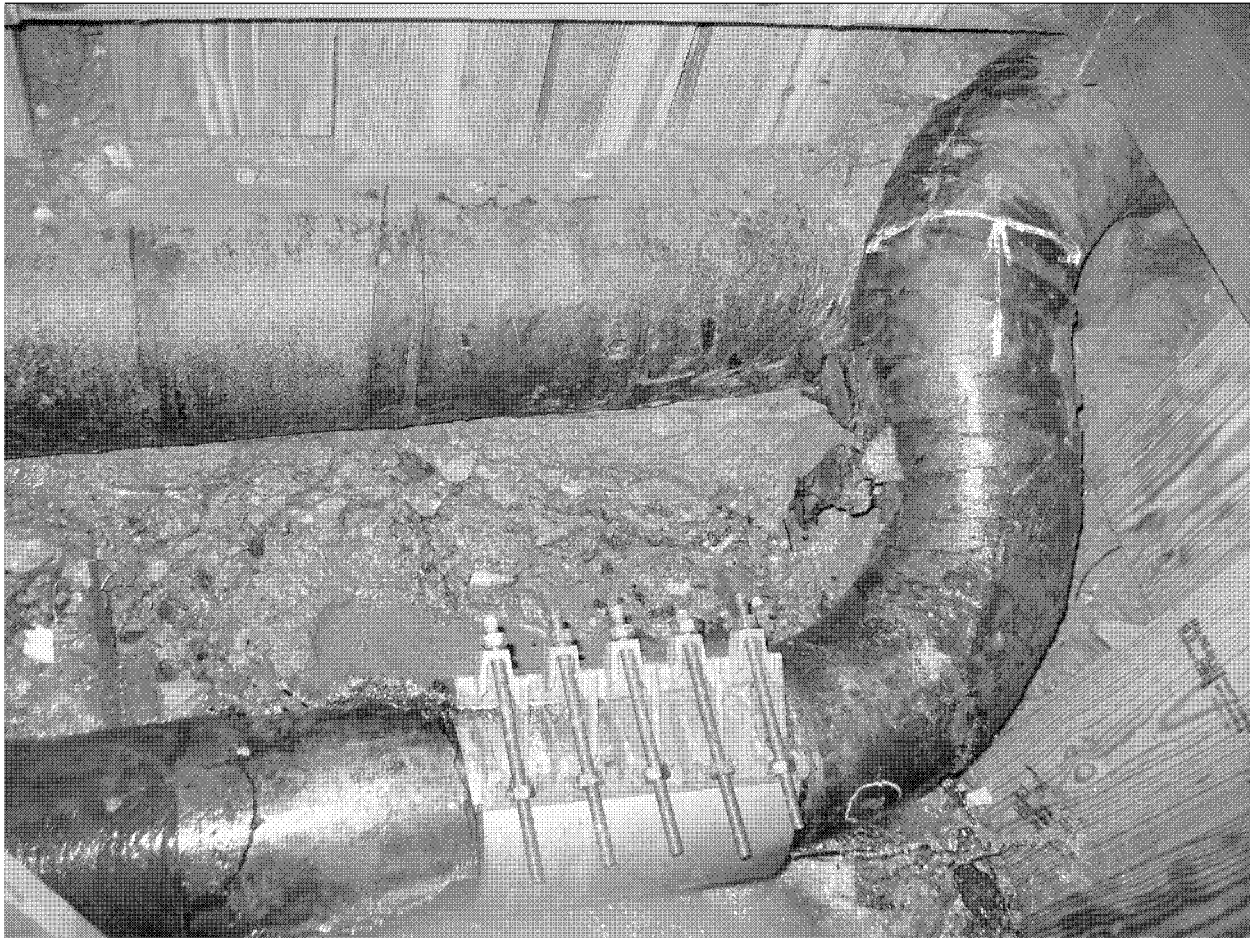
**Figure 2 - Photograph of pipe in the excavation before removal of the pipe sample.**

This photograph was provided to SI by Entergy staff. A leak clamp has been applied to the area of the leak. The white arrow and lines at upper right indicate the limits of coating that was to be removed during the process of replacing the segment of leaking pipe. See next figure for detail of rocks in the backfill to the upper left of the clamp.

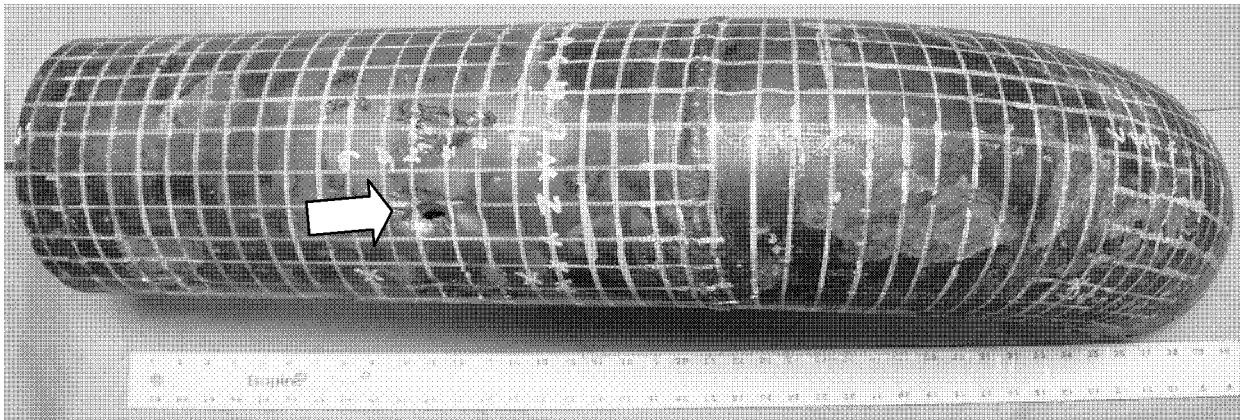
**Figure 9 - Pipe sample, as-received , view 4. Arrow points to location of leak**

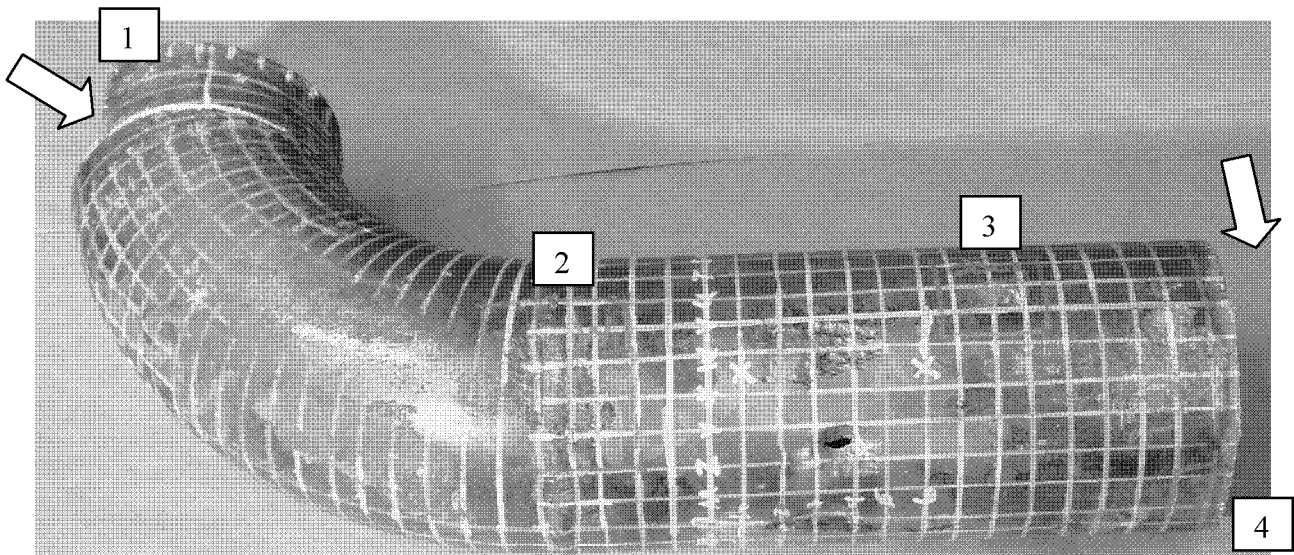
**Figure 10 - Pipe sample marked with red boxes to show locations of samples removed for further analysis**

1. Elbow sample with ID corrosion for metallographic examination,
2. Girth weld sample for metallographic examination,
3. External corrosion pit with internal corrosion on pipe for metallographic examination and EDS analysis of the corrosion product
4. Second sample of pipe for metallographic examination (investigation of possible ERW seam).

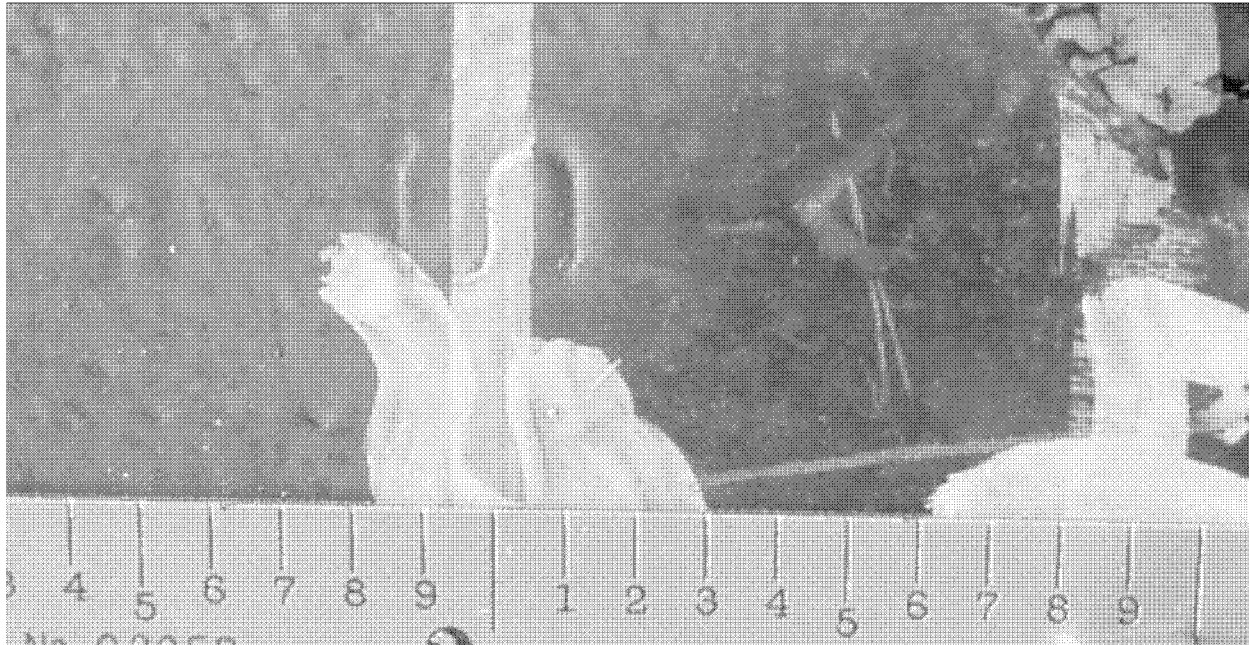
**Figure 11 - "YS" stamp mark on pipe.**

The stamp marks indicate that this pipe is pipe manufactured by Youngstown Steel. At this location the stamps have been partially polished away by erosion from the nearby leak (in this pipe).

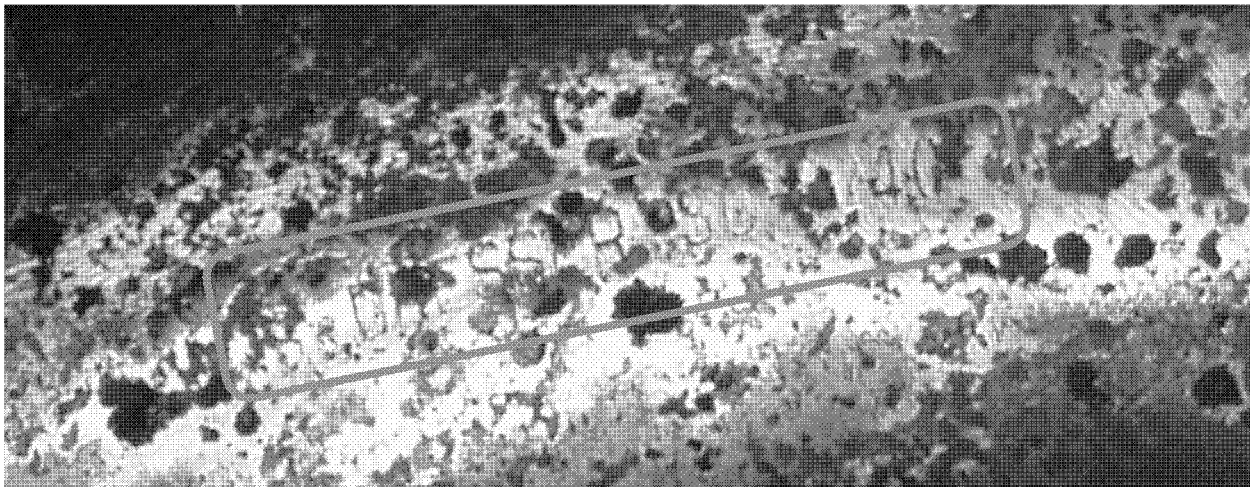
**Figure 14 - Manufacturer's stamp mark after light abrasion with sandpaper.**  
The stamp marks on the neutral axis of the elbow identify it as an 8" schedule 40 fitting manufactured by Dresser. The grade of the fitting is obscured by corrosion.

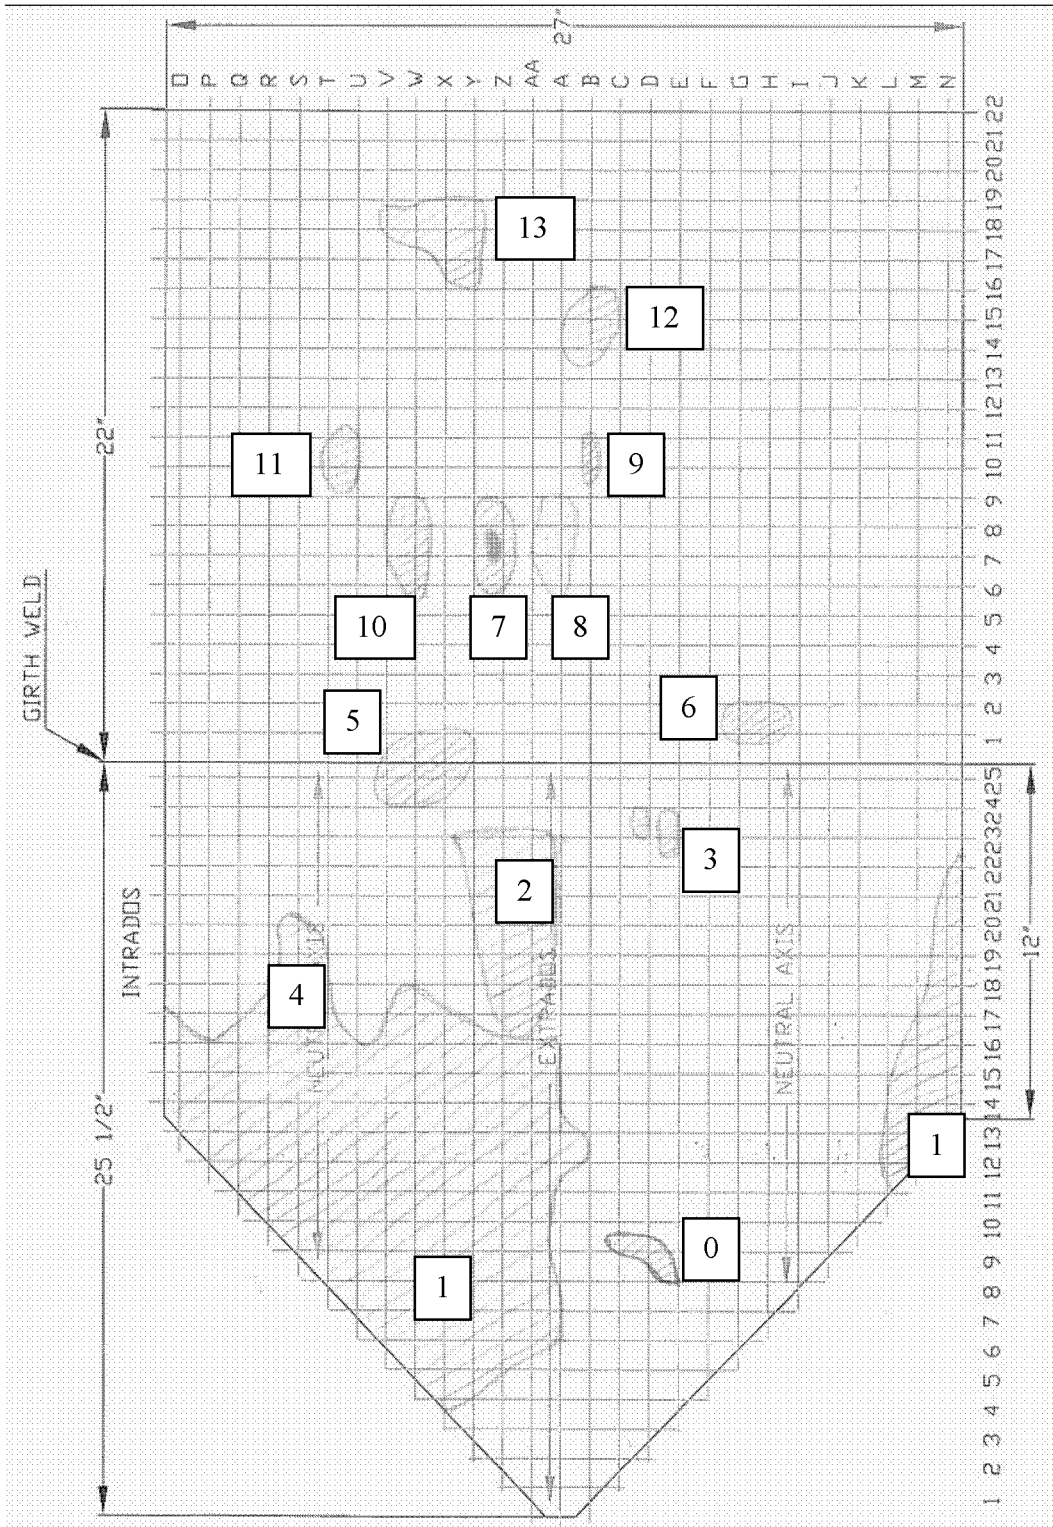
**Figure 15 – Map of external corrosion**

Major areas of corrosion are sketched and numbered. The axial grid lines (marked A, B, C, etc.) are as marked by Entergy. The leak is at location #7. See Table 3 for additional details

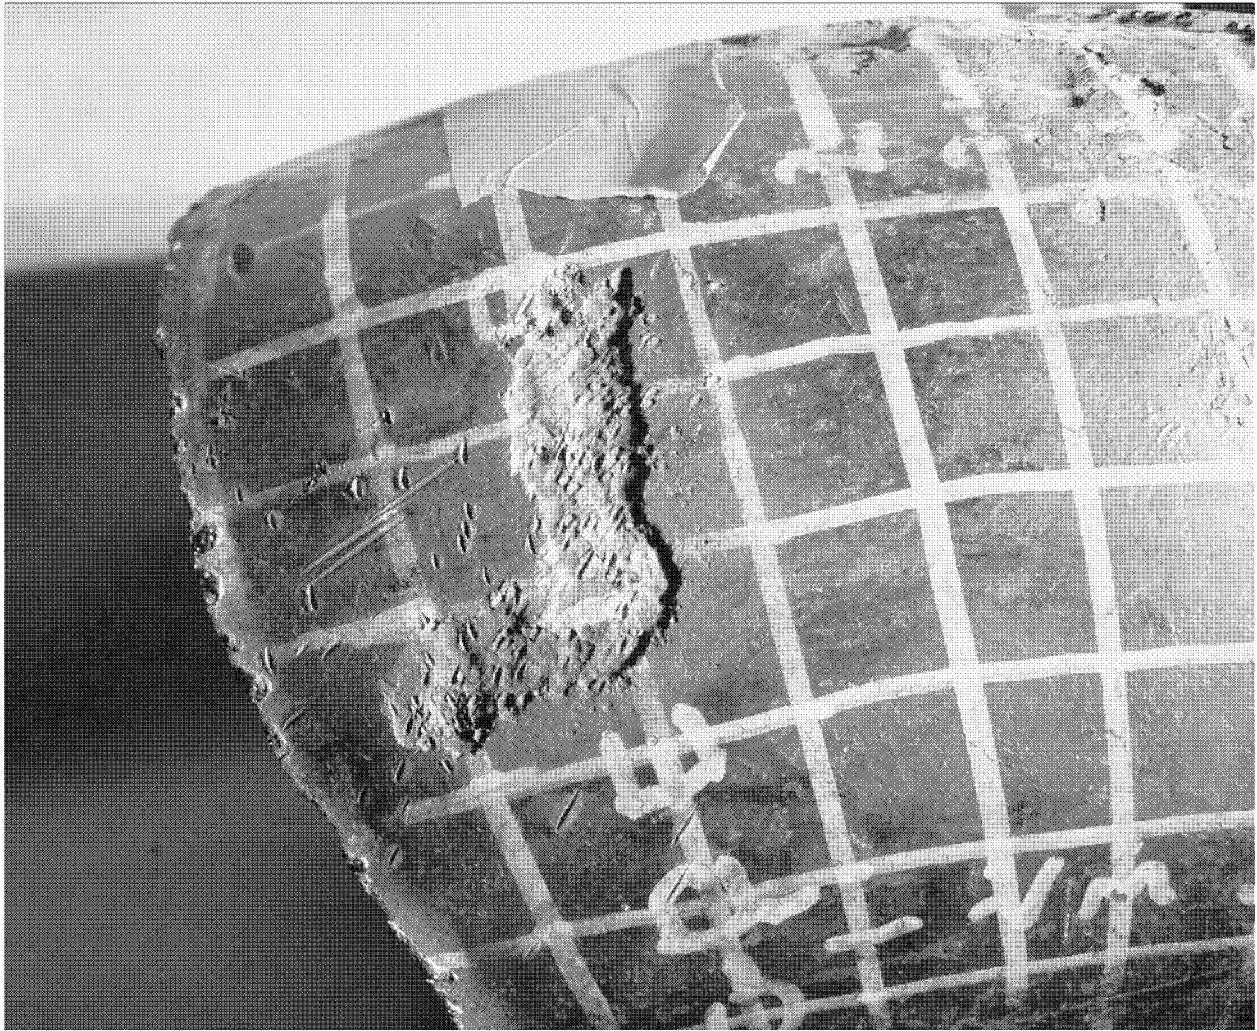
**Figure 16 - External corrosion on elbow (as-received condition) designated Area 0**  
Note the absence of any corrosion surrounding the “L” shaped pit.

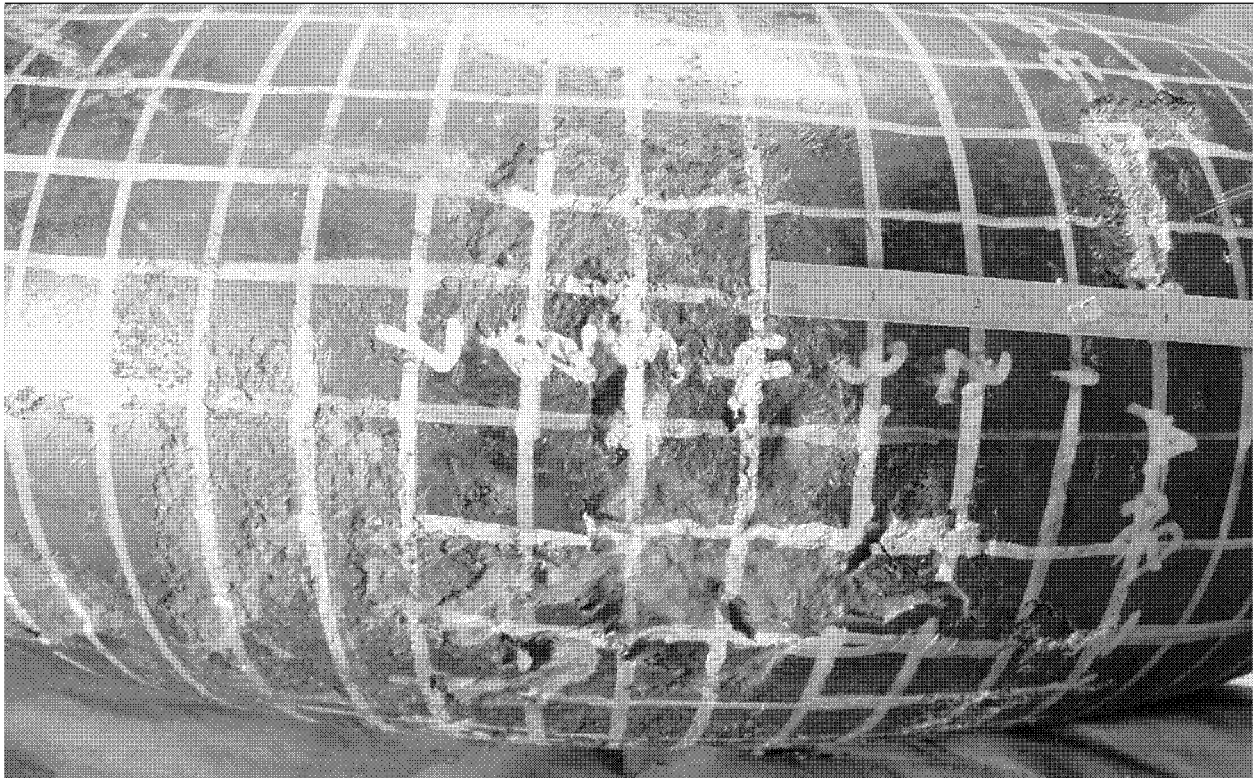
**Figure 17 – External corrosion on the extrados of the elbow, as-received; designated Area 1**

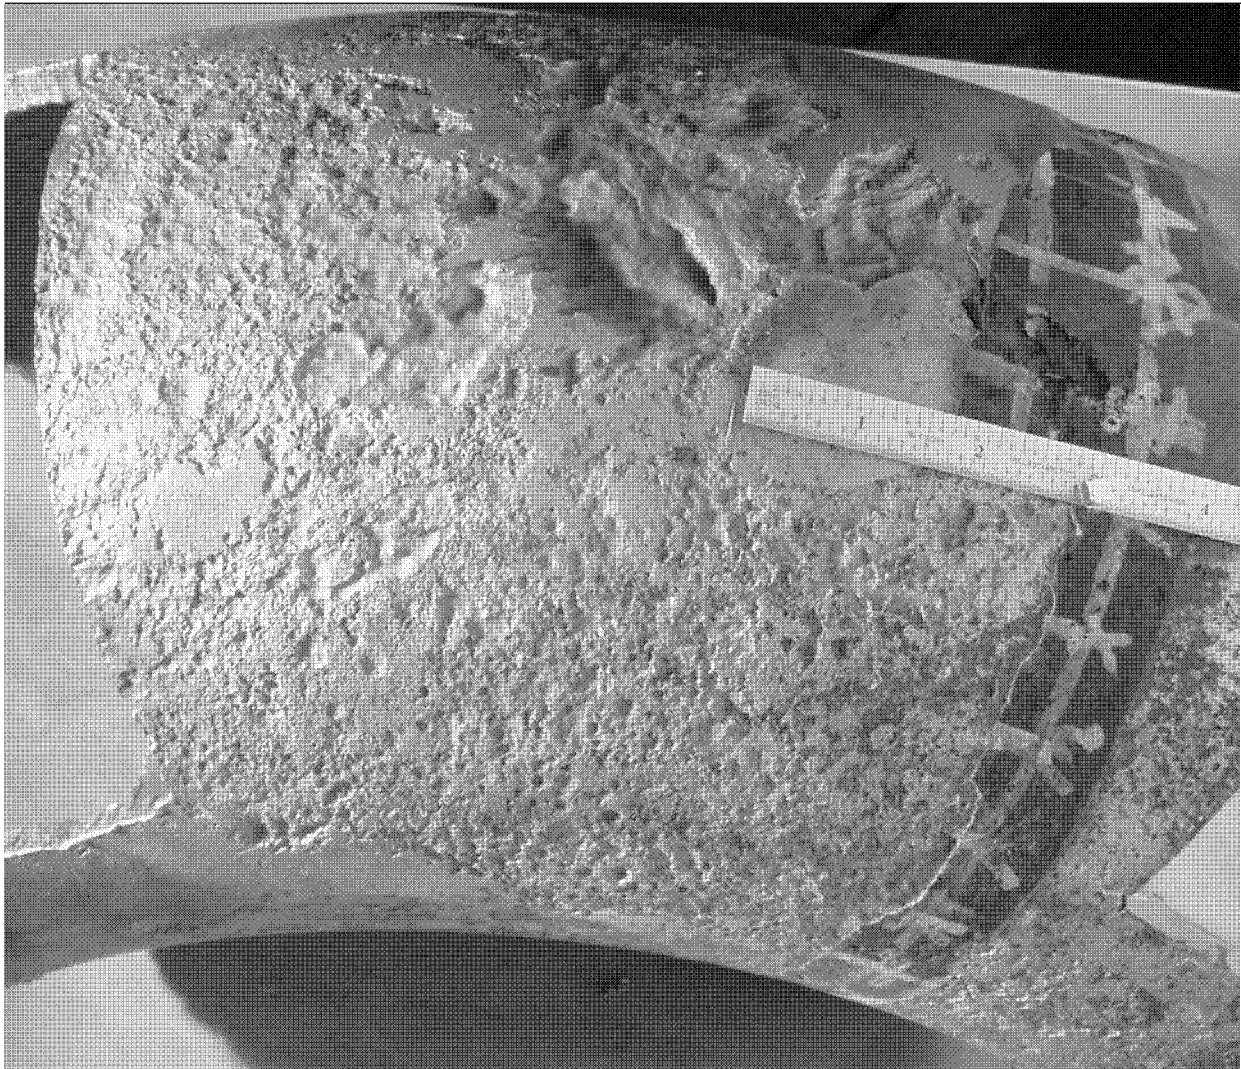
**Figure 18-- Extrados of ell after cleaning, Area 1.**

Note extensive general corrosion compared to the straight pipe. A circumferential band was masked off to prevent loss of the grid line identifications

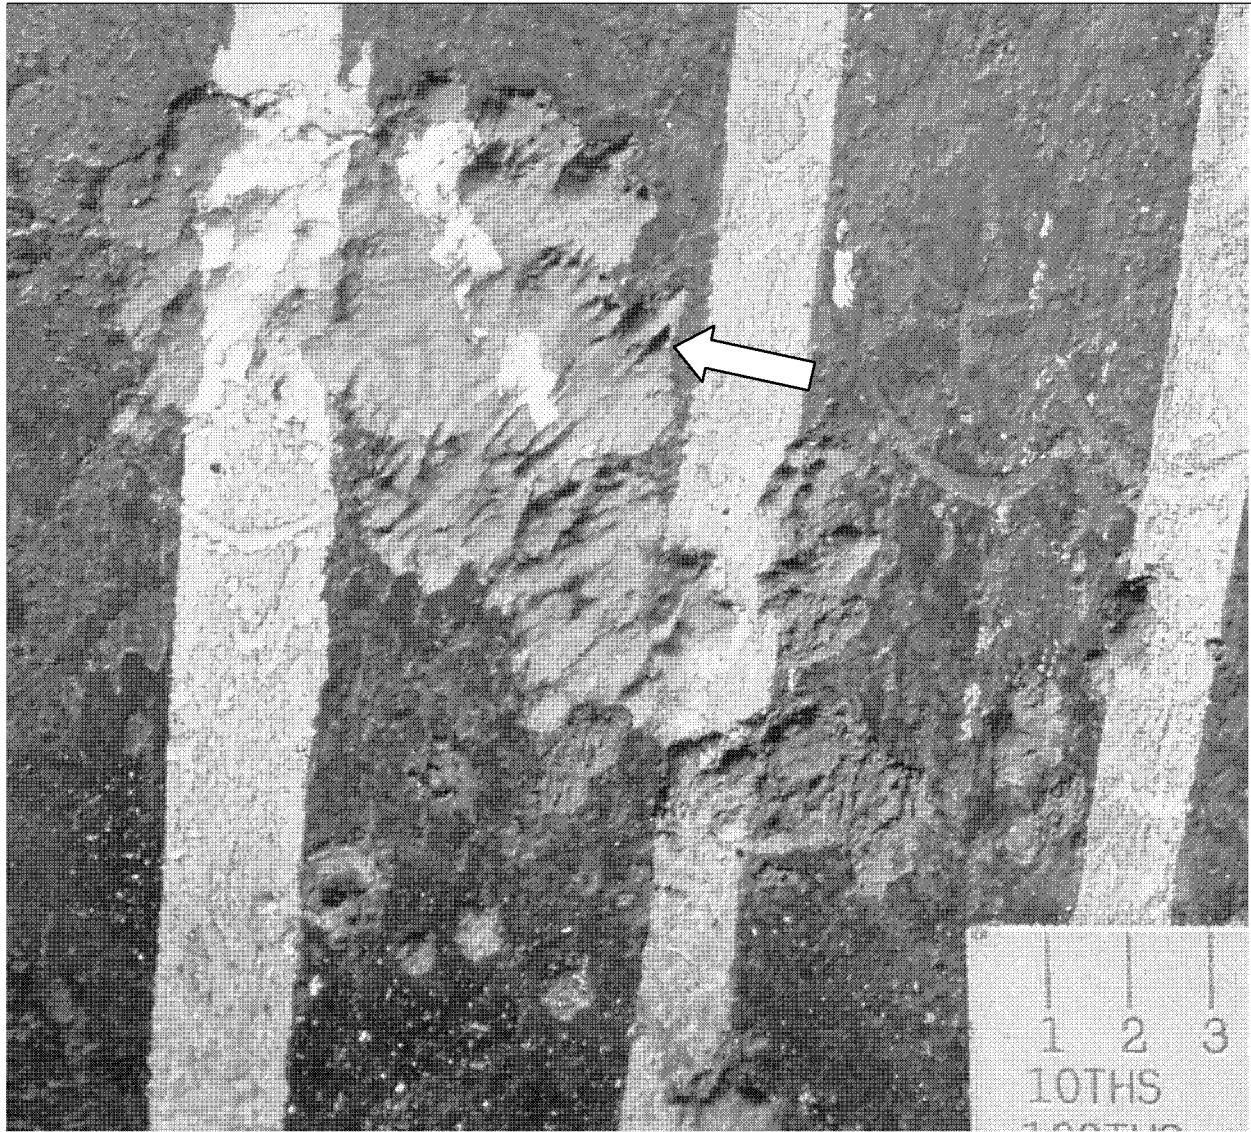
**Figure 19 – Detail of corrosion in Area 4, Location 1**  
Note sharp edges of pits and tunnel like features (arrow points to one example of tunneling).

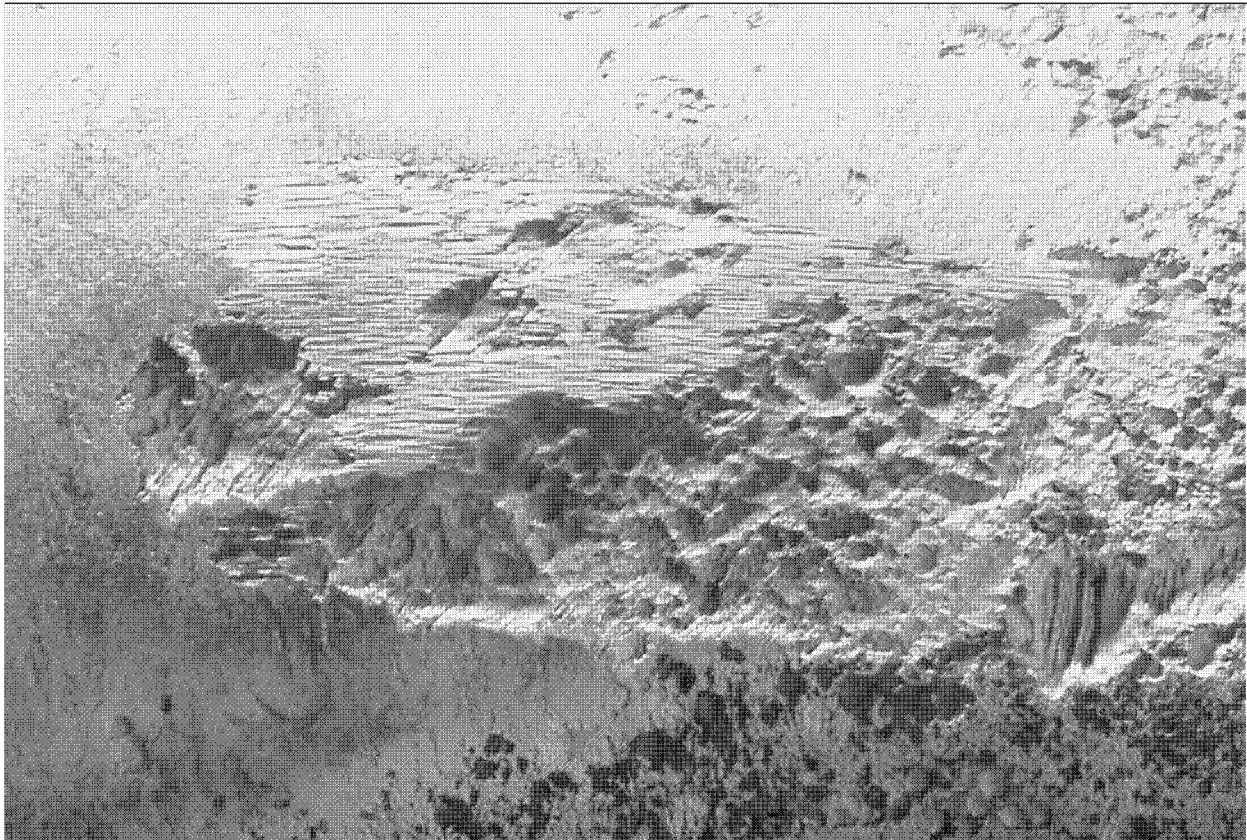
**Figure 20 - Area of Area 4, Location 2 after cleaning by glass bead blasting**

Note scrape marks. These scrape marks appeared to have discoloration and oxidation comparable to the surrounding uncorroded pipe surface suggesting they may have been formed either during the installation process, or prior to the pipe coating process. If they were formed after coating, the coating would have been damaged and exposed the scraped area to the soil. As a result, the scrape would have been eliminated by subsequent corrosion. The striations are elongated features oriented from lower left to upper right in the round pit at upper left.

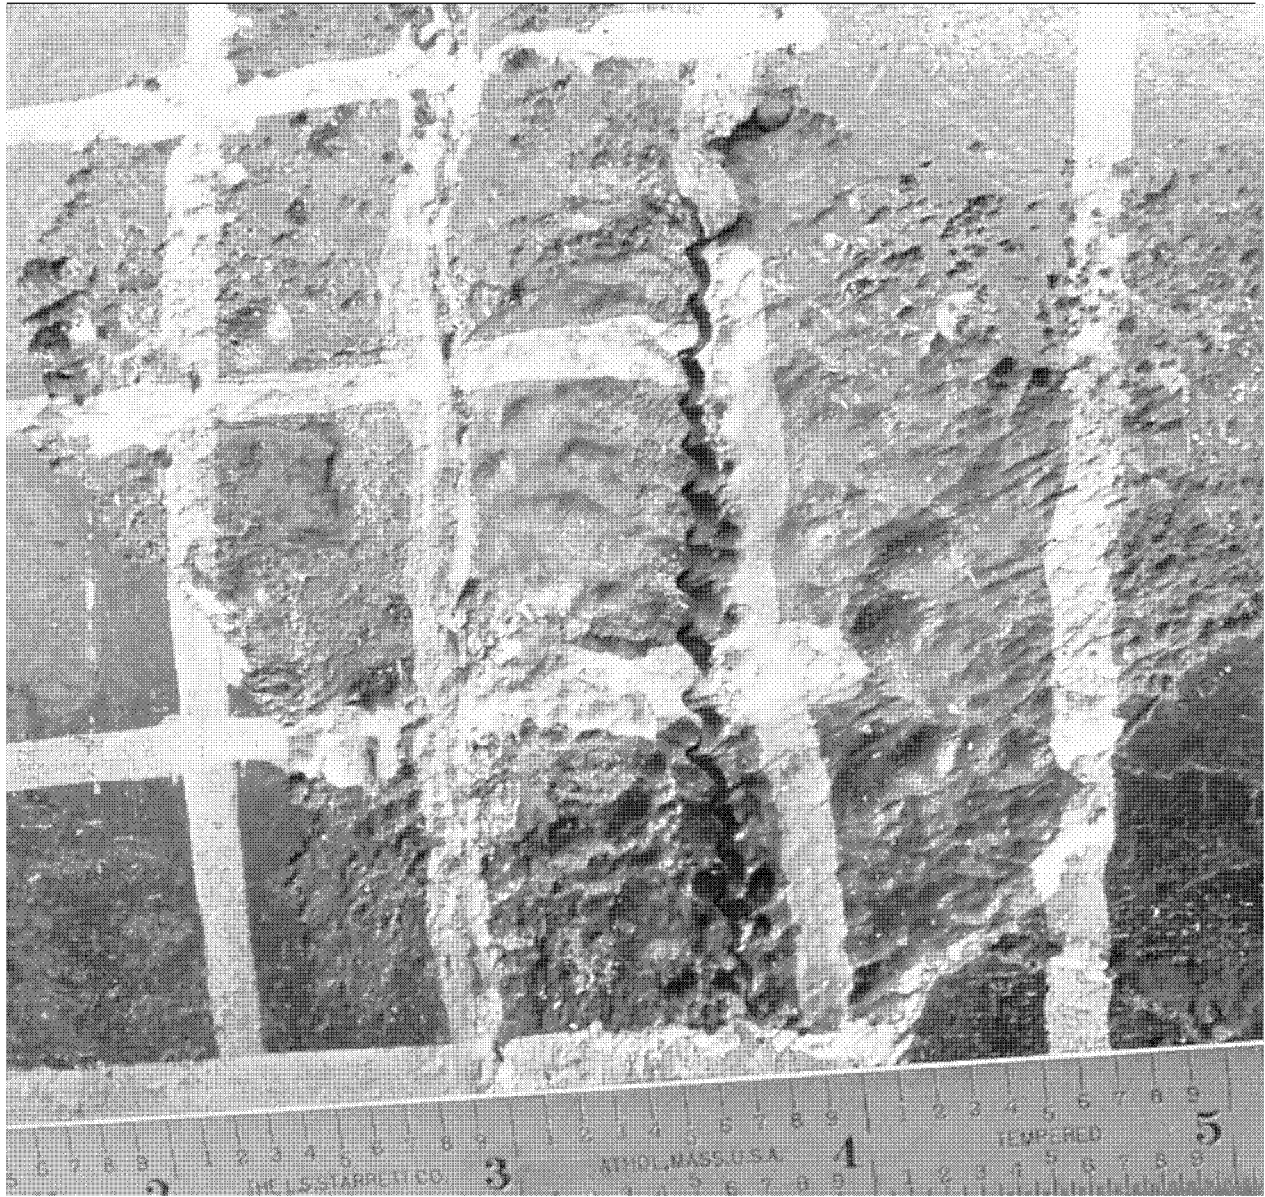
**Figure 21 – Detail of corrosion on girth weld in the location designated Area 5.**

Note corrosion undercutting the toe of the weld and striations in adjacent corrosion on the elbow. The striations are short linear features oriented about 25 degrees off the longitudinal axis of the pipe and are most visible to the right of the weld

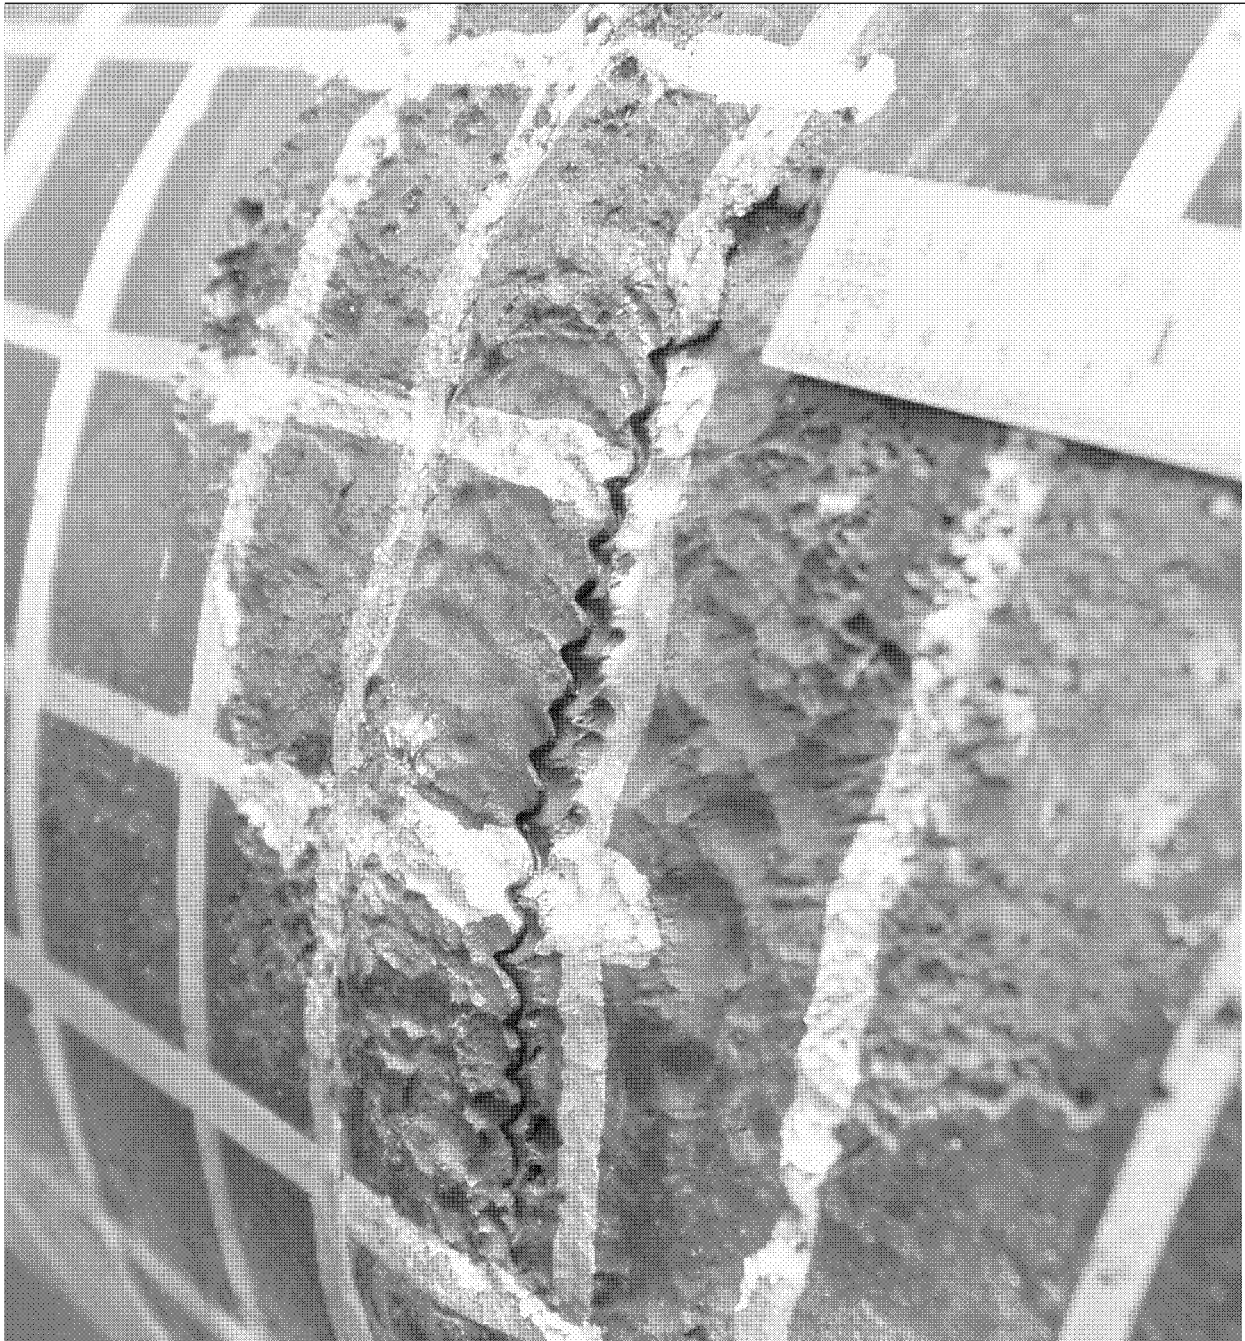
**Figure 22 – Second view showing detail of the corrosion undercutting the toe of the weld**

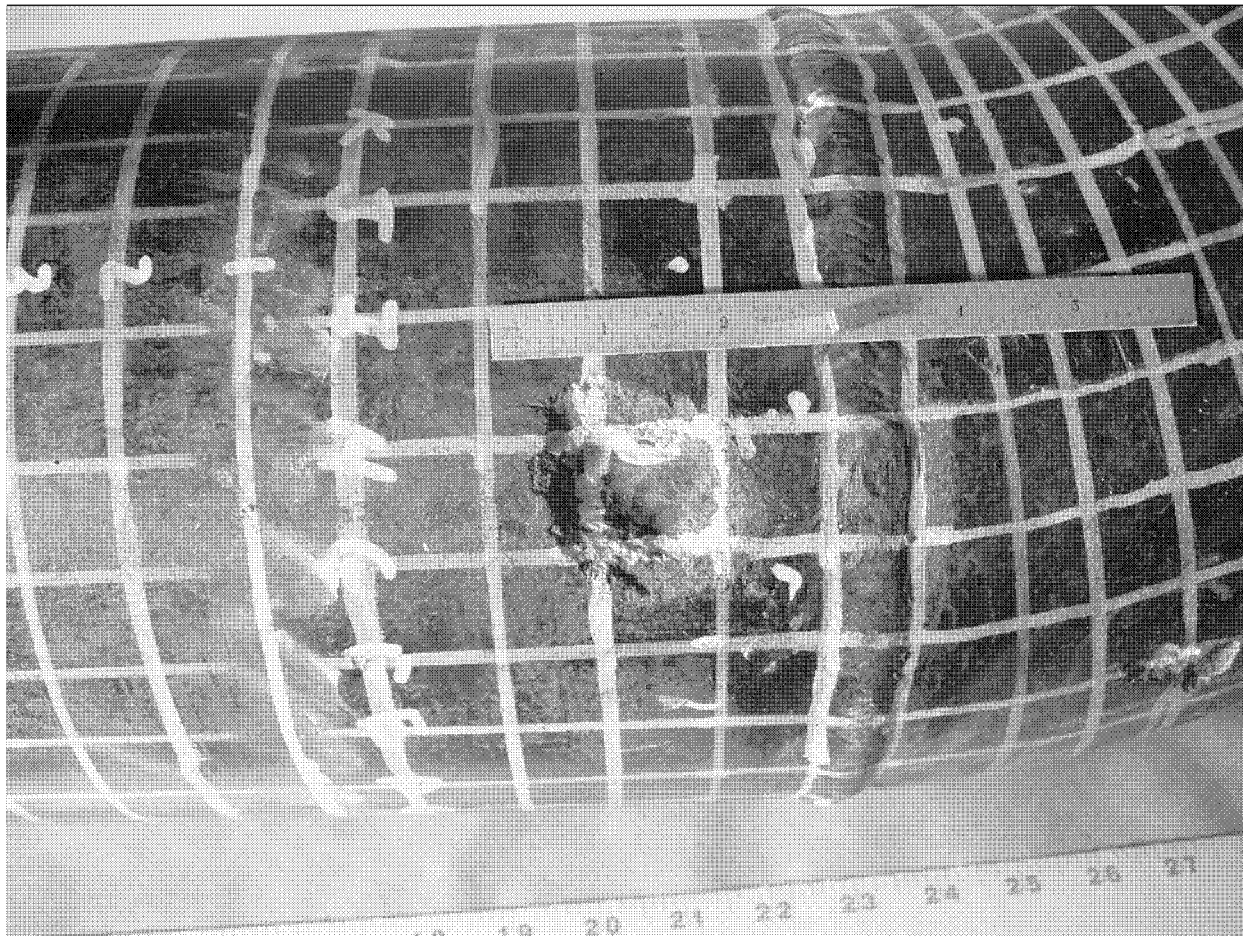
**Figure 23 – External corrosion on the pipe (as-received condition), designated Area 6. Note absence of corrosion around this pit.**

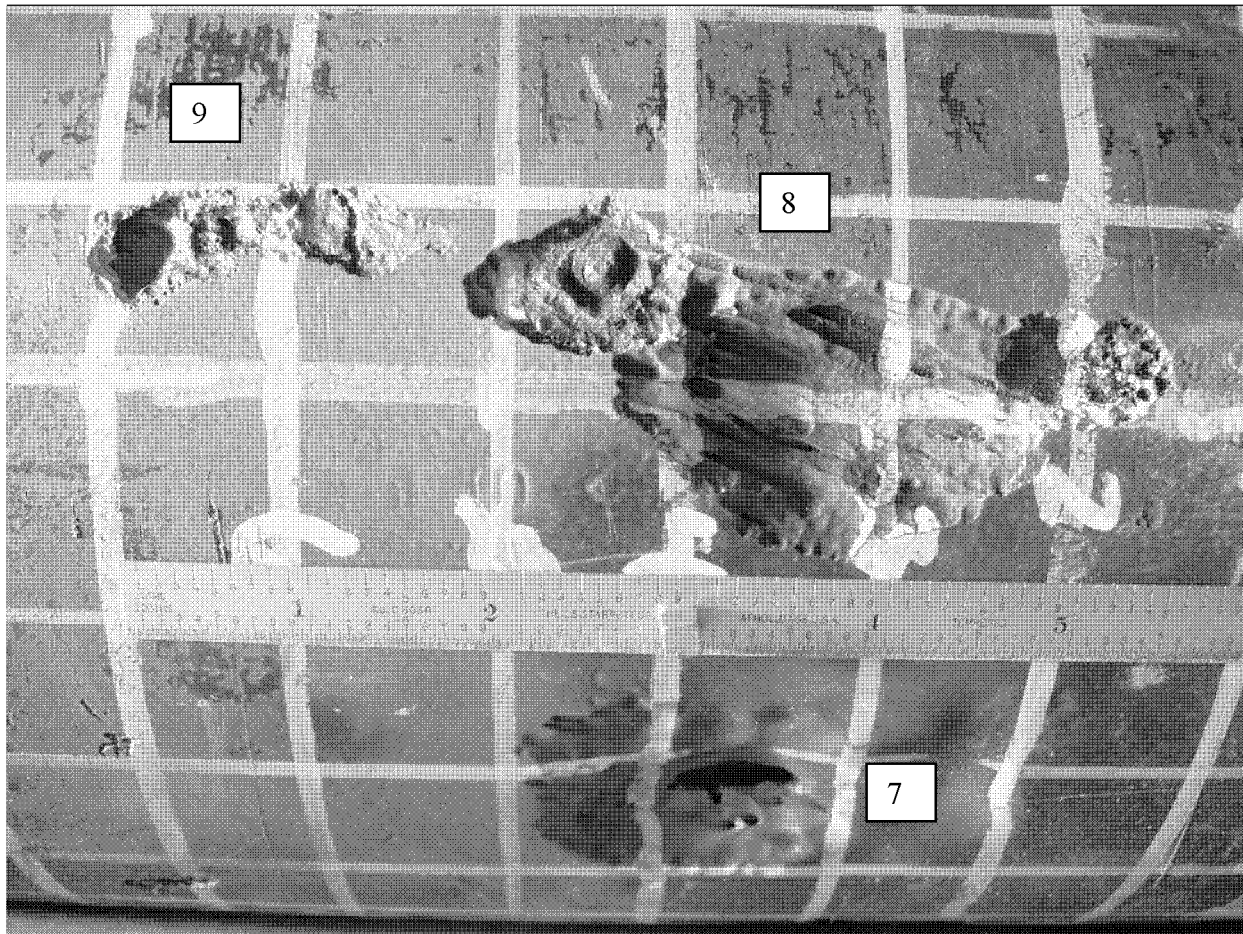
**Figure 24 – Outside surface of pipe (as received) showing leak and two other areas of corrosion in addition to identifying “YS” and “API” stamp marks. Areas designated 7, 8, and 9**

A very subtle feature that appeared to be an ERW seam runs horizontally through the “YS” stamp mark. Youngstown Steel manufactured both seamless pipe and ERW pipe in this size range. Only the seamless pipe could have met the requirements of ASTM A106. Subsequent metallographic examination of the location showed no microstructural evidence of a seam and the seam-like feature may be the remnants of the embossing wheel that produced the “YS” stamp during the manufacturing process of seamless pipe. The area surrounding the leak (Area 7) was eroded and polished as a result of turbulent water in the area of the leak. In comparison, areas of metal loss a few inches or more from the leak (i.e., see areas 8 and 9) have irregular topographies typical of corrosion that has not been modified by erosion.

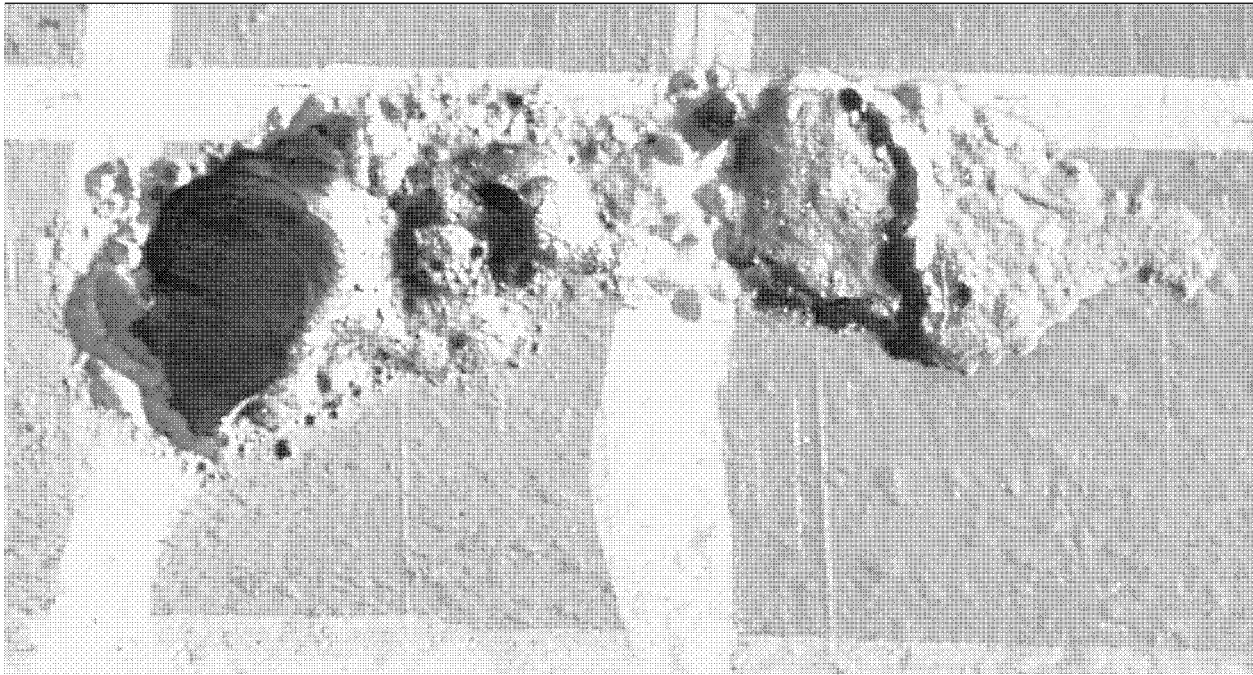
**Figure 25 – Detail of Area 9 (as received) showing multitudes of small overlapping pits of various sizes, resulting in an almost spongy appearance**

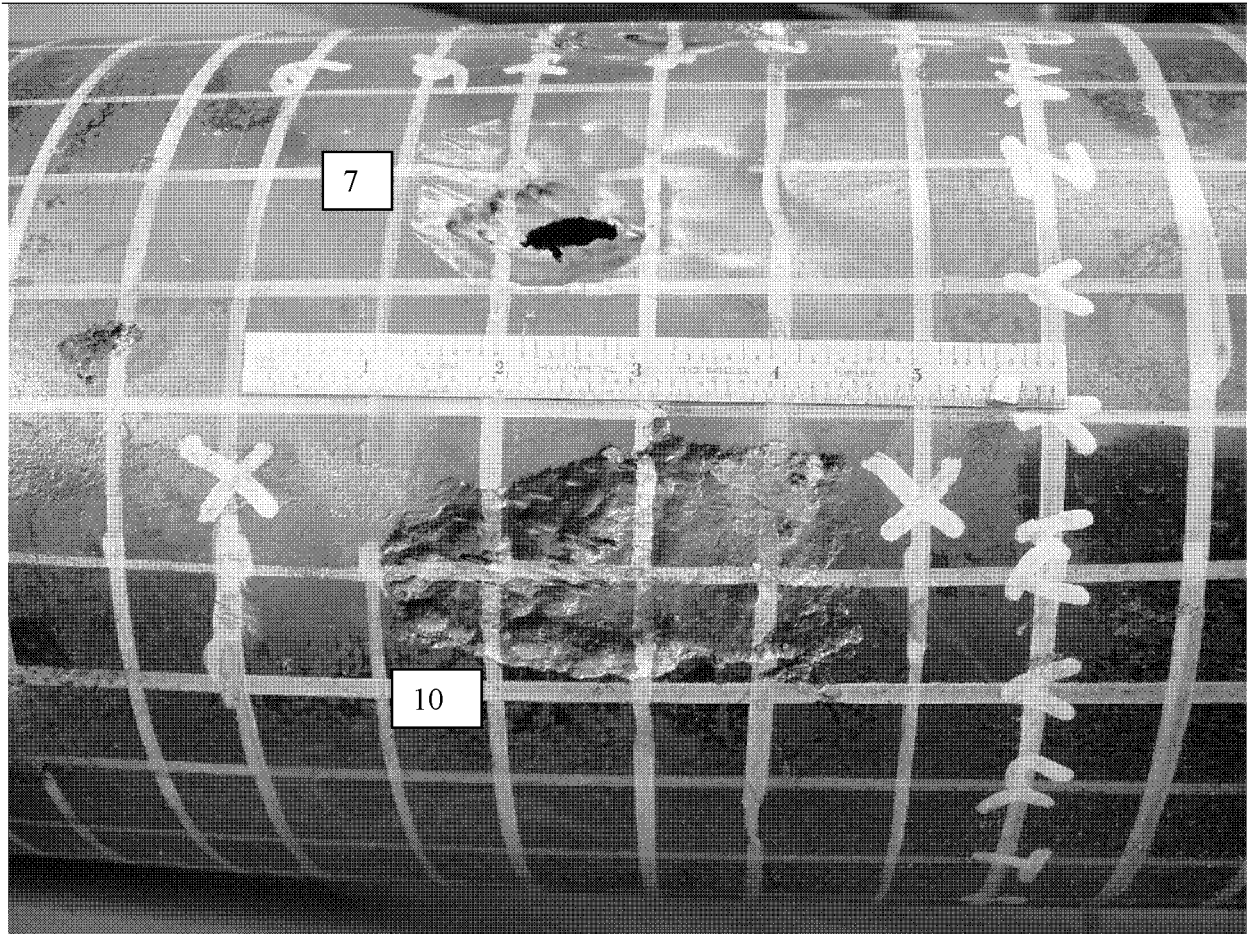
**Figure 26 – Another view of the area of the leak and adjacent corrosion in the pipe (as-received), Designated Areas 7 and 10, respectively.**

Note polishing (erosion) of the surface surrounding the leak caused by leaking water.

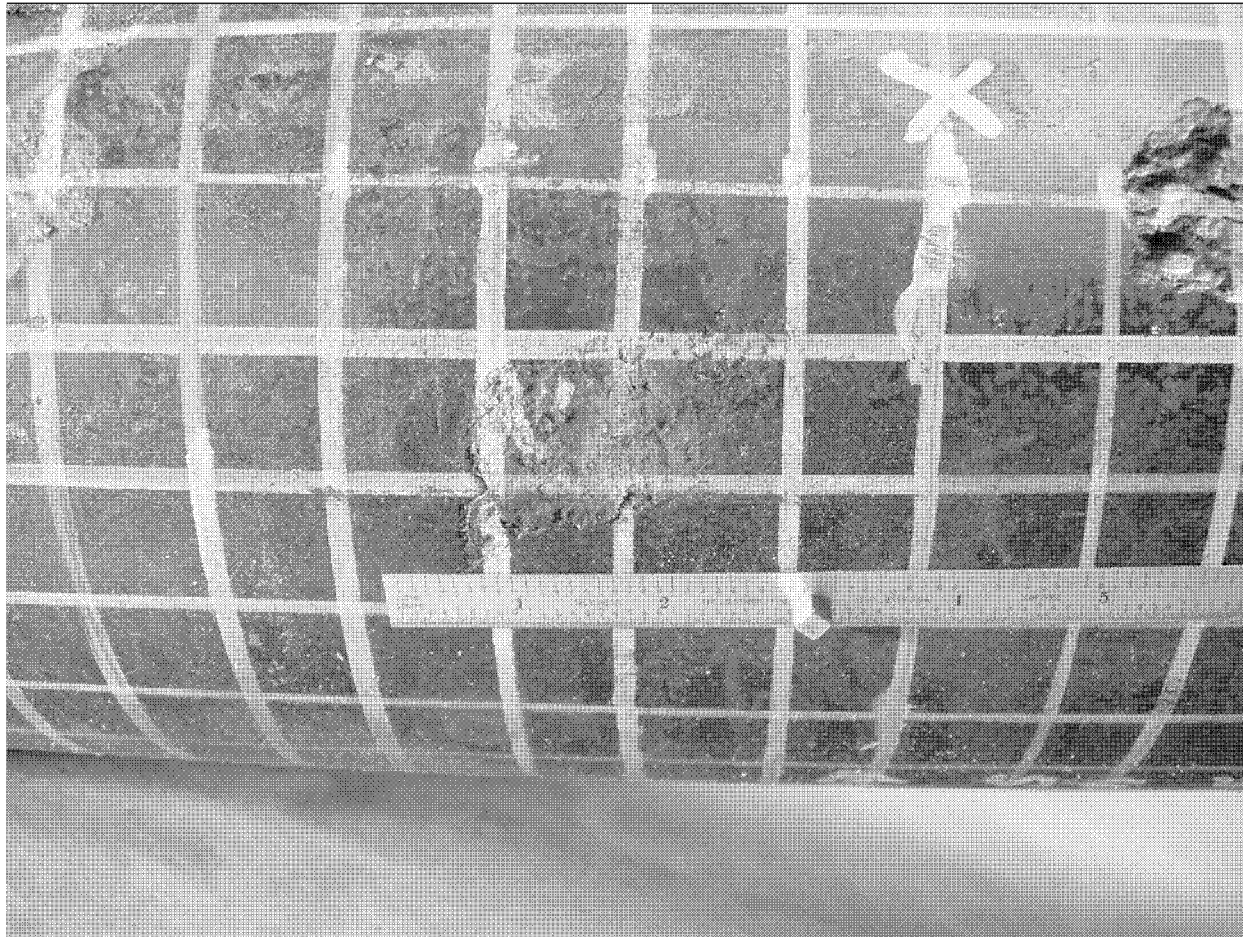
**Figure 27 – External corrosion pit in the pipe (as-received condition) designated Area 11.** Note absence of corrosion around the pit. In this example the corrosion product fills the area of metal loss so that the corrosion product surface is nearly flush with the pipe surface. See next figure for detail
