United States Nuclear Regulatory Commission Official Hearing Exhibit	
In the Matter of:	Entergy Nuclear Operations, Inc. (Indian Point Nuclear Generating Units 2 and 3)

<b>ASLBP #:</b> 07-858-03-LR-BD01
	<b>Docket #:</b> 05000247   05000286
	<b>Exhibit #:</b> NYS000202-00-BD01
	<b>Admitted:</b> 10/15/2012
	<b>Rejected:</b>
<b>Other:</b>	<b>Identified:</b> 10/15/2012
	<b>Withdrawn:</b>
	<b>Stricken:</b>

Significance Level 2 Report

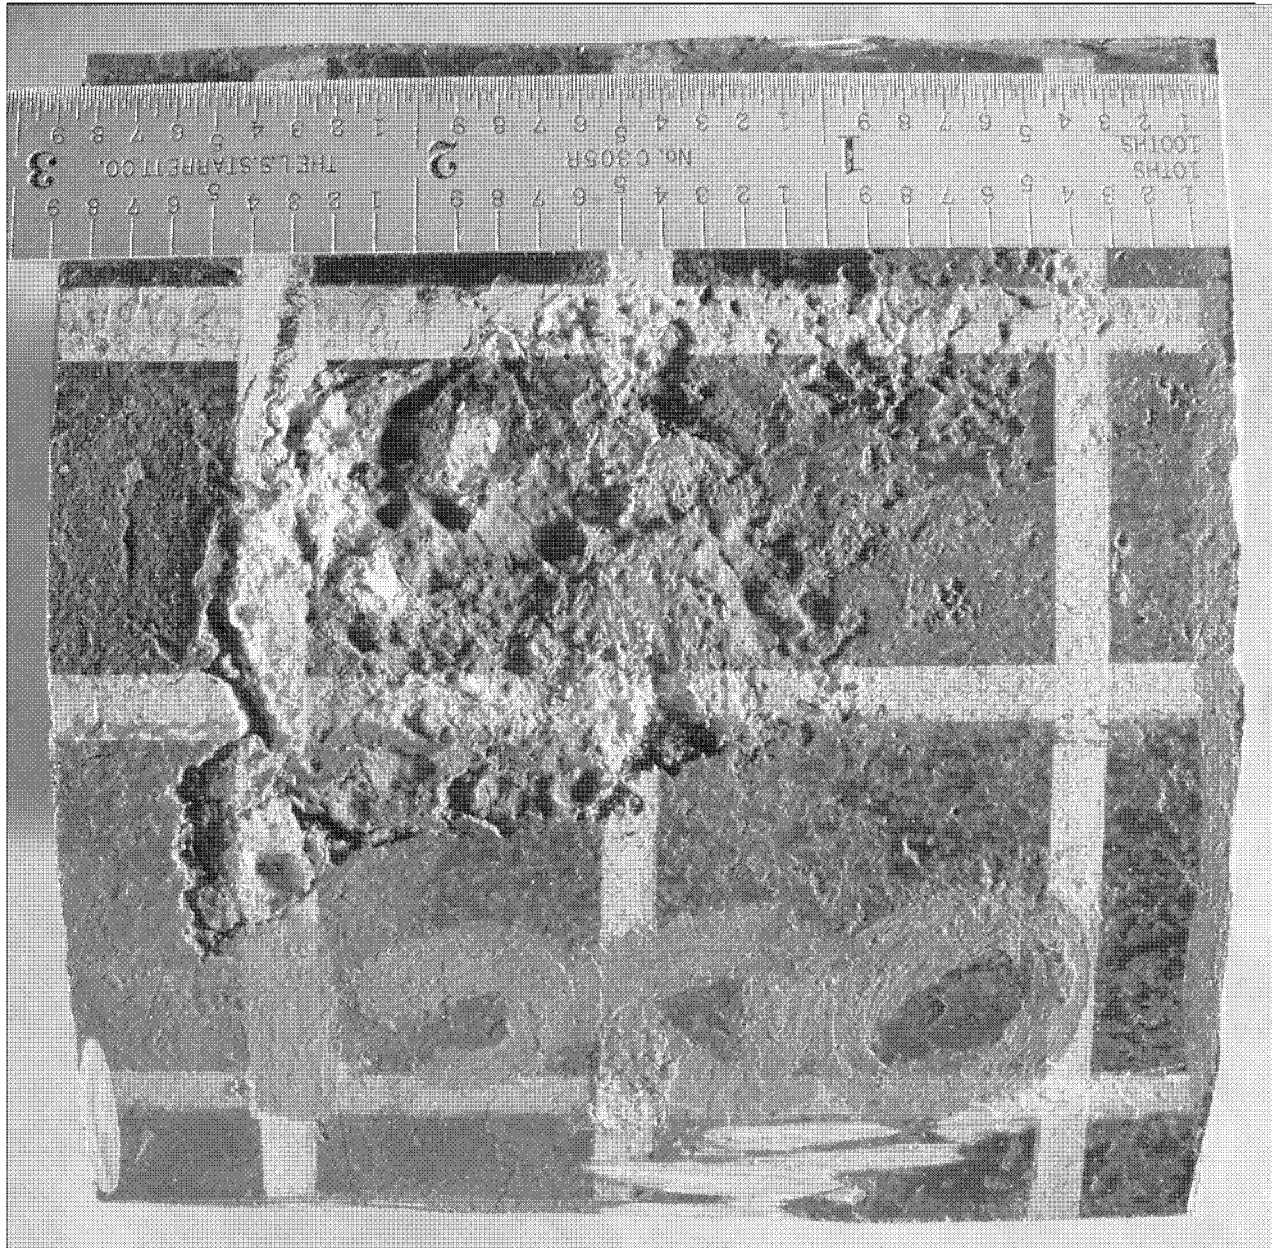
**Figure 28 – Detail of Area 11 in previous figure. This sample was cross sectioned for metallographic examination.**

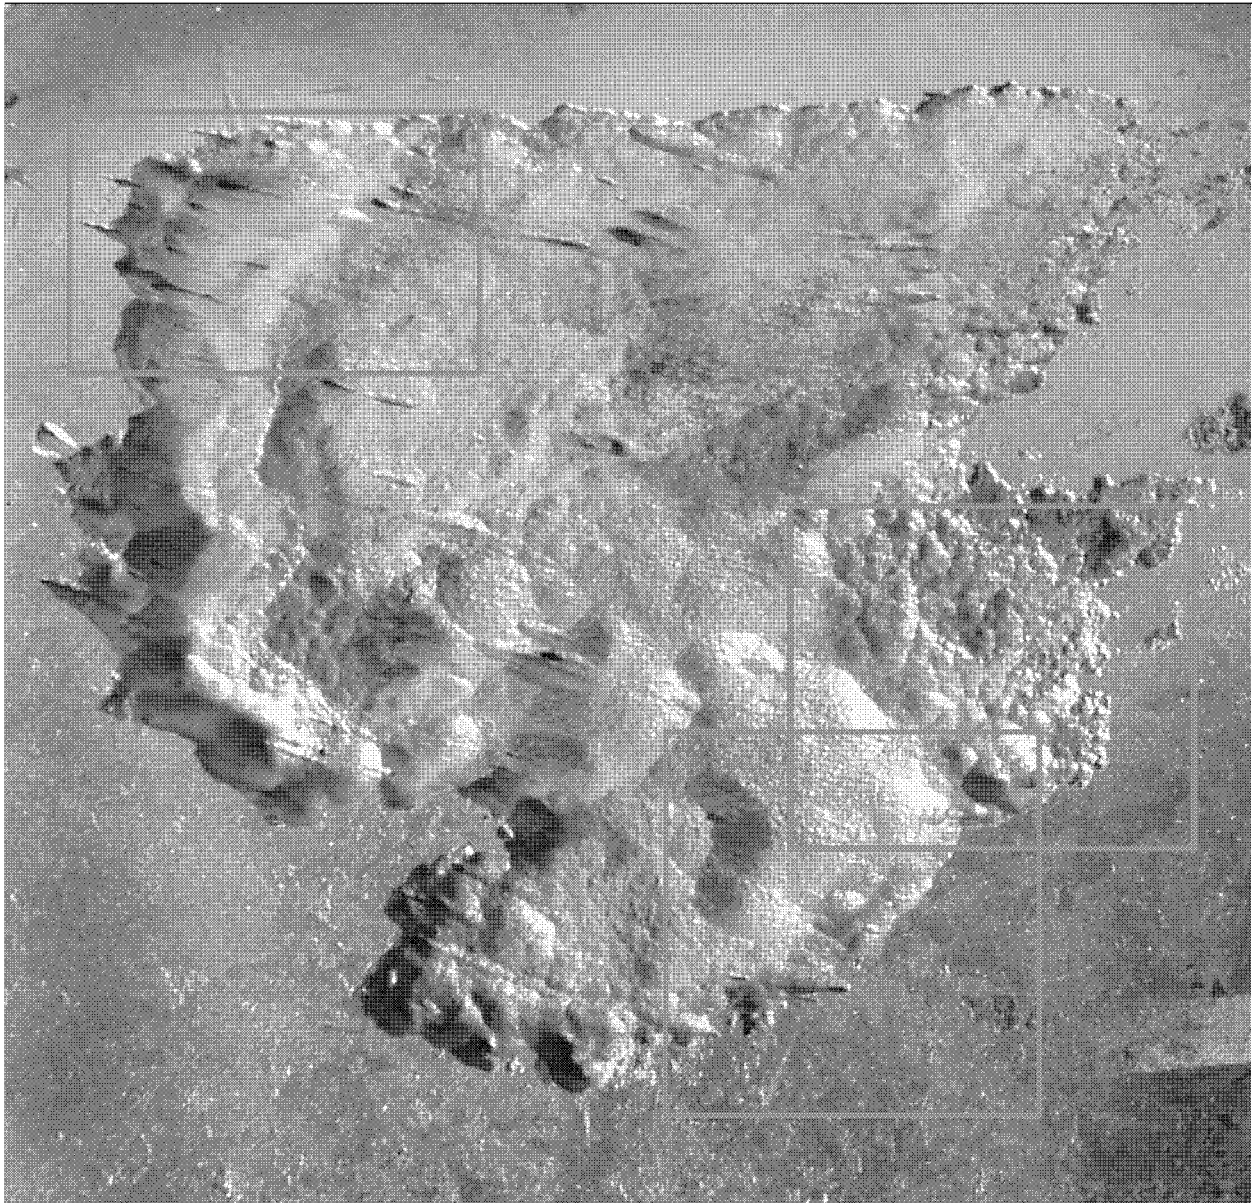
**Figure 29 – Detail of Area 13 after cleaning.**  
See following figures for details of areas bounded by blue boxes.

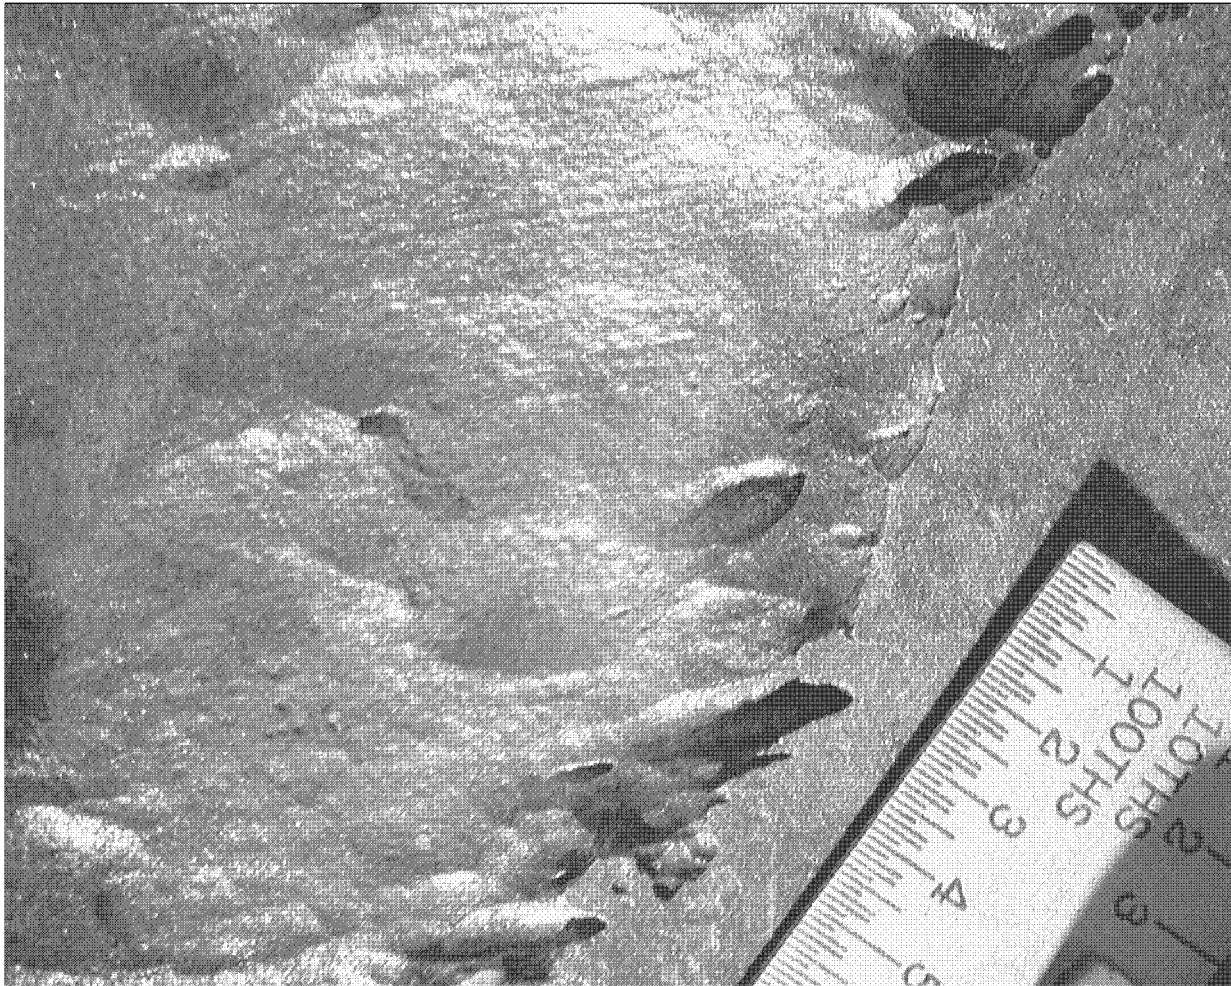
**Figure 30 - Detail of previous figure (Area 13). Note steep, undercut edges and relatively smooth bottom.**

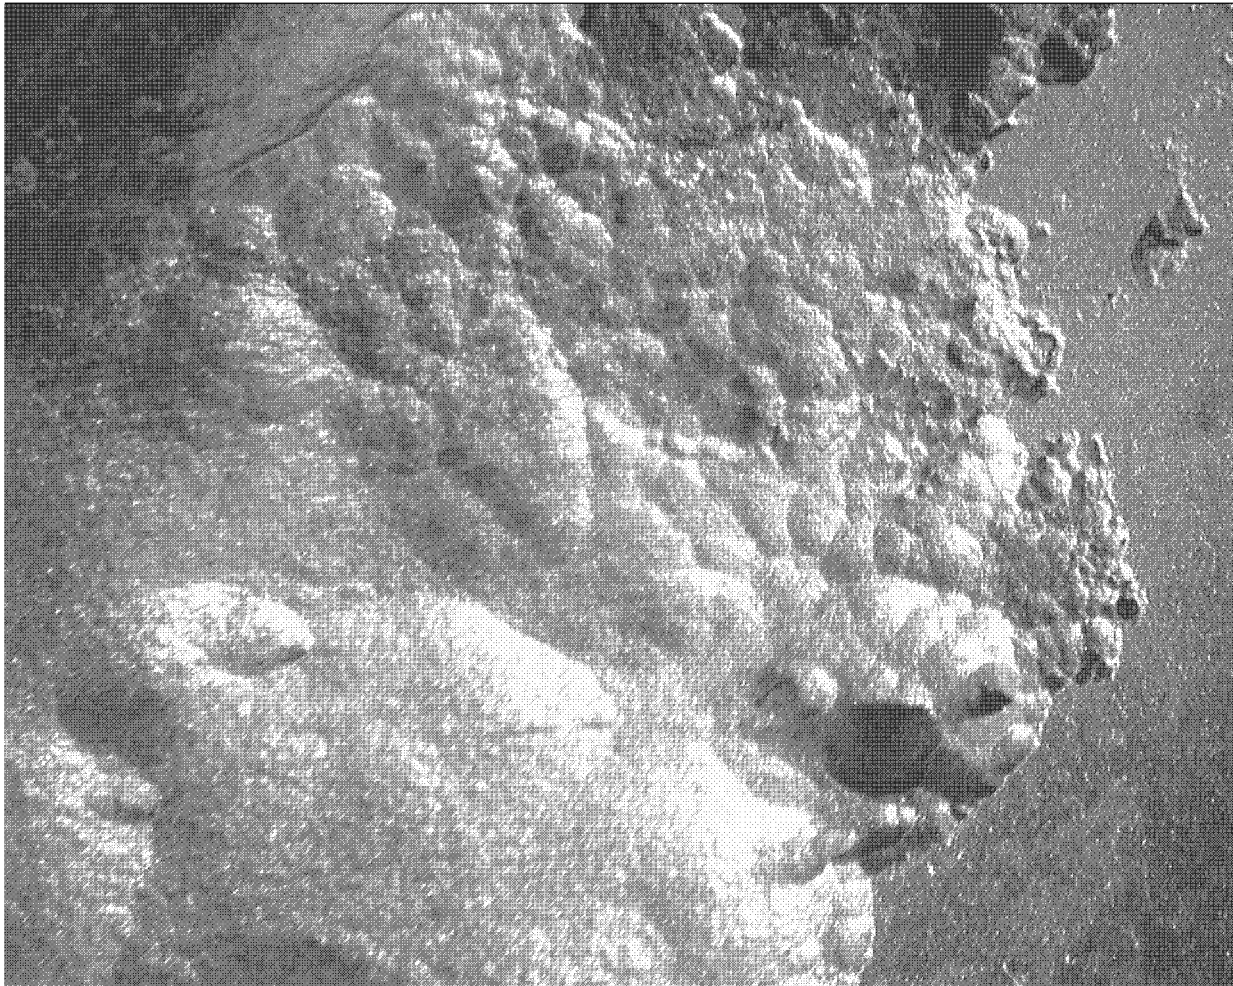
**Figure 31 - Detail of cleaned exterior pit in Area 13 Note pit-within-pit morphology in this area of less severe metal loss.**

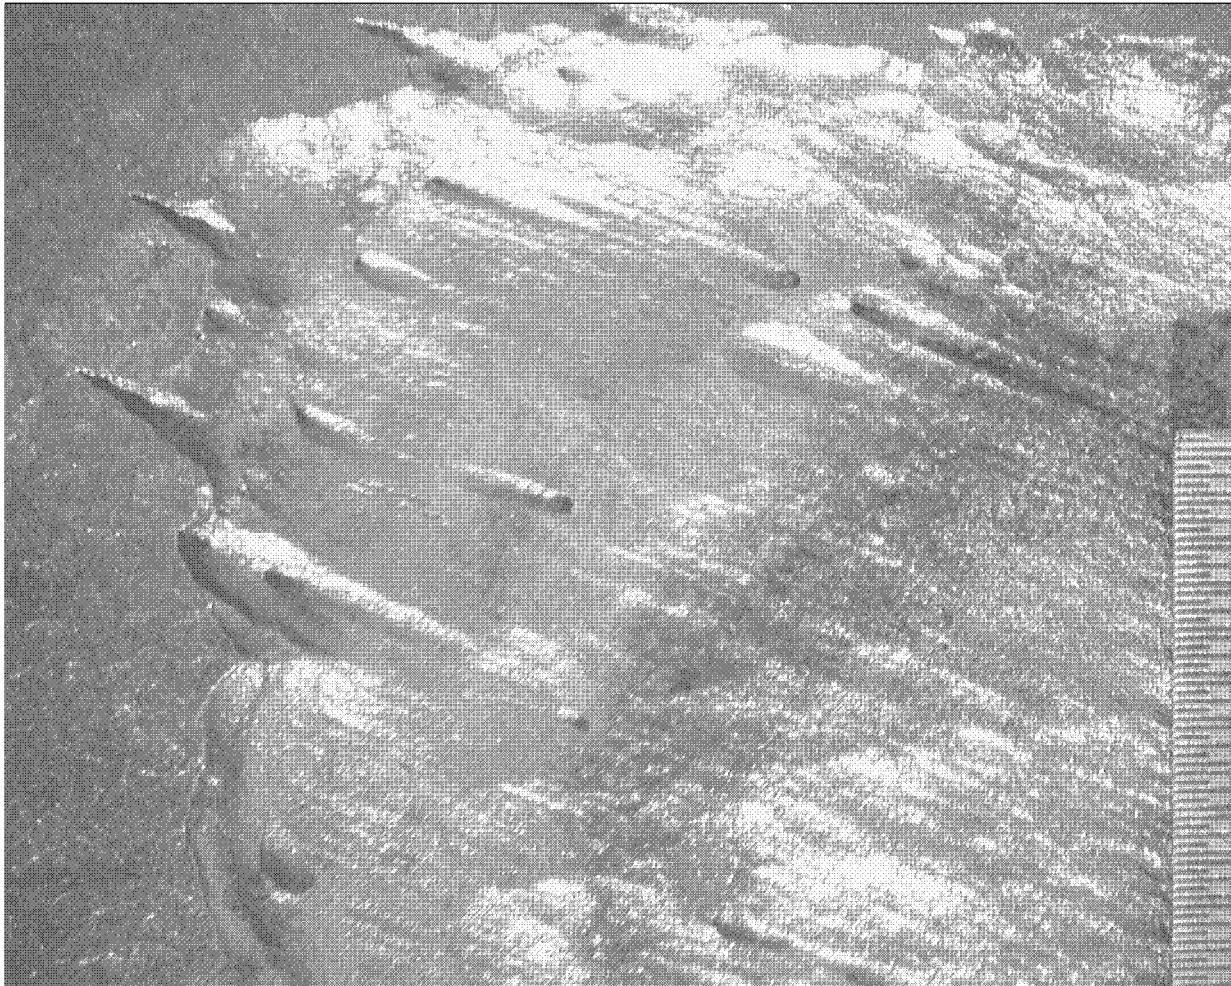
**Figure 32 - Detail of cleaned pit (Area 13). Note tunneling and striations trending from upper left toward lower right.**

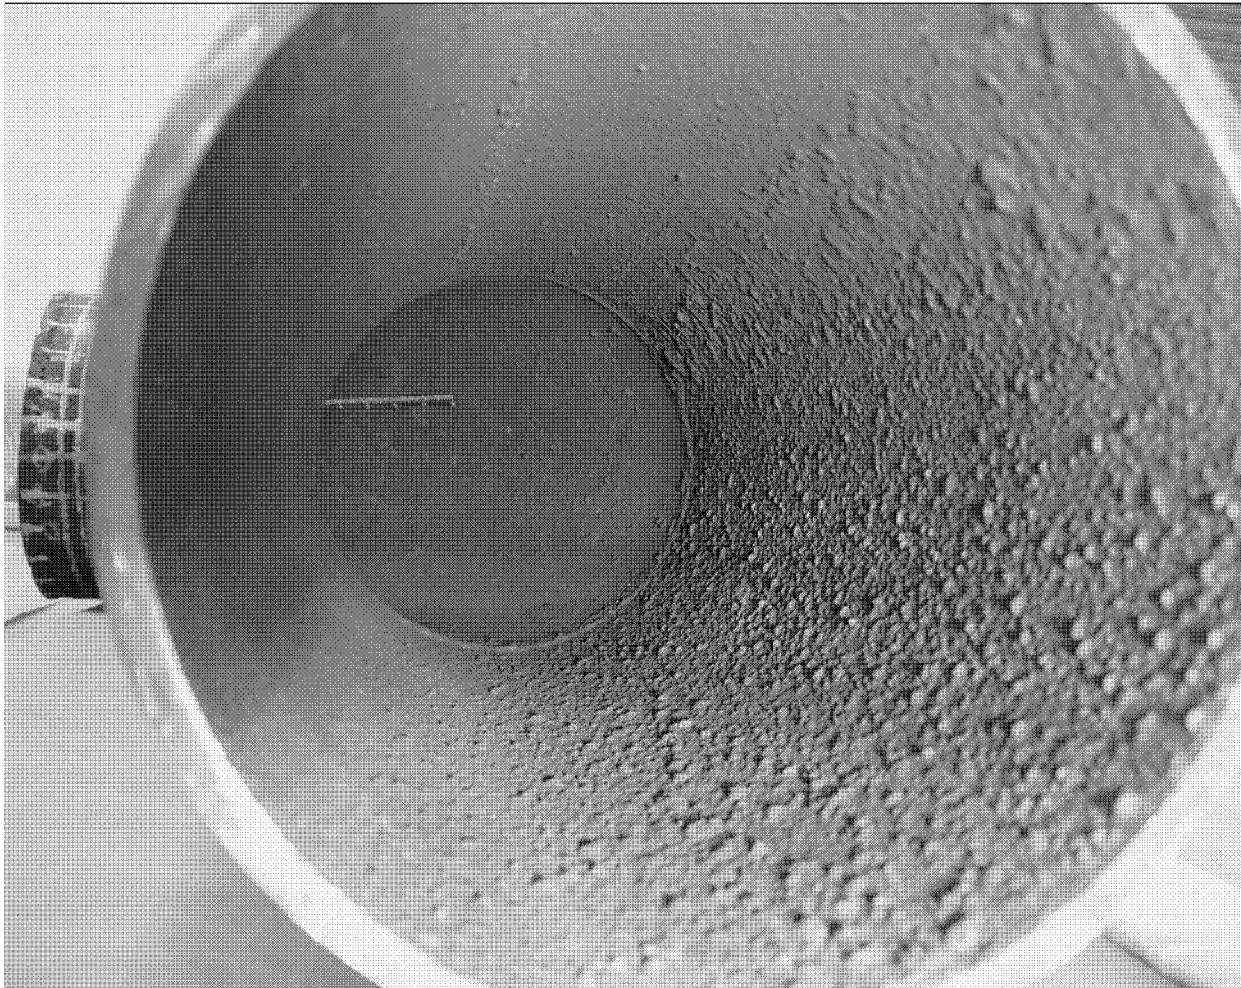
**Figure 33 – Inside view of pipe sample looking from straight pipe toward the elbow (as received condition).**

Pattern of rust red tubercles was different on the elbow than on the pipe. See following figures for details.

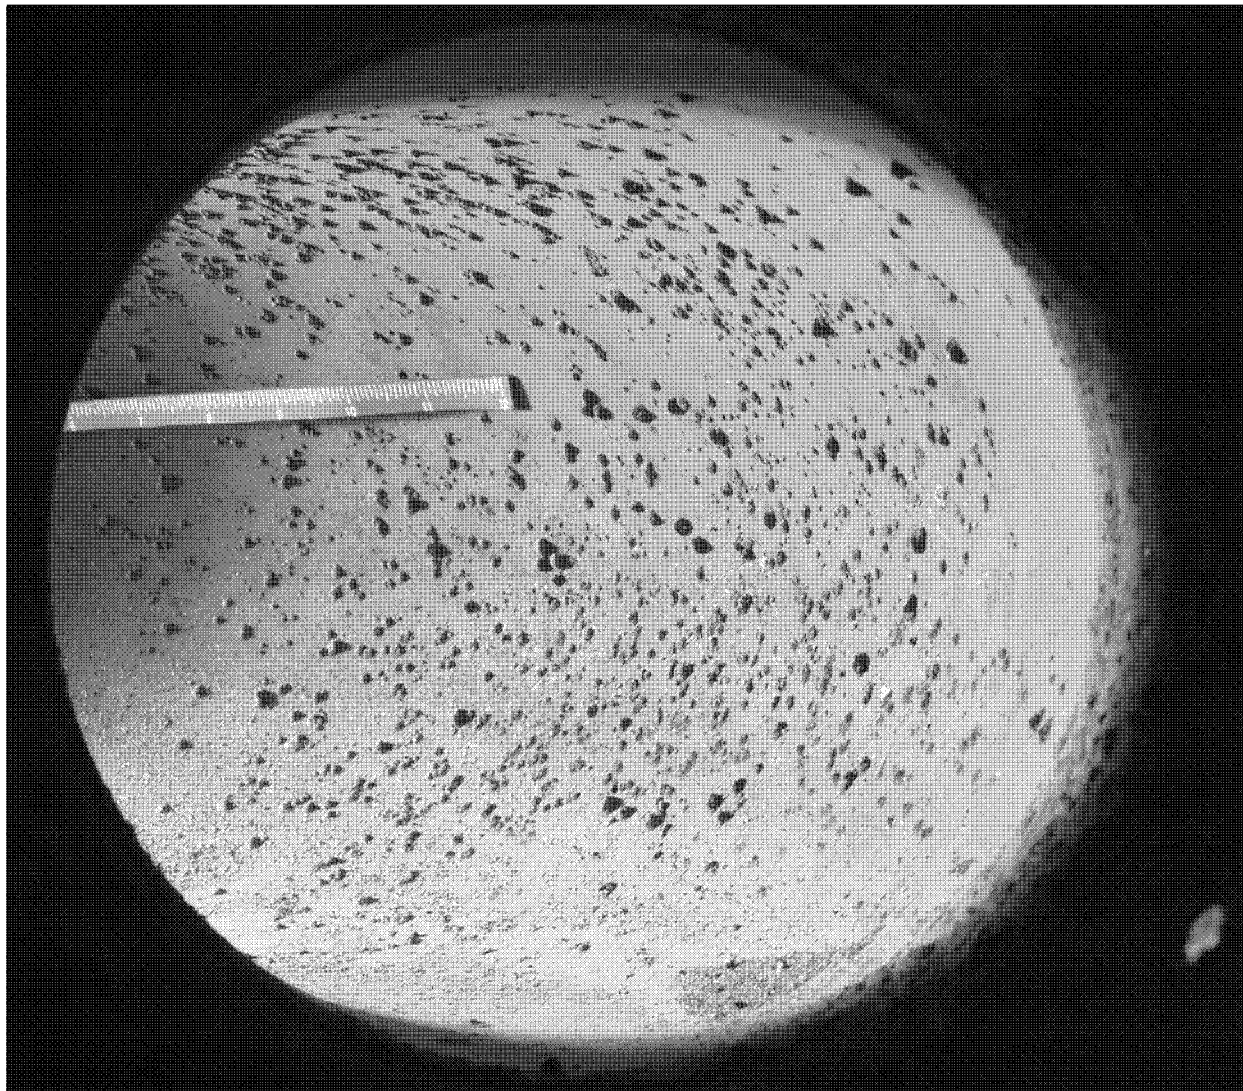
**Figure 34 – View into pipe from the end of the elbow.**

Note more widely spaced tubercles, relative to those illustrated in the previous figure.  
Numbered divisions on red scale are inches.

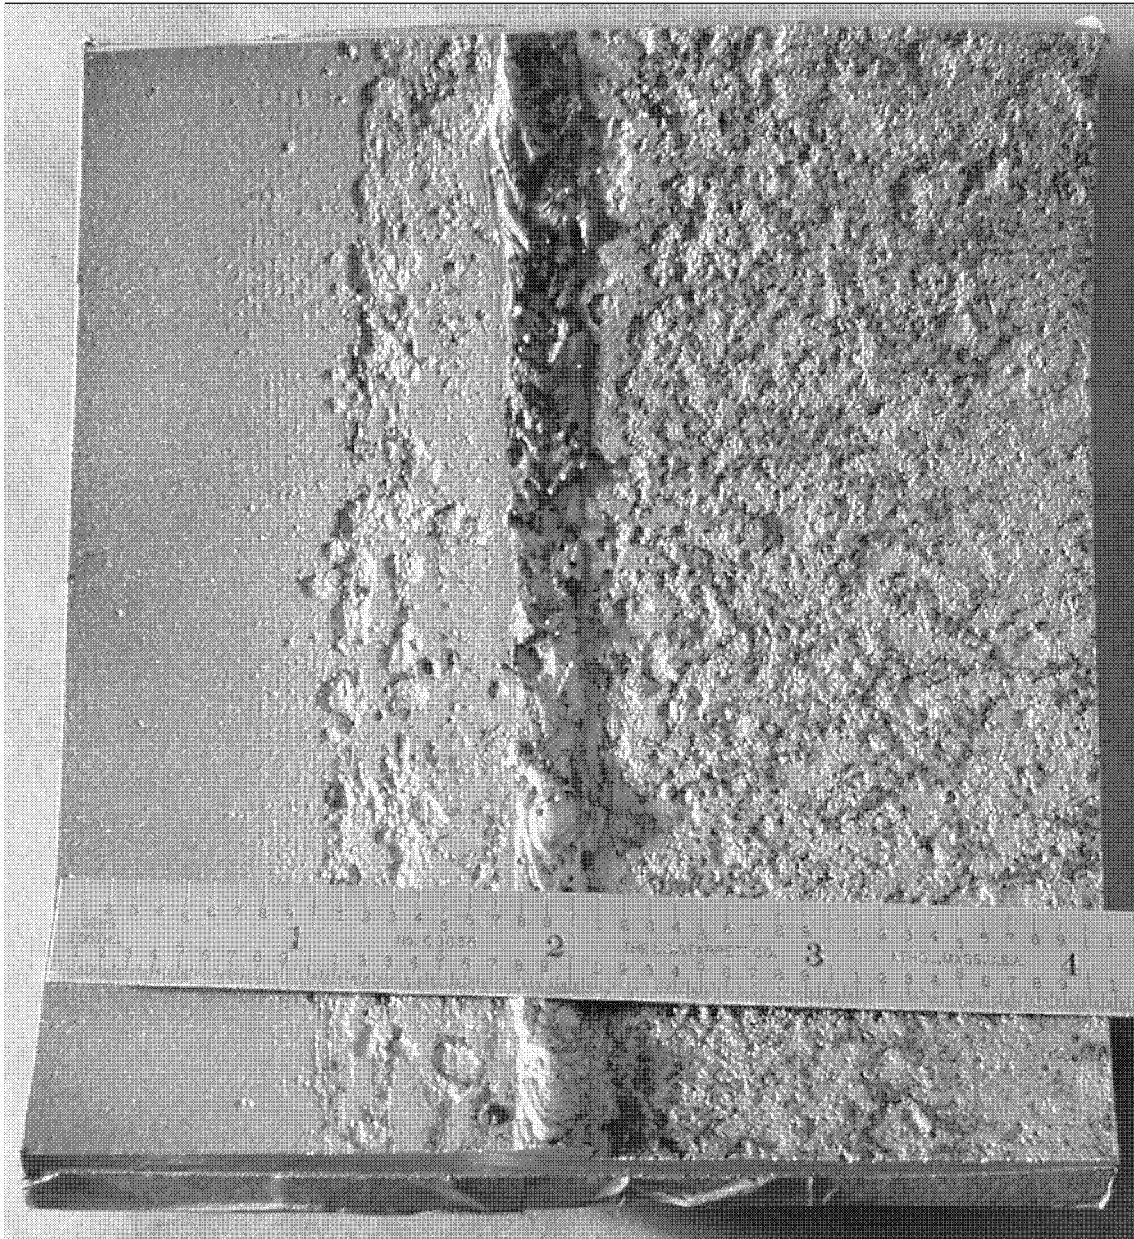
**Figure 35 – Inside surface near girth weld, after cleaning by glass bead blasting.**  
Pipe is at right, elbow is at left. Narrow band of corrosion pitting adjacent to the weld is typically related to localized microstructural changes in the weld heat affected zone and to changes in the oxide scale resulting from the thermal cycles associated with welding. In this case the corrosion extends beyond the limits of the microstructural changes and is therefore most likely also influenced by changes in the oxide film on the surface or ..

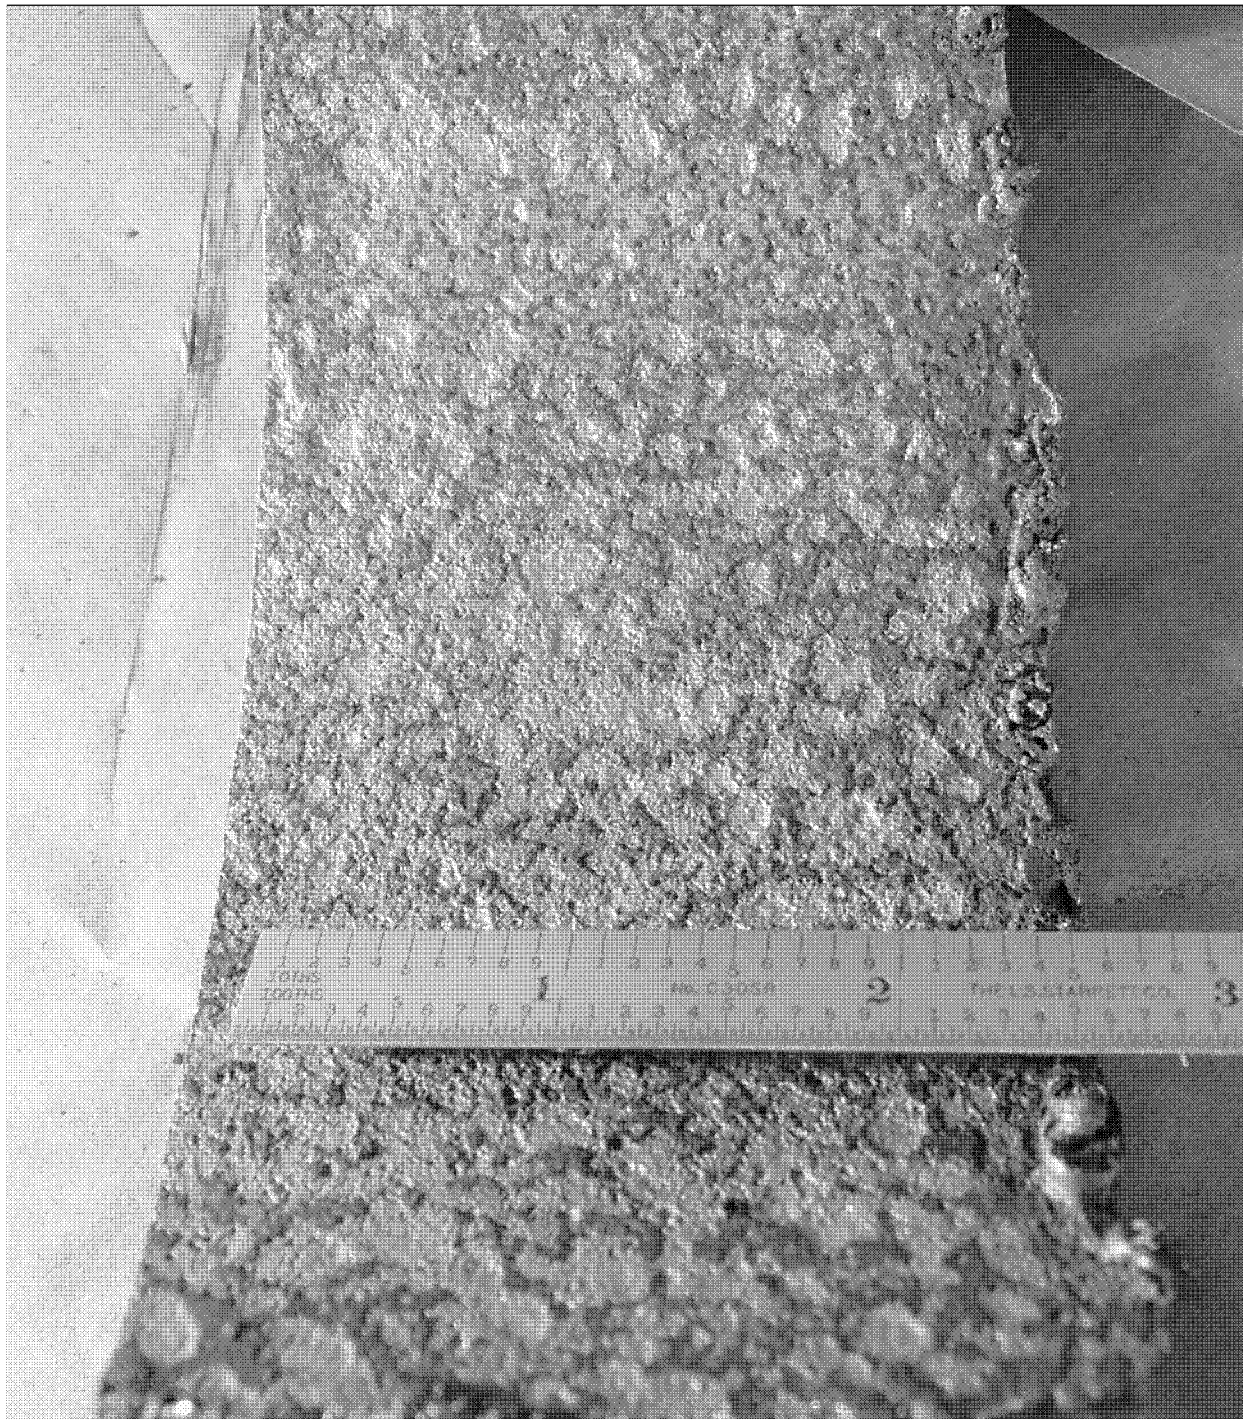
**Figure 36 – Inside surface of the pipe after cleaning showing superficial general corrosion.**

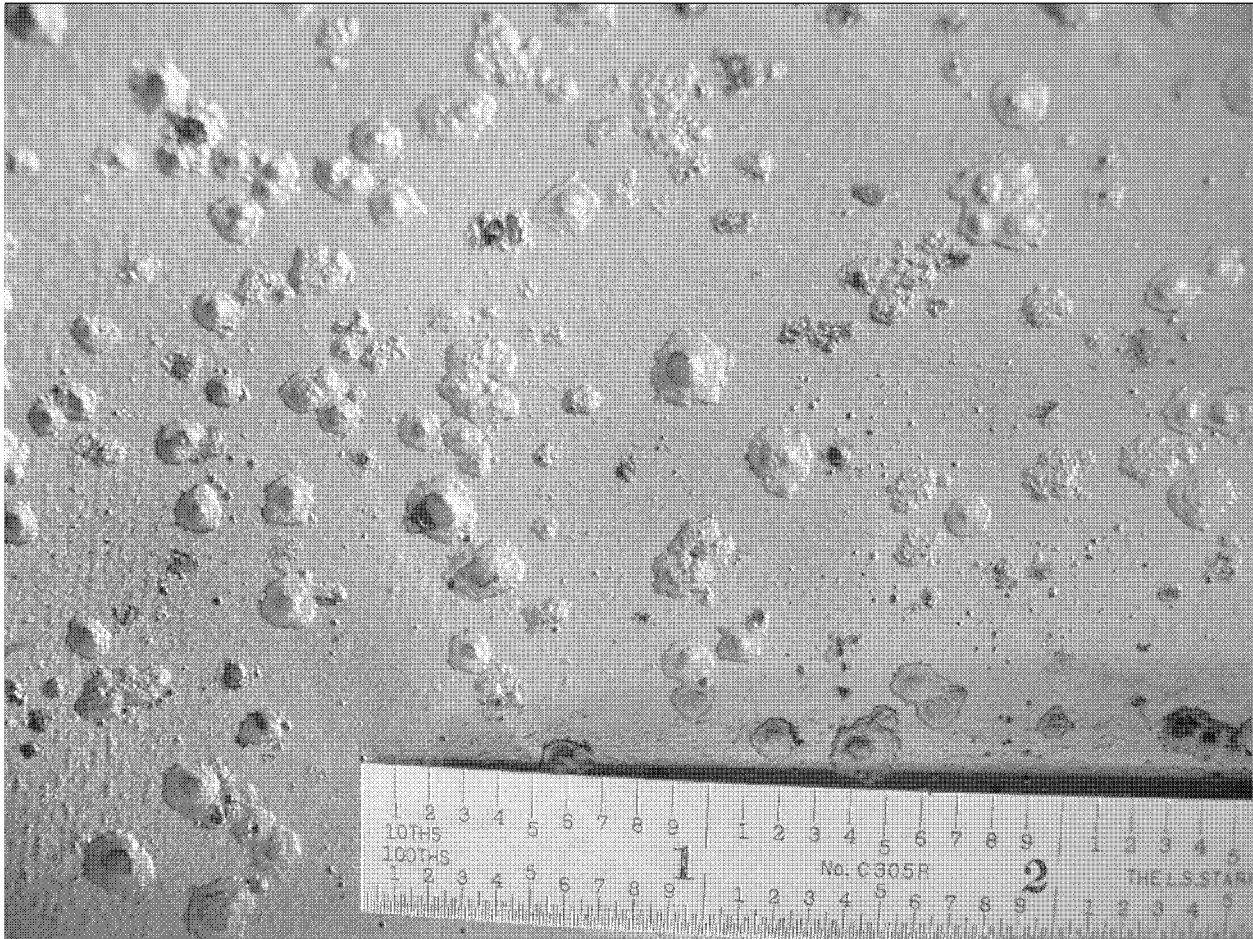
**Figure 37 - Detail of the inside surface of the elbow after cleaning.**

Maximum measured pit depth is approximately 0.018 inches, corresponding to an average long term corrosion rate of only about 0.5 mpy (1 mpy = 0.001 inch per year, or 1 mil per year).

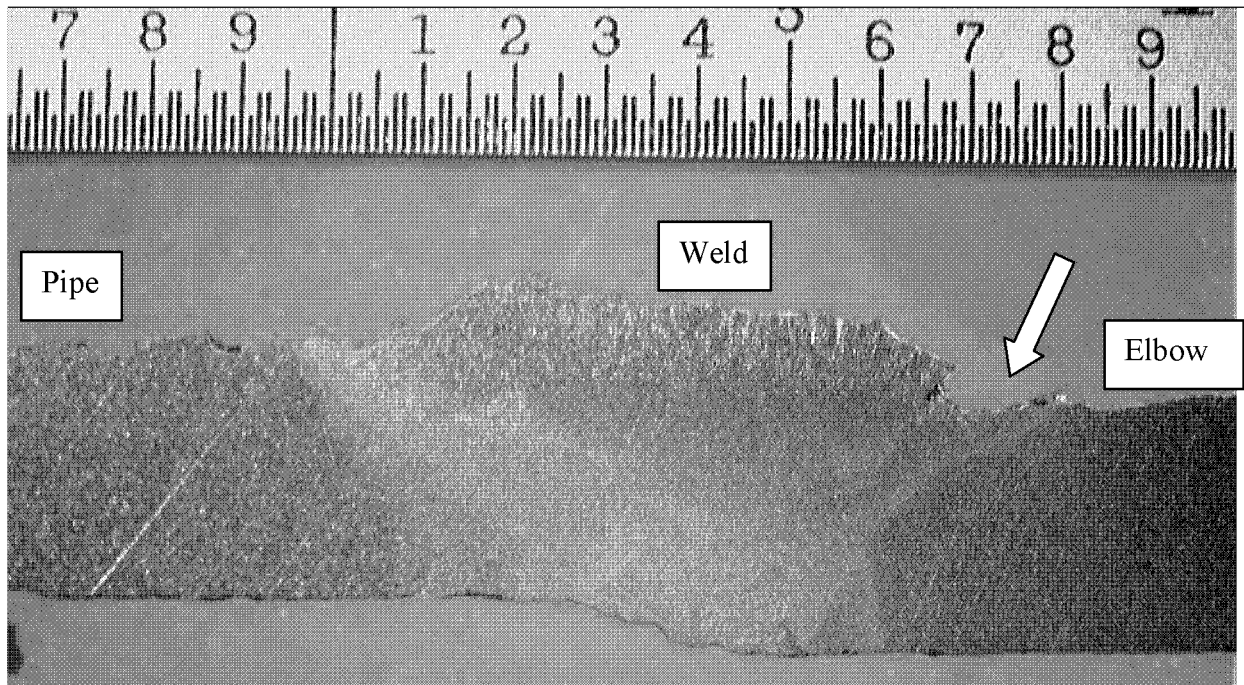
**Figure 38 – Polished and etched cross section through area of external corrosion on the girth weld**

This is the same location as identified as Area 5 in Figures 21 and 22. The inside surface of the weld is at the bottom of this figure. See the next figure for detail of the area near the arrow. Note that the good workmanship of the weld root pass completely accommodated the slight high-low condition at the inside surface of the joint, resulting in no evidence of any lack of fusion due to high-low.

At this location it is apparent that the corrosion on the inside surface is superficial, with virtually no apparent corrosion on the inside of the elbow. External corrosion has affected both the pipe and the elbow, with the greatest depth of metal loss being located in the elbow heat affected zone. However, the metal loss at that location is no deeper than the metal loss at some other areas of the elbow remote from the weld. Numbered divisions on the scale are 0.1 inch increments.

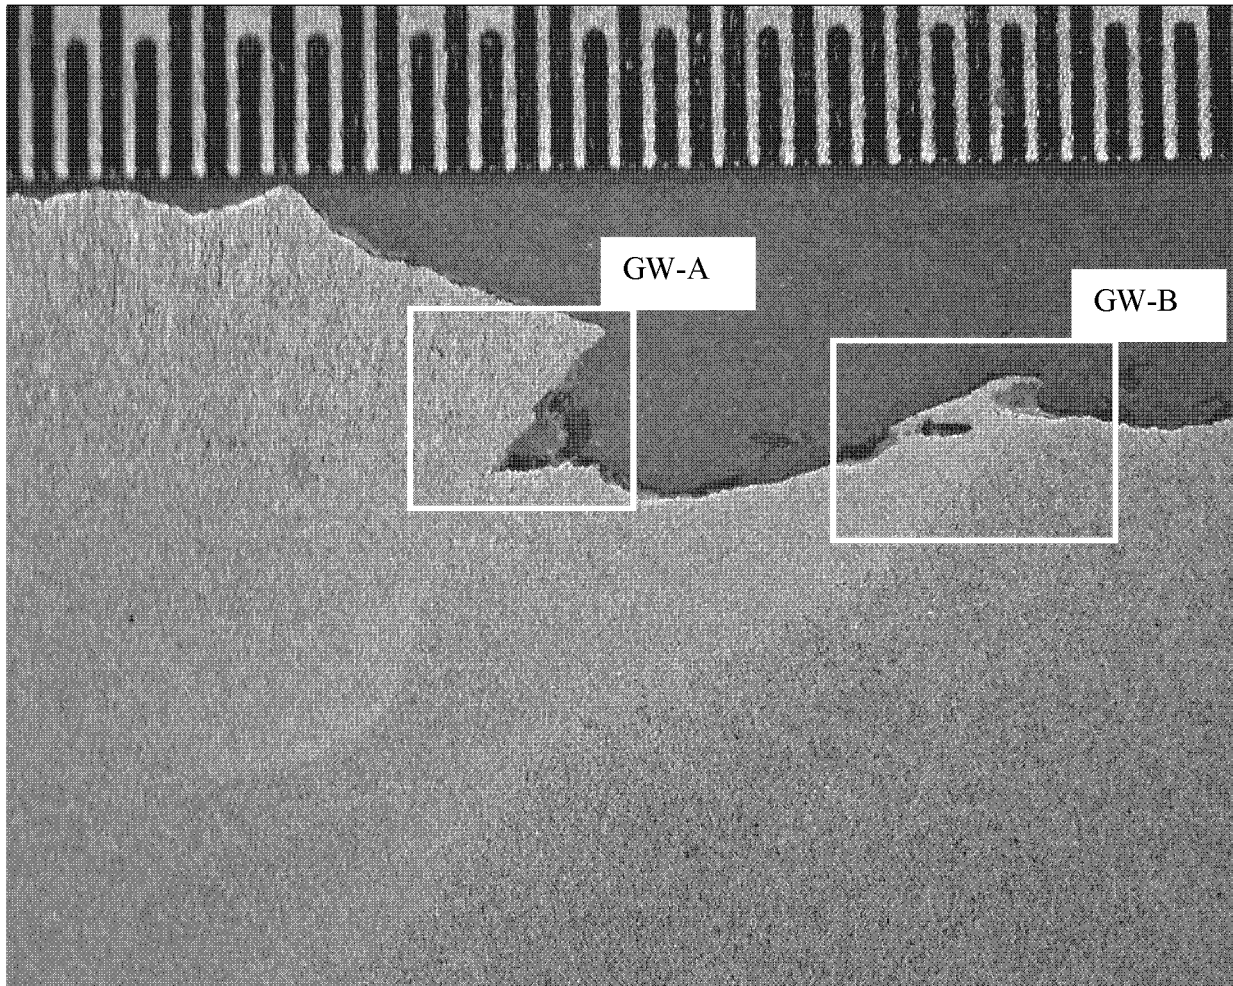
**Figure 39 - Detail of previous figure showing areas of corrosion at the outside surface of the pipe.**

See following figures for detail of areas GW-A and GW-B. The preferential corrosion of the weld HAZ is clearly evident. Small divisions on the scale are 0.01 inch.

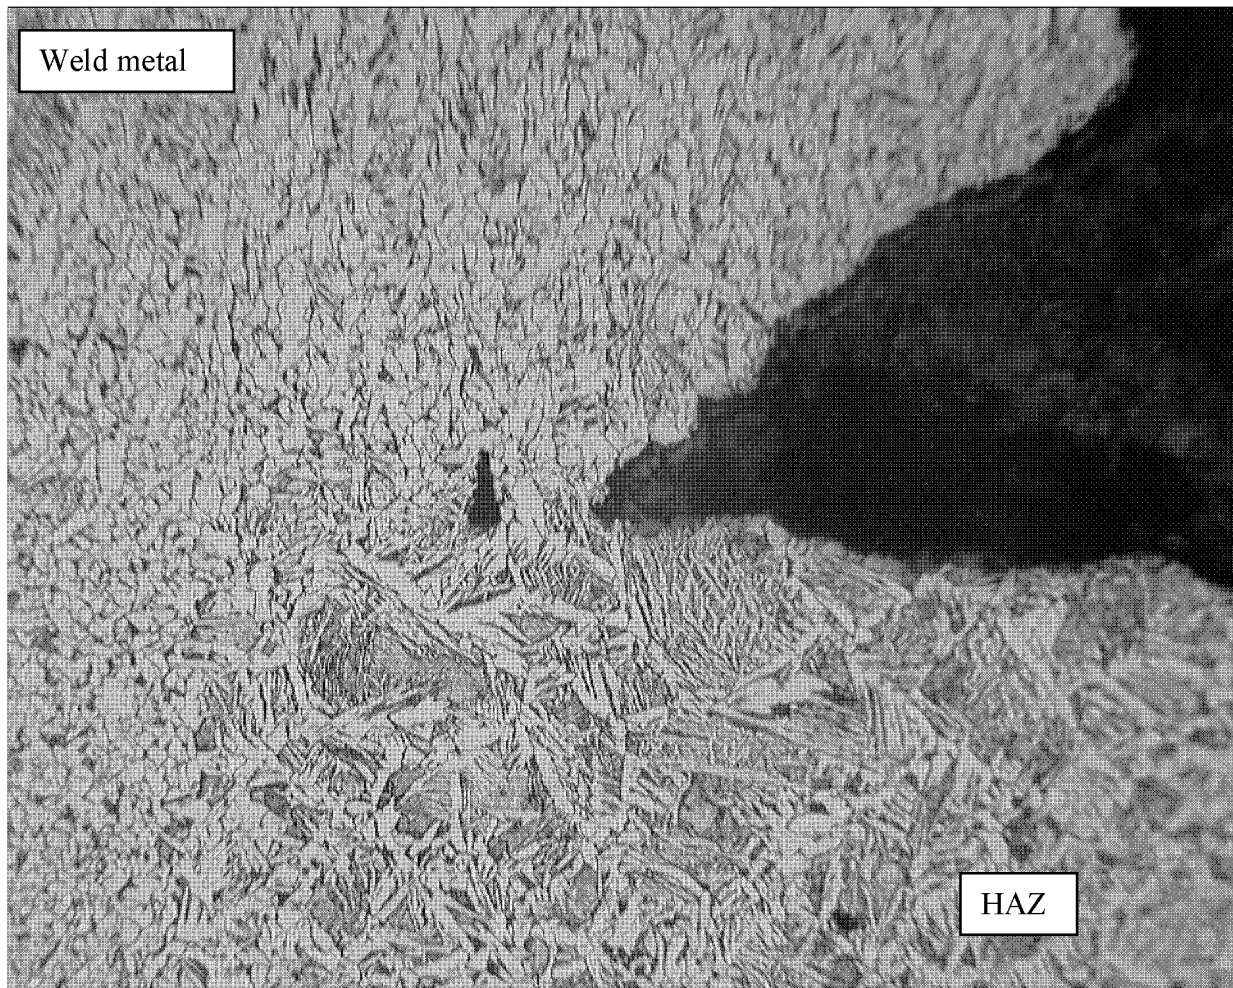
**Figure 40 - Detail of previous figure, Area GW-A.**

Note preferential corrosion of the heat affected zone, leaving the weld metal standing in relief.

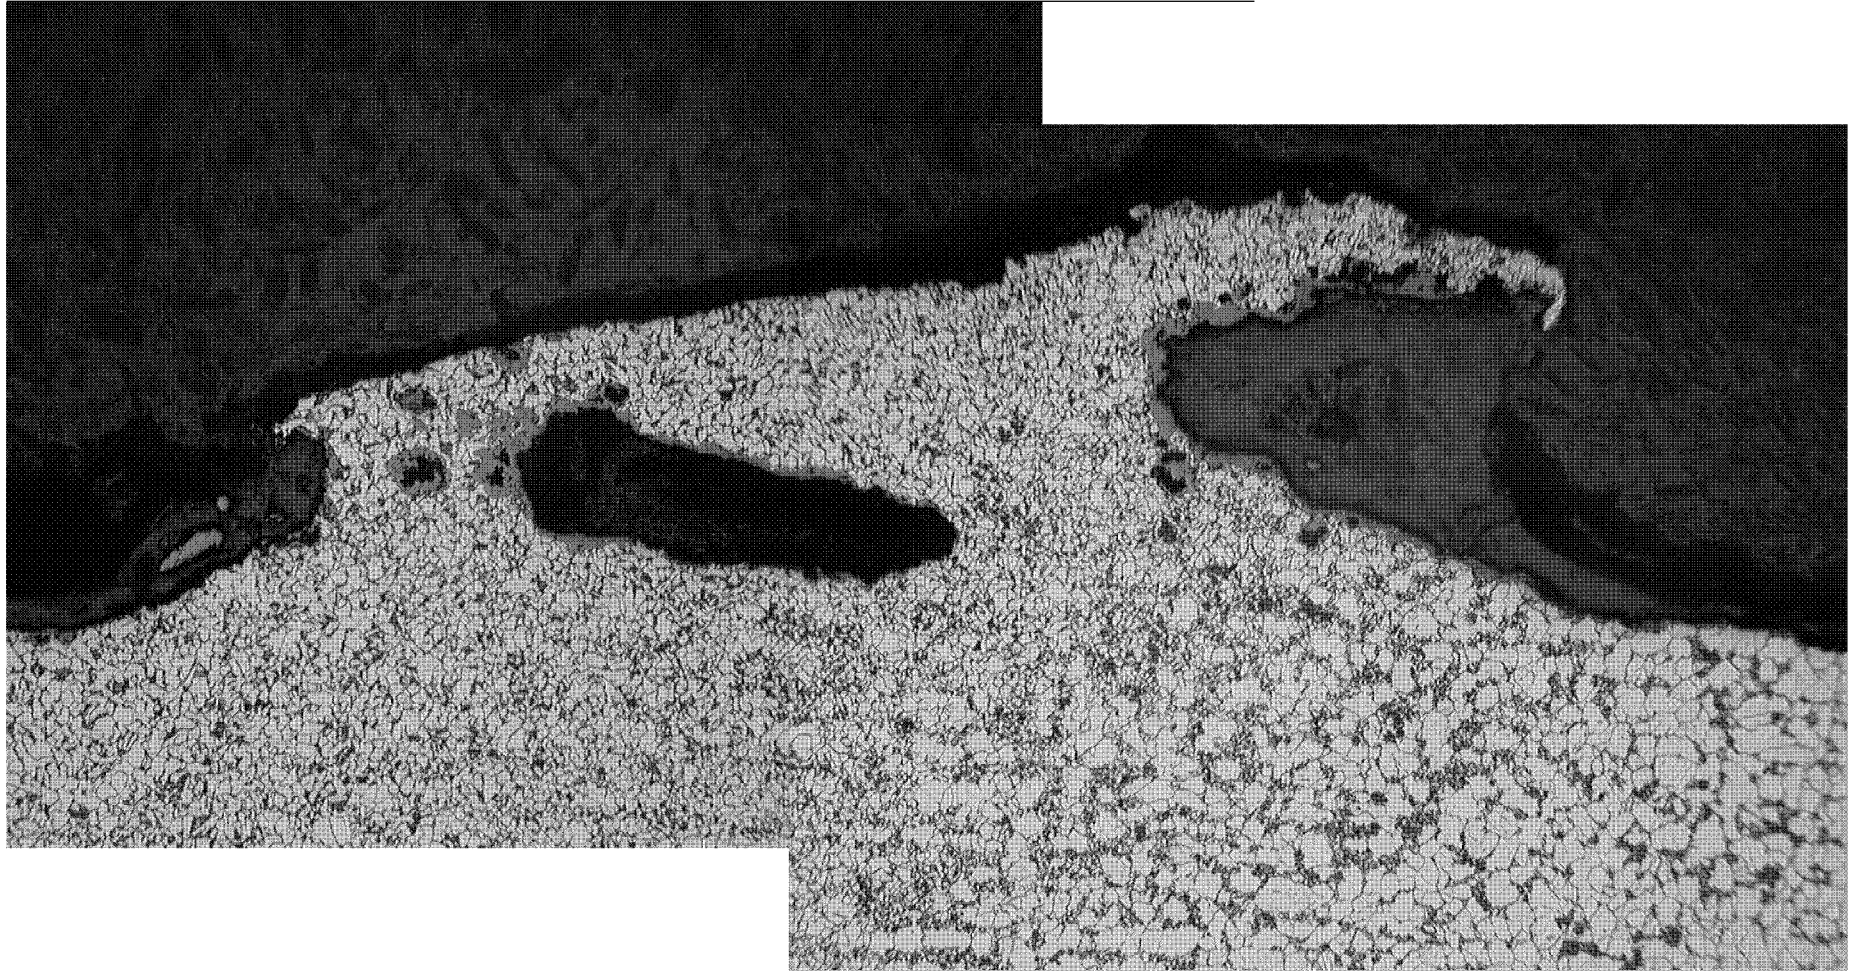
**Figure 41 - Detail of cross section through corrosion on the outside surface of the pipe, immediately adjacent to the girth weld (Area GW-B).**

Note the irregular profile of the corrosion that is undercutting the surface

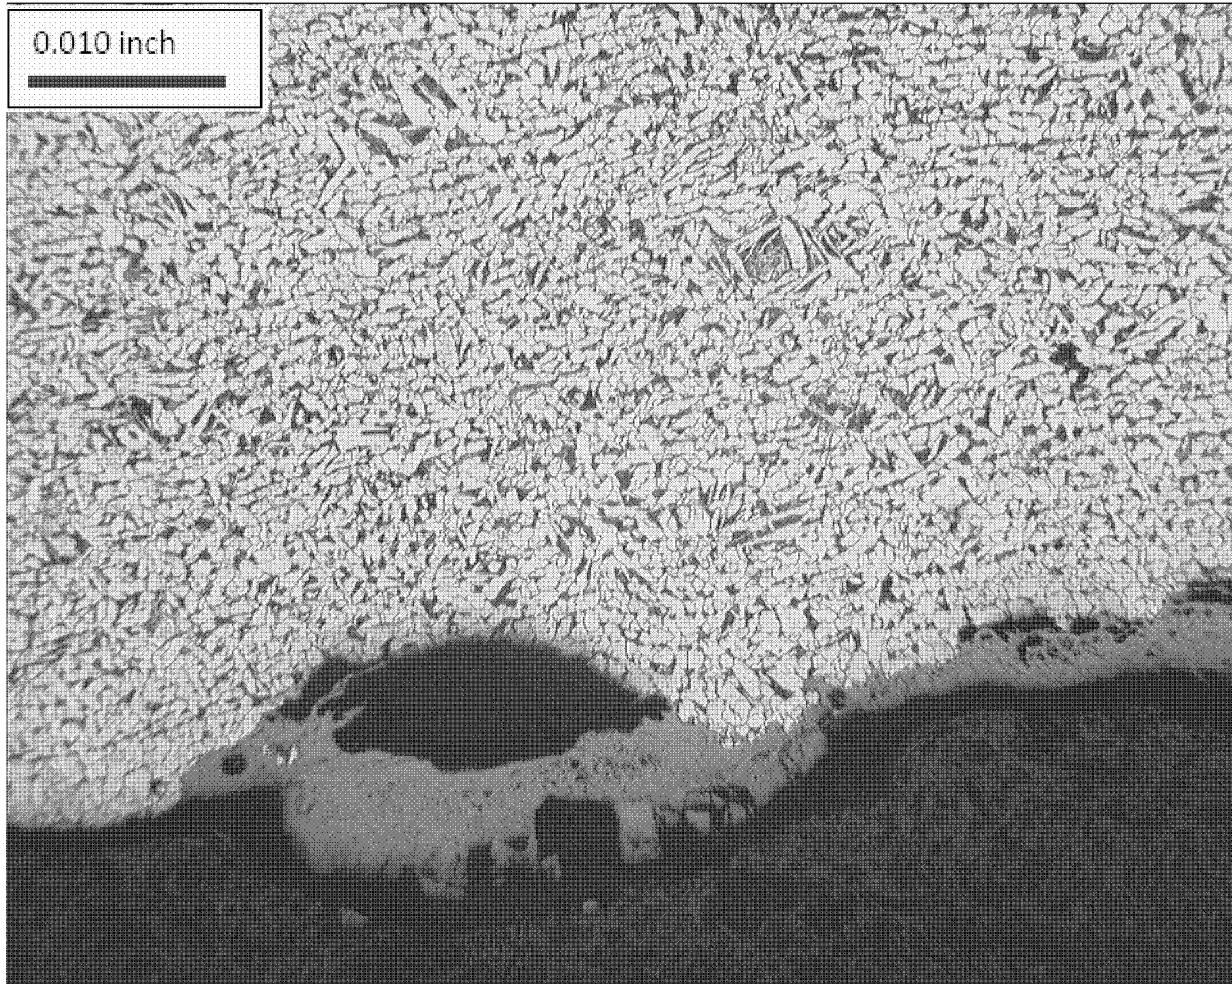
**Figure 44 - Microstructure of pipe at inside surface showing blistered corrosion product over a corrosion pit.**

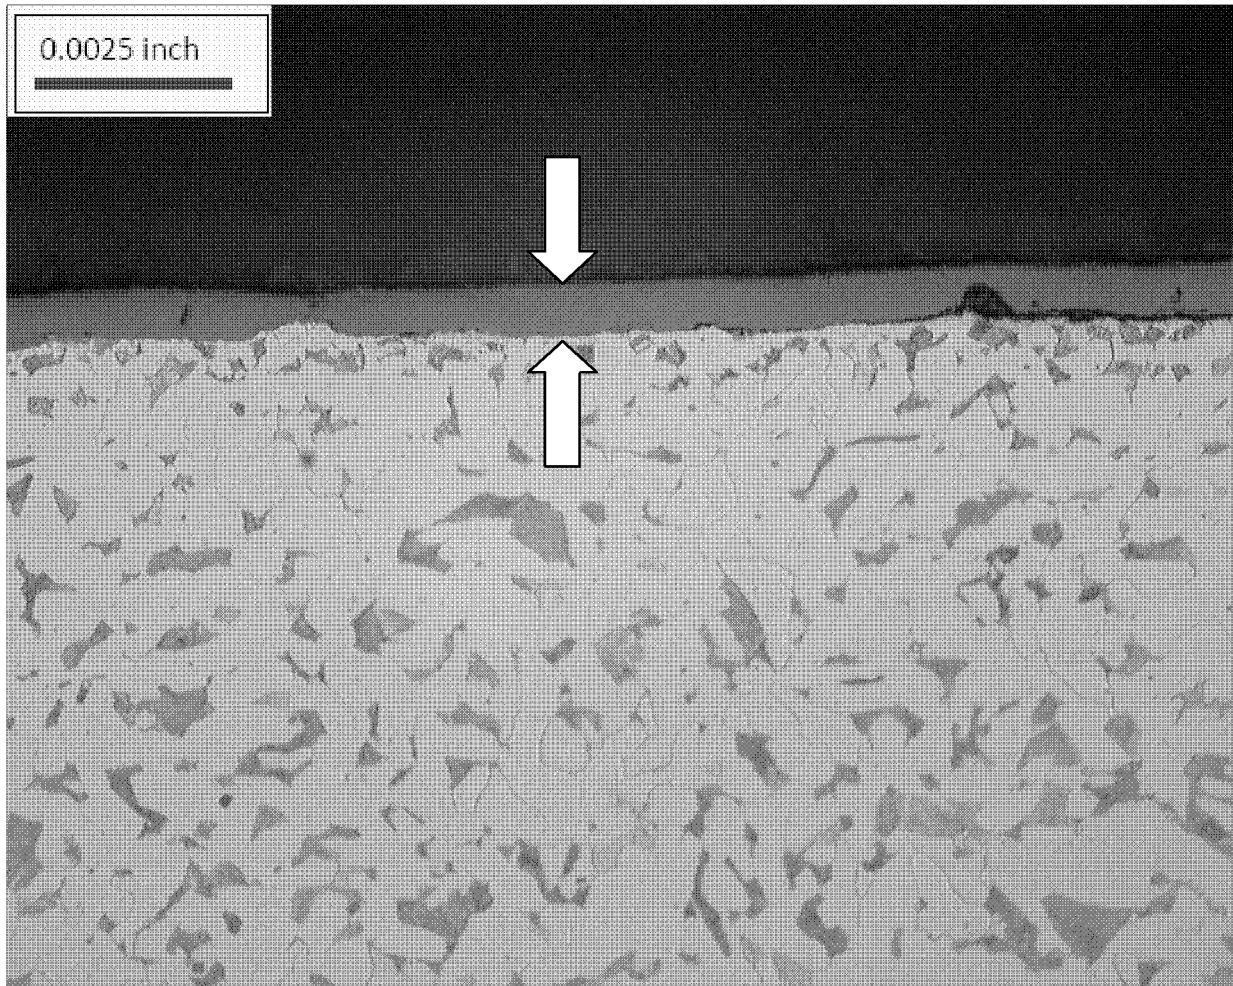
**Figure 47 - Cross section through the pipe immediately adjacent to an external corrosion pit showing intact mill scale (between arrows)**

The presence of intact mill scale indicates that there was no corrosion on this surface and that there was no surface preparation prior to external coating. A small amount of decarburization of the surface is present, as expected for this type of steel product.
