United States Nuclear Regulatory Commission Official Hearing Exhibit	
In the Matter of:	Entergy Nuclear Operations, Inc. (Indian Point Nuclear Generating Units 2 and 3)

<b>ASLBP #:</b> 07-858-03-LR-BD01
	<b>Docket #:</b> 05000247   05000286
	<b>Exhibit #:</b> NYS000202-00-BD01
	<b>Admitted:</b> 10/15/2012
	<b>Rejected:</b>
<b>Other:</b>	<b>Identified:</b> 10/15/2012
	<b>Withdrawn:</b>
	<b>Stricken:</b>

Significance Level 2 Report

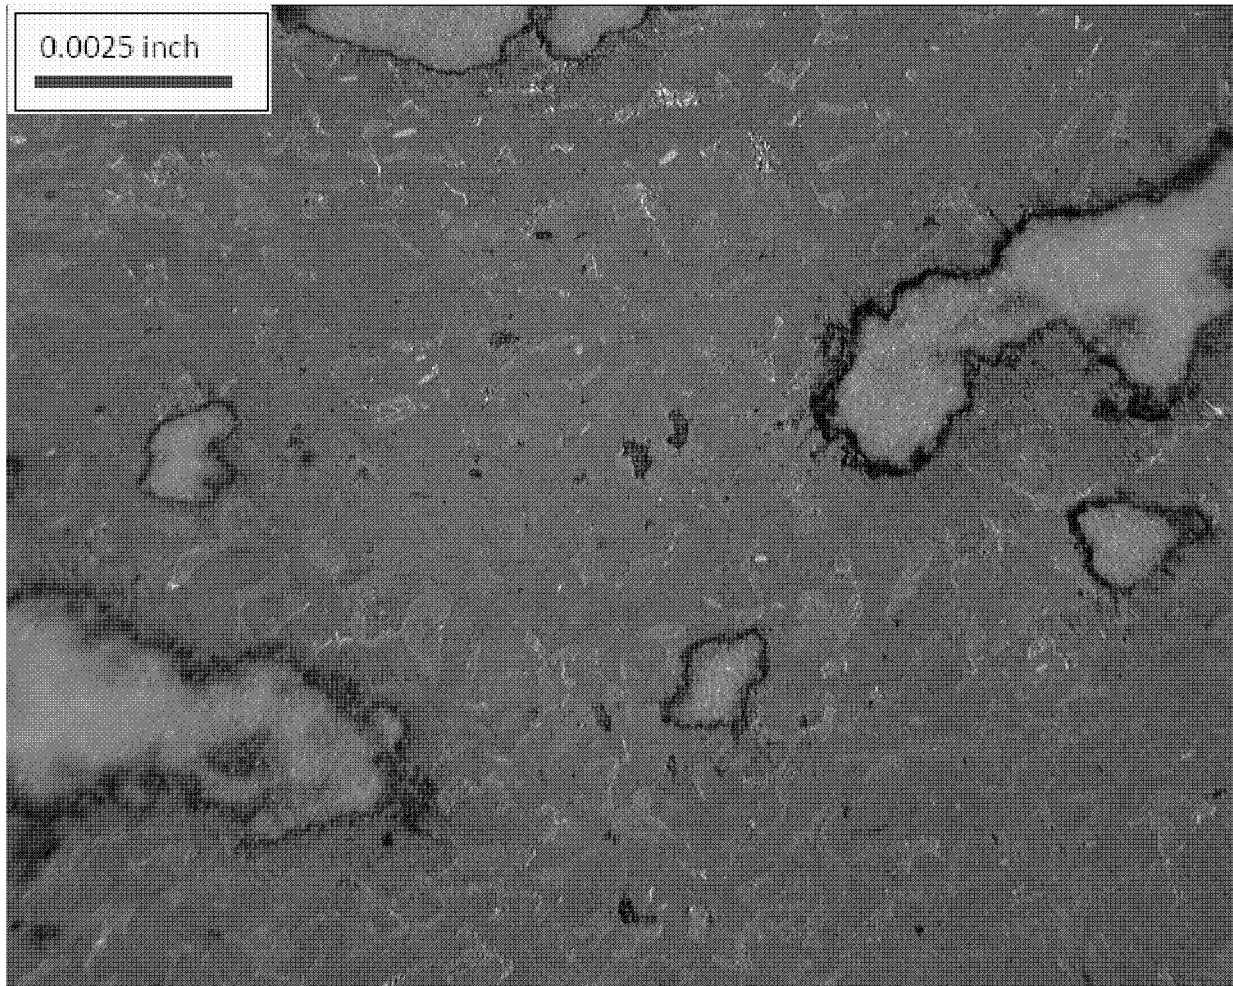
**Figure 48- Detail of corrosion product in a pit on the outside of the pipe**

The corrosion has preferentially corroded the proeutectoid ferrite and the ferrite lamellae of the pearlite leaving the iron carbide constituent of the pearlite grains uncorroded. The resulting shiny irregular globular-shaped areas replicate in the corrosion product the size and shape of the original pearlite grains. This appearance is typical of iron carbonate corrosion products.
