Entergy Nuclear Operations, Inc.
(Indian Point Nuclear Generating Units 2 and 3)ASLBP #: 07-858-03-LR-BD01
Docket #: 05000247 | 05000286
Exhibit #: ENT000115-00-BD01
Admitted: 10/15/2012
Rejected:
Other:Identified: 10/15/2012
Withdrawn:
Stricken:

UNITED STATES
NUCLEAR REGULATORY COMMISSION
OFFICE OF INSPECTION AND ENFORCEMENT
WASHINGTON, D. C. 20555

December 22, 1982

IE INFORMATION NOTICE NO. 82-53: MAIN TRANSFORMER FAILURES AT THE NORTH ANNA
NUCLEAR POWER STATION

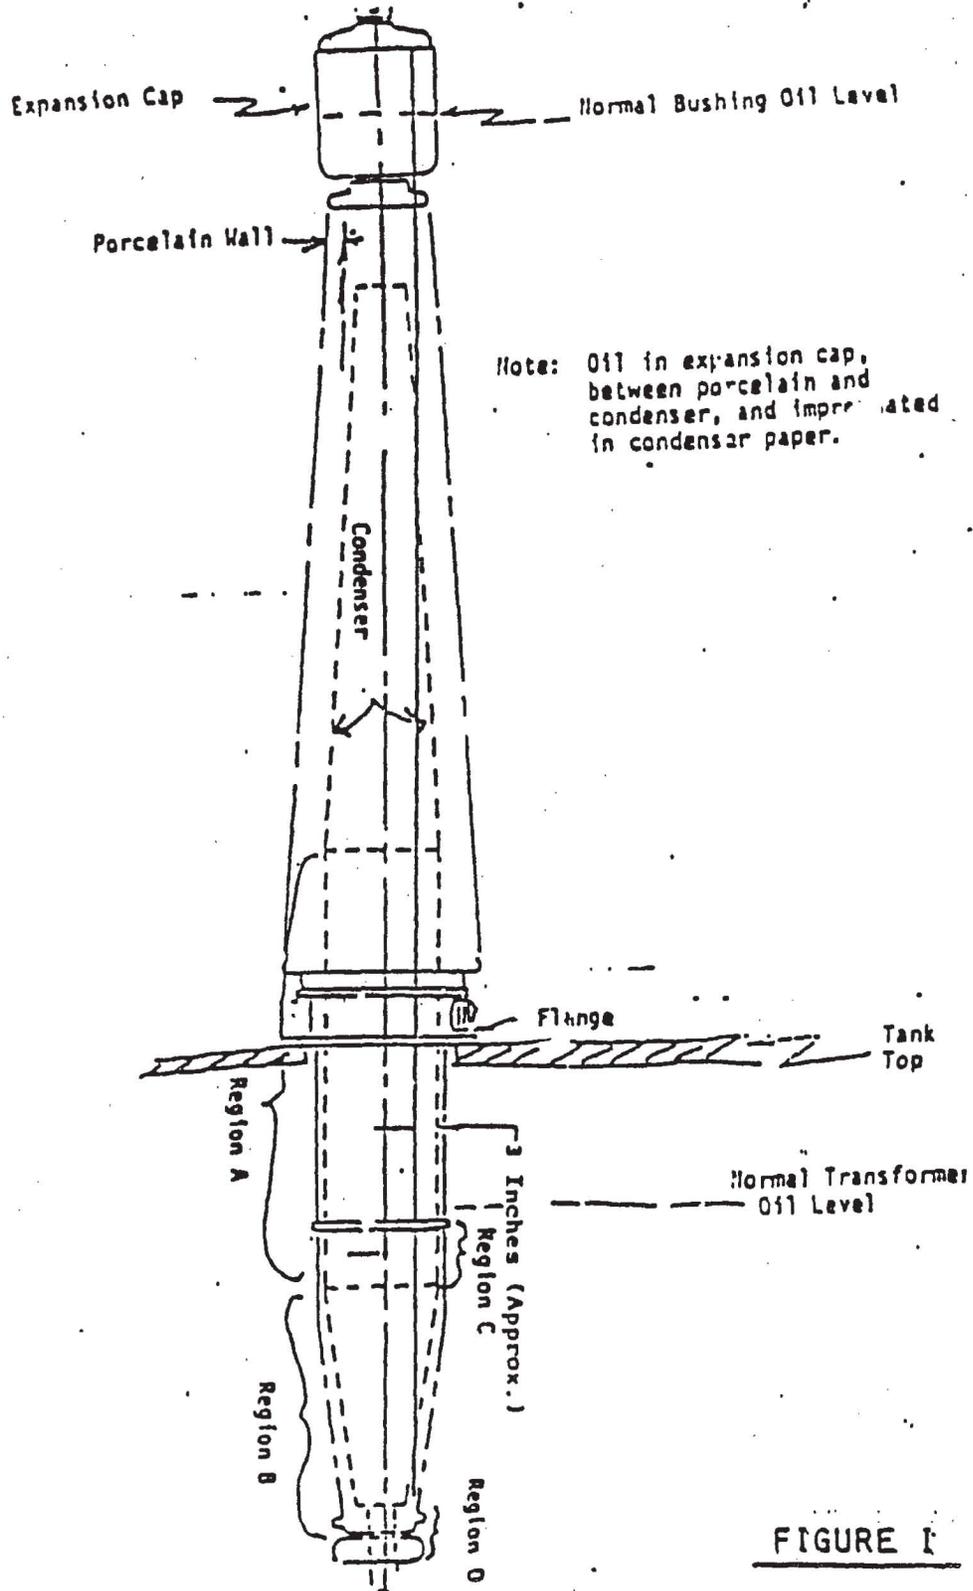
FIGURE 1

Factory inspections of these bushings (see attached Figure 1) disclosed burning of the tap and ground foils on the straight portion of the condenser where the flange and ground sleeve are attached (Region A of Figure 1). The insulating paper between these foils was wrinkled and burned on the edges in this region and across the surface of the condenser from Region A to the bottom end of the condenser taper. Arc marks were found on the lower bushing corona end shield and the ground sleeve of Phase C transformer, and on the HV lead tank wall of Phase B transformer. Based on the factory inspections, it was concluded that the failures originated as arcs between the ground and tap foils in the straight portion of the condenser (Region A). These arcs then propagated across the surface of the tapered portion of the condenser (Region B). On Phase C transformer, the gas generated by this burning disintegrated the lower portion of the bushing and established an arc path from the lower corona shield to the steel ground sleeve. The arc path on the Phase B transformer included the high voltage lead connected to the bottom of the bushing, the tank wall, and windings.

Since the bushings were improperly positioned (i.e., in the near-horizontal position) during their transportation and storage periods, portions of the condenser were not completely covered by oil. The absence of oil allowed the gas in the expansion cap to permeate the exposed paper layers. Once gas permeates the paper region the bushings are degraded electrically and long time periods are required to completely reimpregnate the paper with oil. Such degraded bushings are susceptible to corona discharges on overvoltage conditions such as those experienced by these bushings before their ultimate failures.

Corona discharges are usually extinguished when the voltage returns to normal; however, the dielectric quality of the bushing is reduced each time a corona discharge occurs. As a result, new corona discharges will occur at lower voltage levels than those of the previous discharges. This process is cumulative and can continue until the corona extinction voltage level is less than the normal operating level, in which case disruptive failures will occur. Unlike previous disruptive events at North Anna, the transformer failure of July 3 generated such great internal forces that the transformer box and one oil pump discharge pipe ruptured. The oil that erupted from these two breaks ignited, and the resultant fire shorted out the overhead bus bars from a three-phase reserve station service (RSS) transformer. The affected RSS transformer is one of three transformers that supply Unit 1 and 2 with offsite power (startup power) whenever a unit generator is not available. These transformers are also the preferred sources of power for the Class 1E loads whenever a unit generator is not available. Underground cables serve the 4160-V emergency buses from these RSS transformers, and the overhead bus bars and cables serve the normal service station buses; however, there are no isolation breakers near the RSS transformer for the overhead bus bars.
