**ATTACHMENT (4)**

**AREA WALK-BY CHECKLIST**

## Area Walk-By Checklists (AWCs)

**Table A-1: Area Walk-By Checklists**

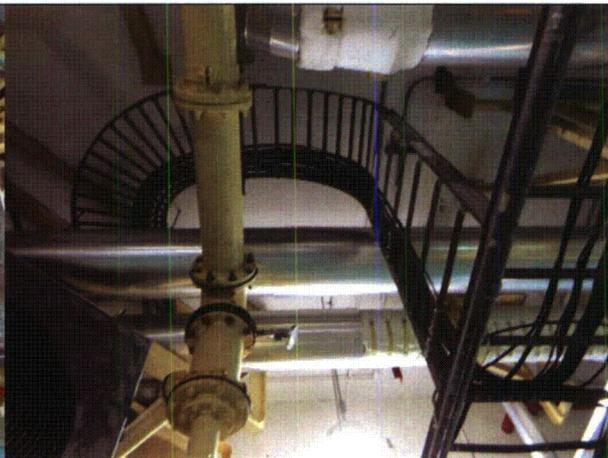
Area # AUX, -15, CAL-AB-101 8-6-12 192

2. Does anchorage of equipment in the area appear to be free of significant degraded conditions? Yes  
*Observed that LPSI 21 is missing an anchor bolt. This condition has been evaluated by calculation CA02066.*
