ENTERGY	ENGINEERING STANDARD	EN-EP-S-002-MULTI	REV. 0
	Buried Piping and Tanks General Visual Inspection	PAGE 12 OF 12

ATTACHMENT 7.1	INSPECTION CHECKLIST
----------------	----------------------

Piping / Tank	IP3 AFW/Cond Return to CST (8-inch Line 1080) (Ref. WO # 279578-03)	INSPECTION DATE:	12/9/2011
ELEVATION:	pipe centerline @ EL. 11'-6"; grade @ El. 18' (approx.)	LOCATION DWG:	9321-F-23593
		INSPECTOR:	J. Peterson

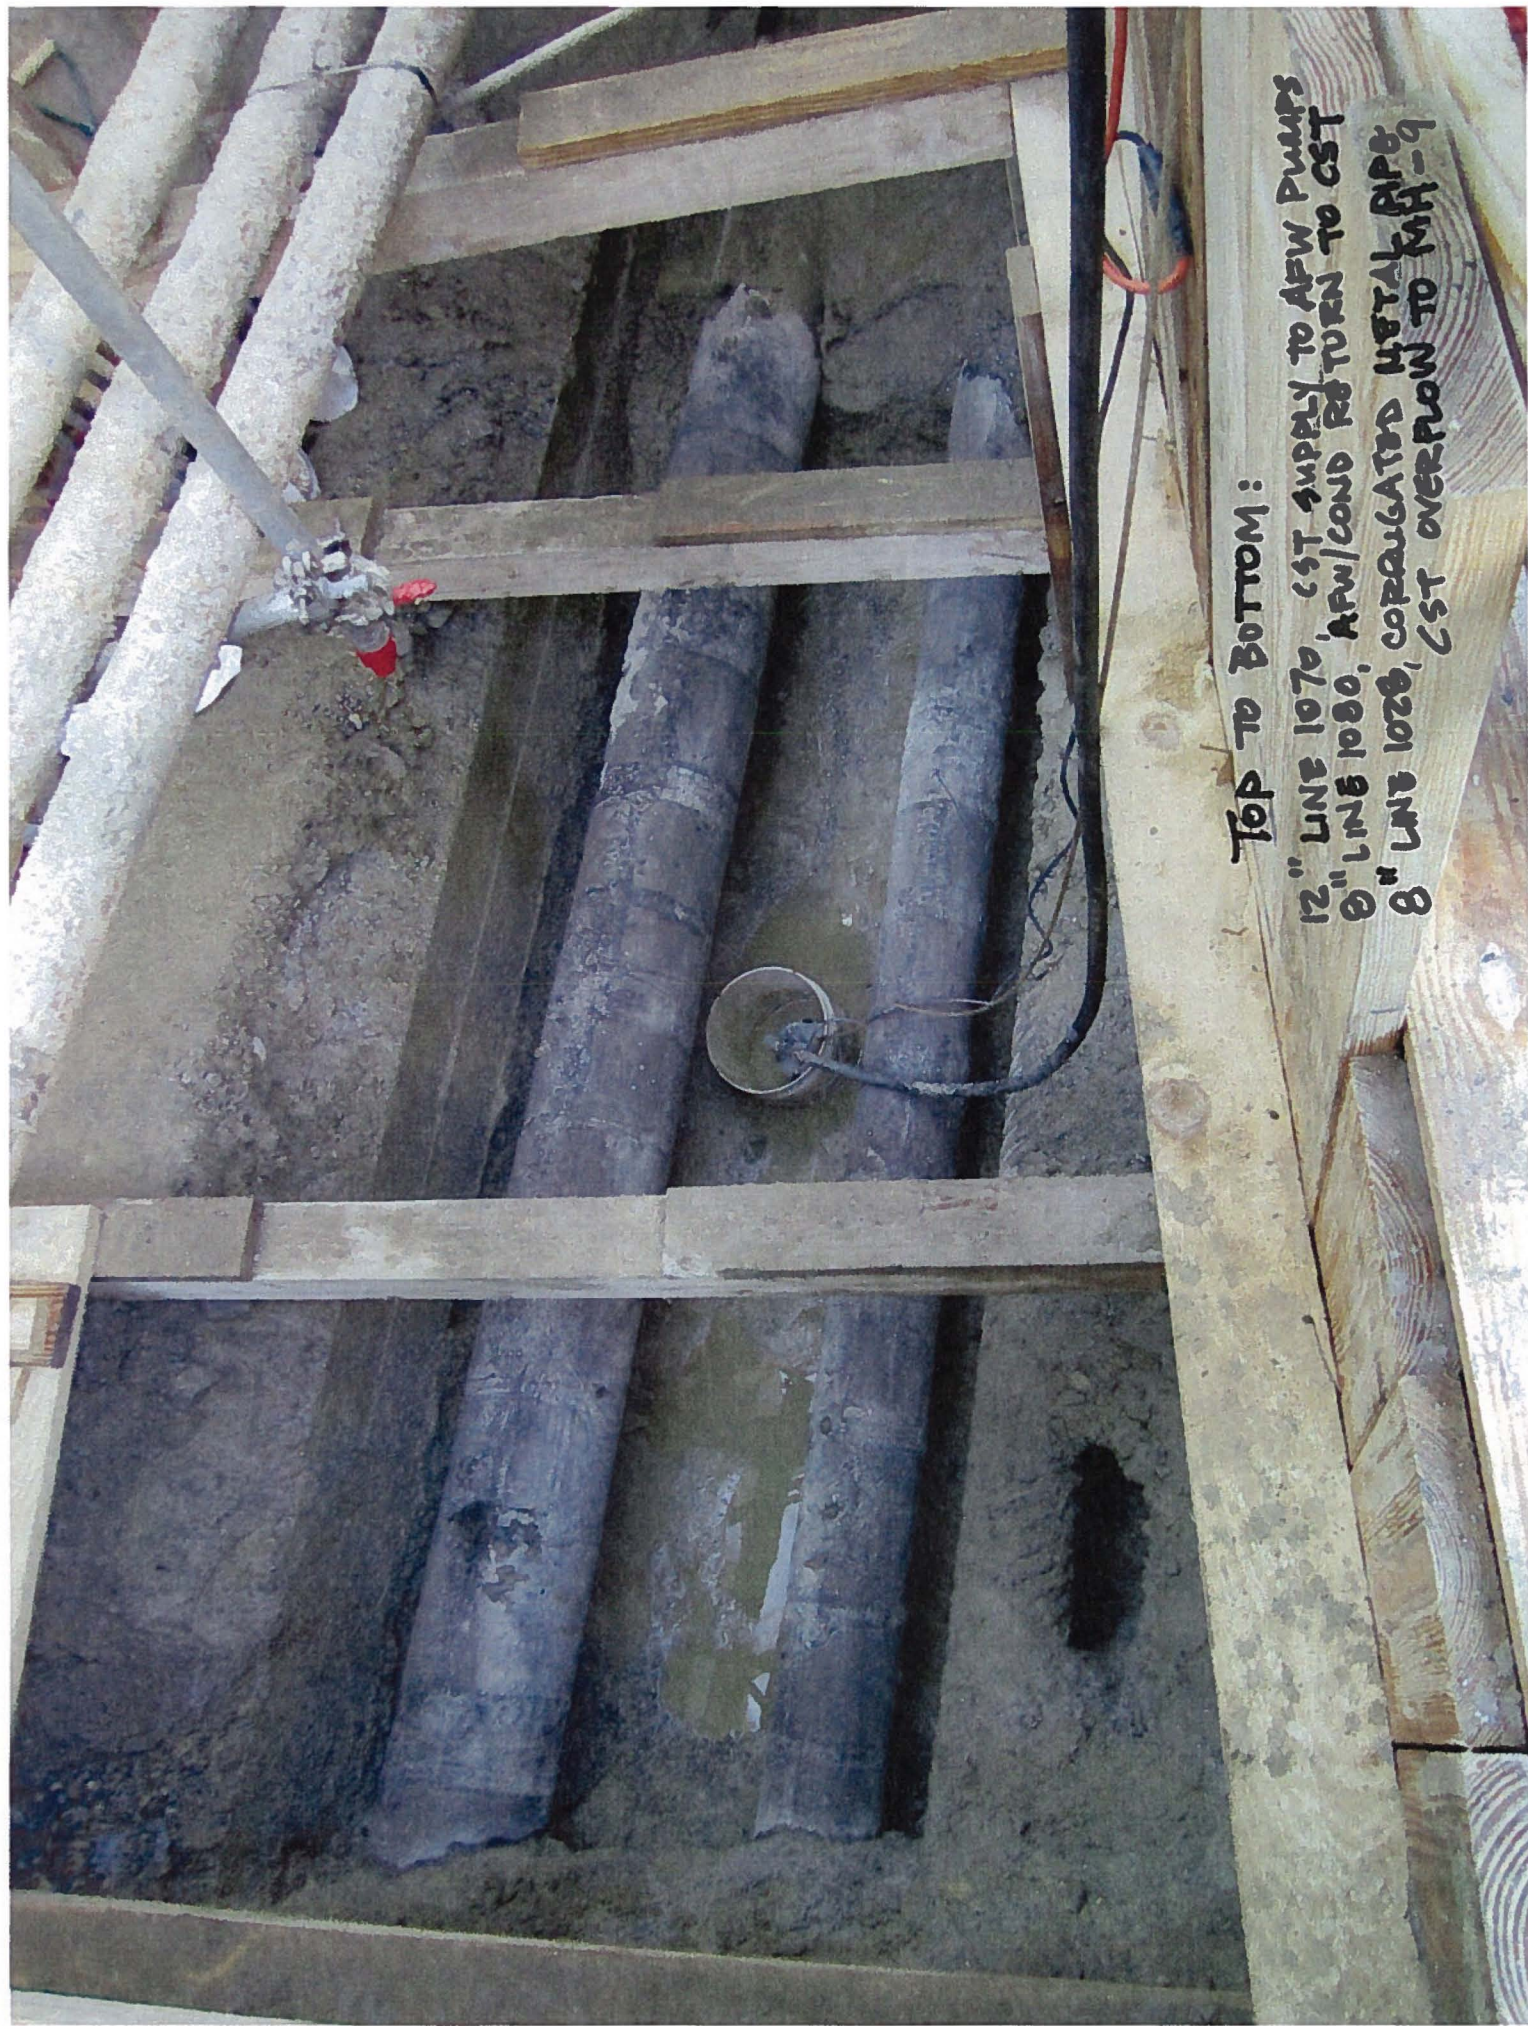
TOP TO BOTTOM:

12" LINE 1070, CST SUPPLY TO APW PUMPS  
8" LINE 1080, APW/COND RETURN TO CST  
8" LINE 1028, CORRUGATED METAL PIPE  
CST OVERFLOW TO KHH-9

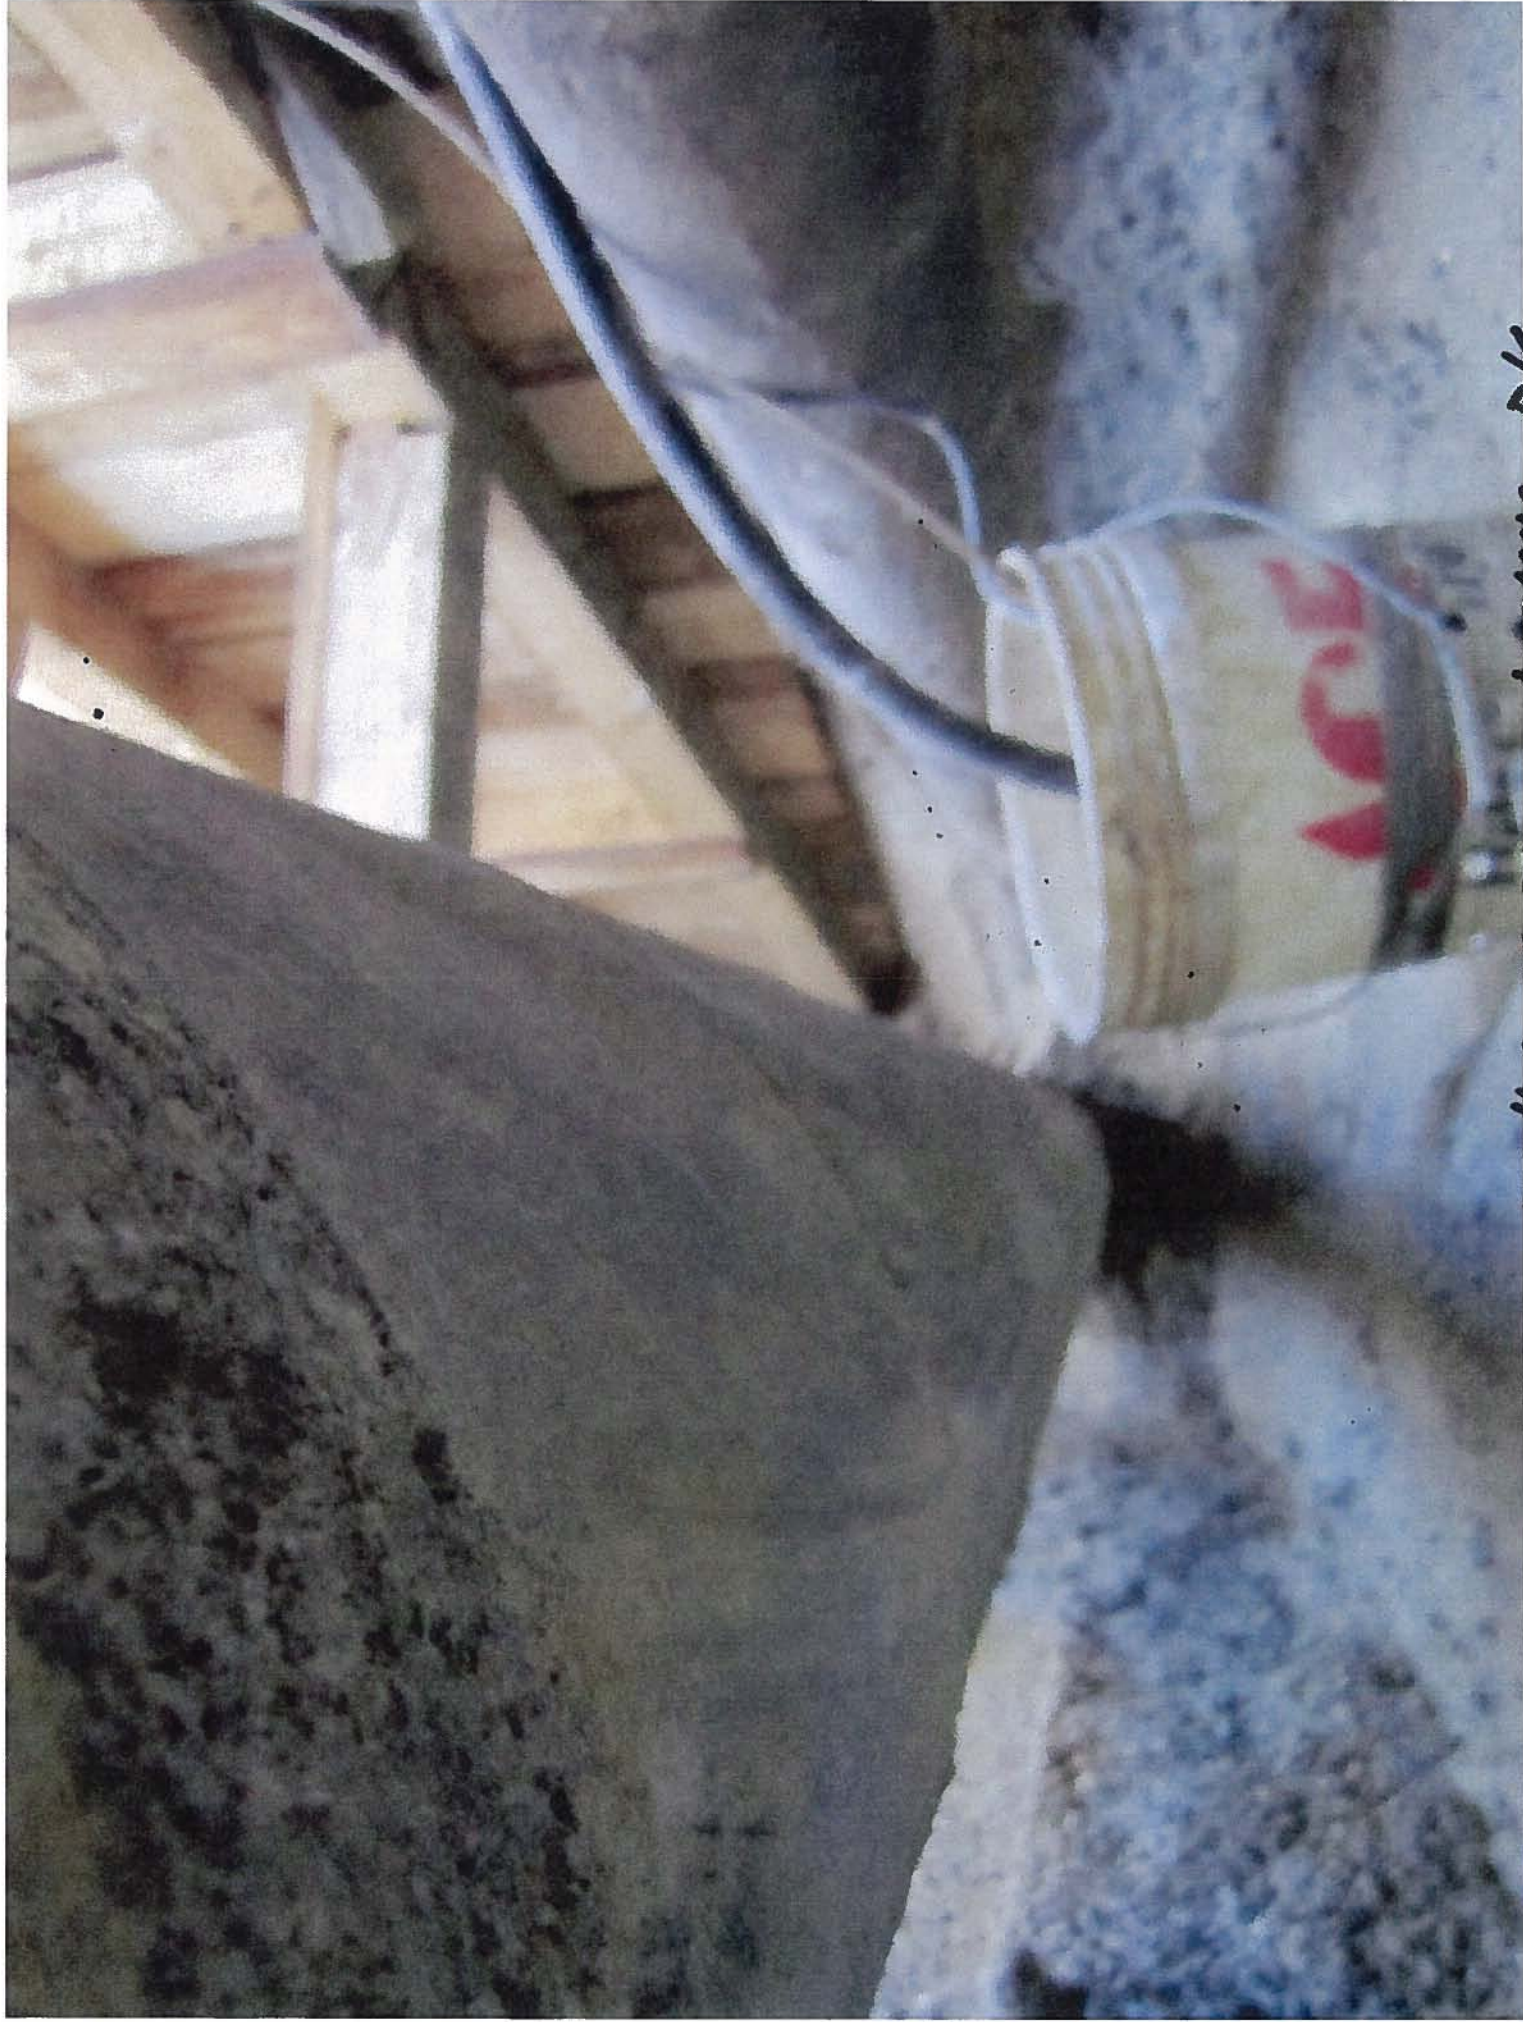
12" LINE IN - LOOKING D/S

TO AFW PUMPS

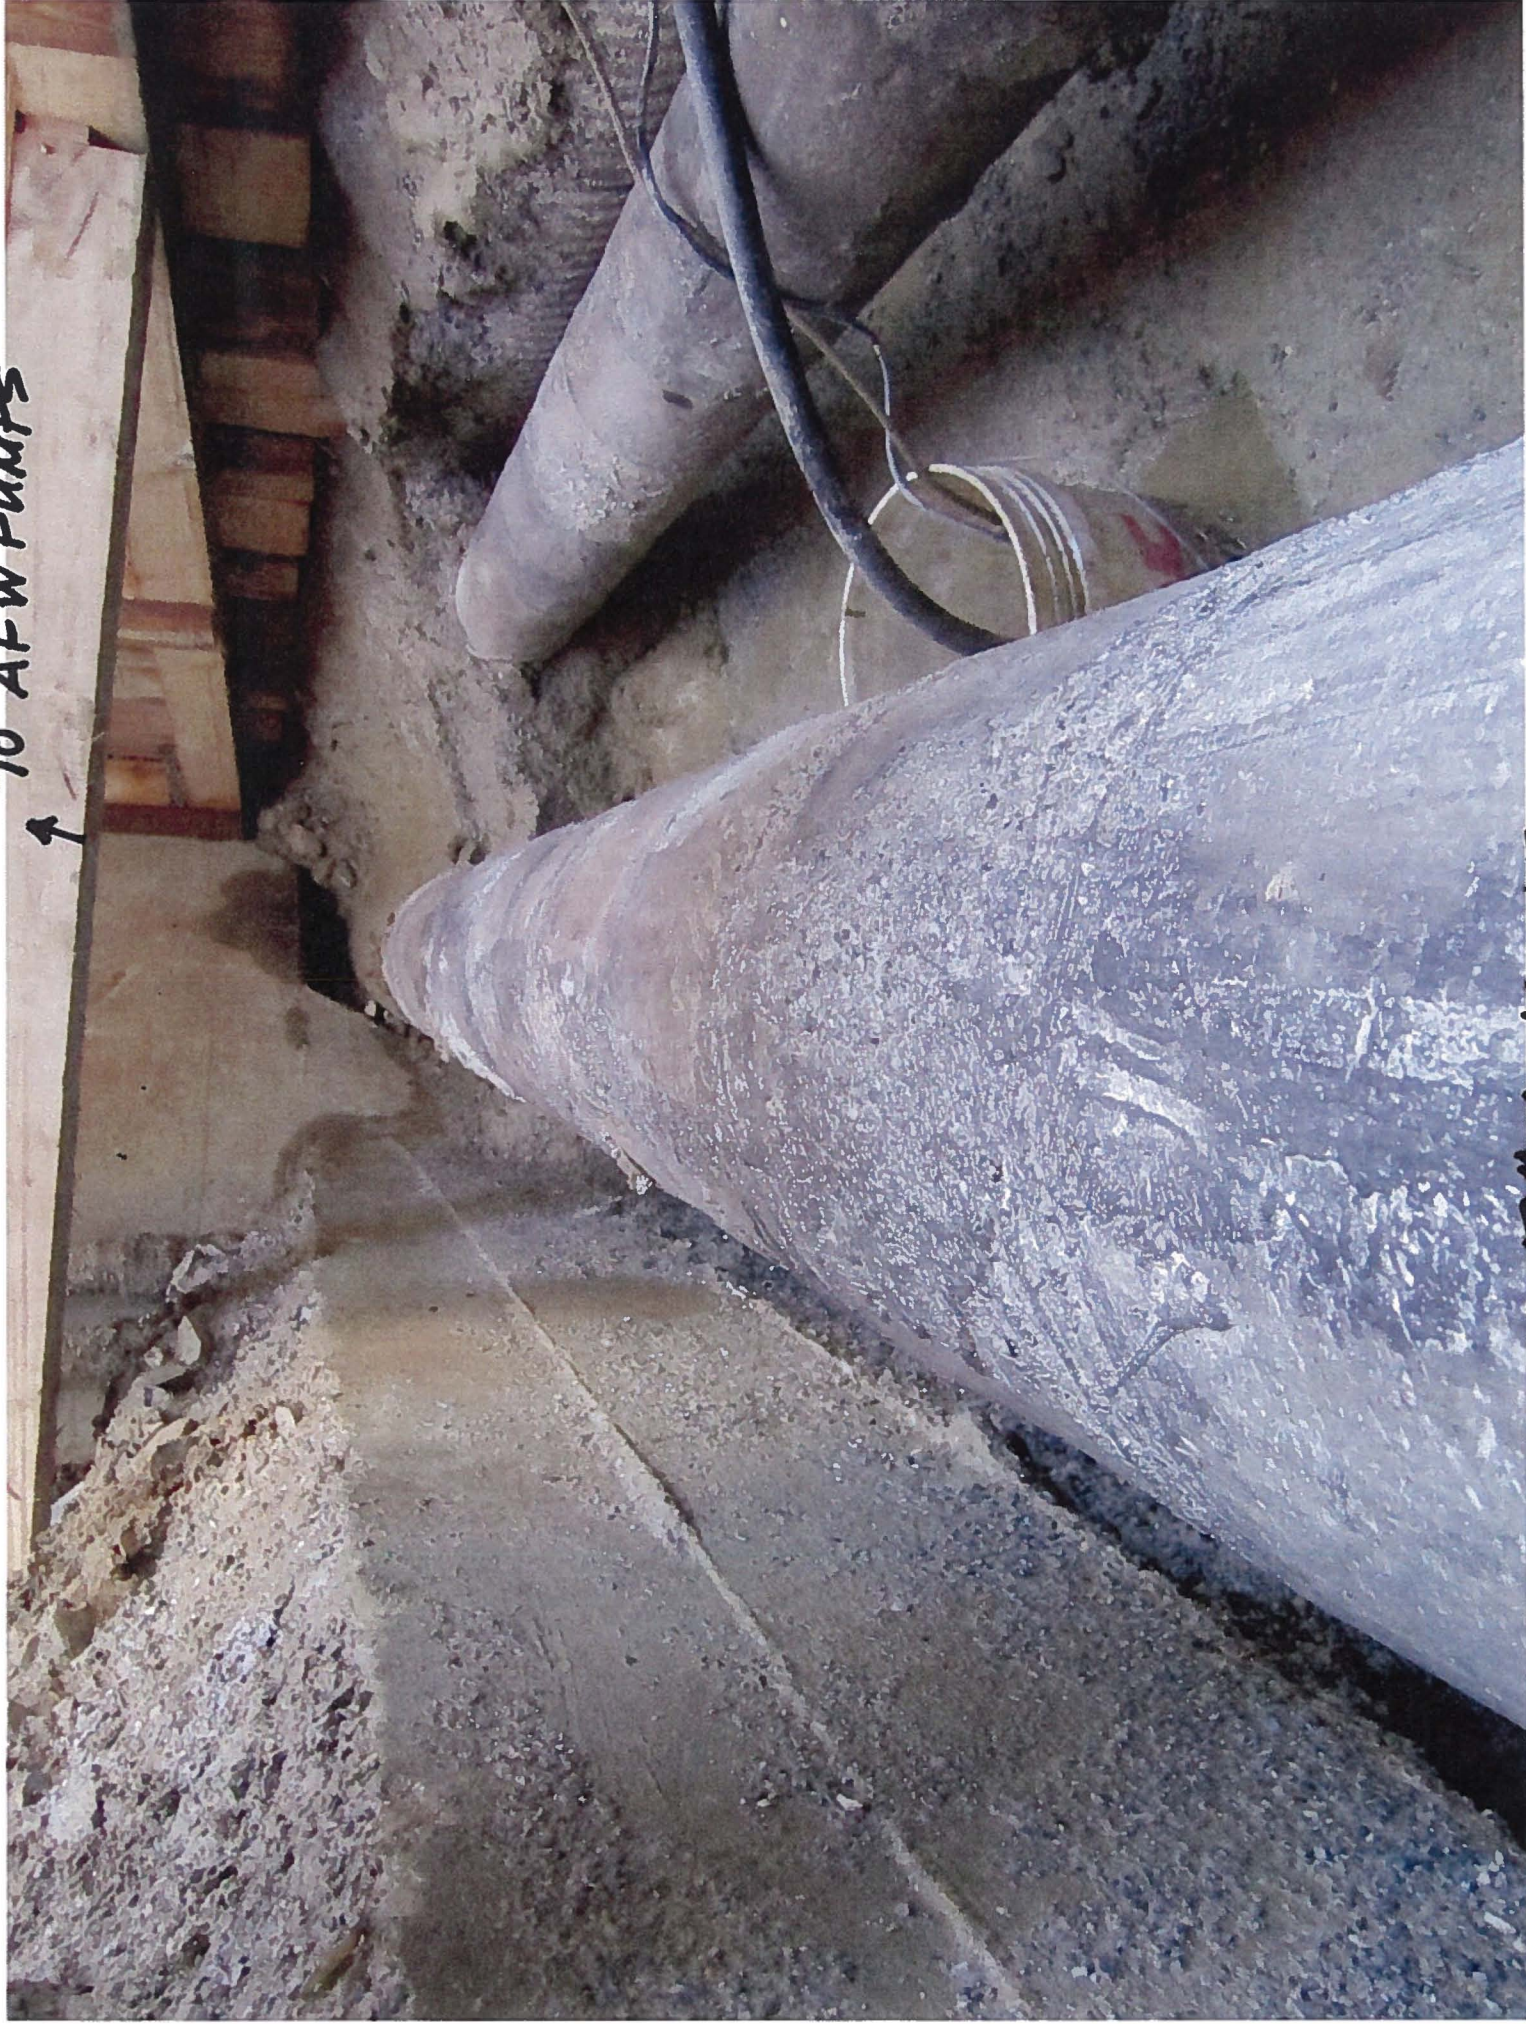
12" 1 INE 1070

↑ to east

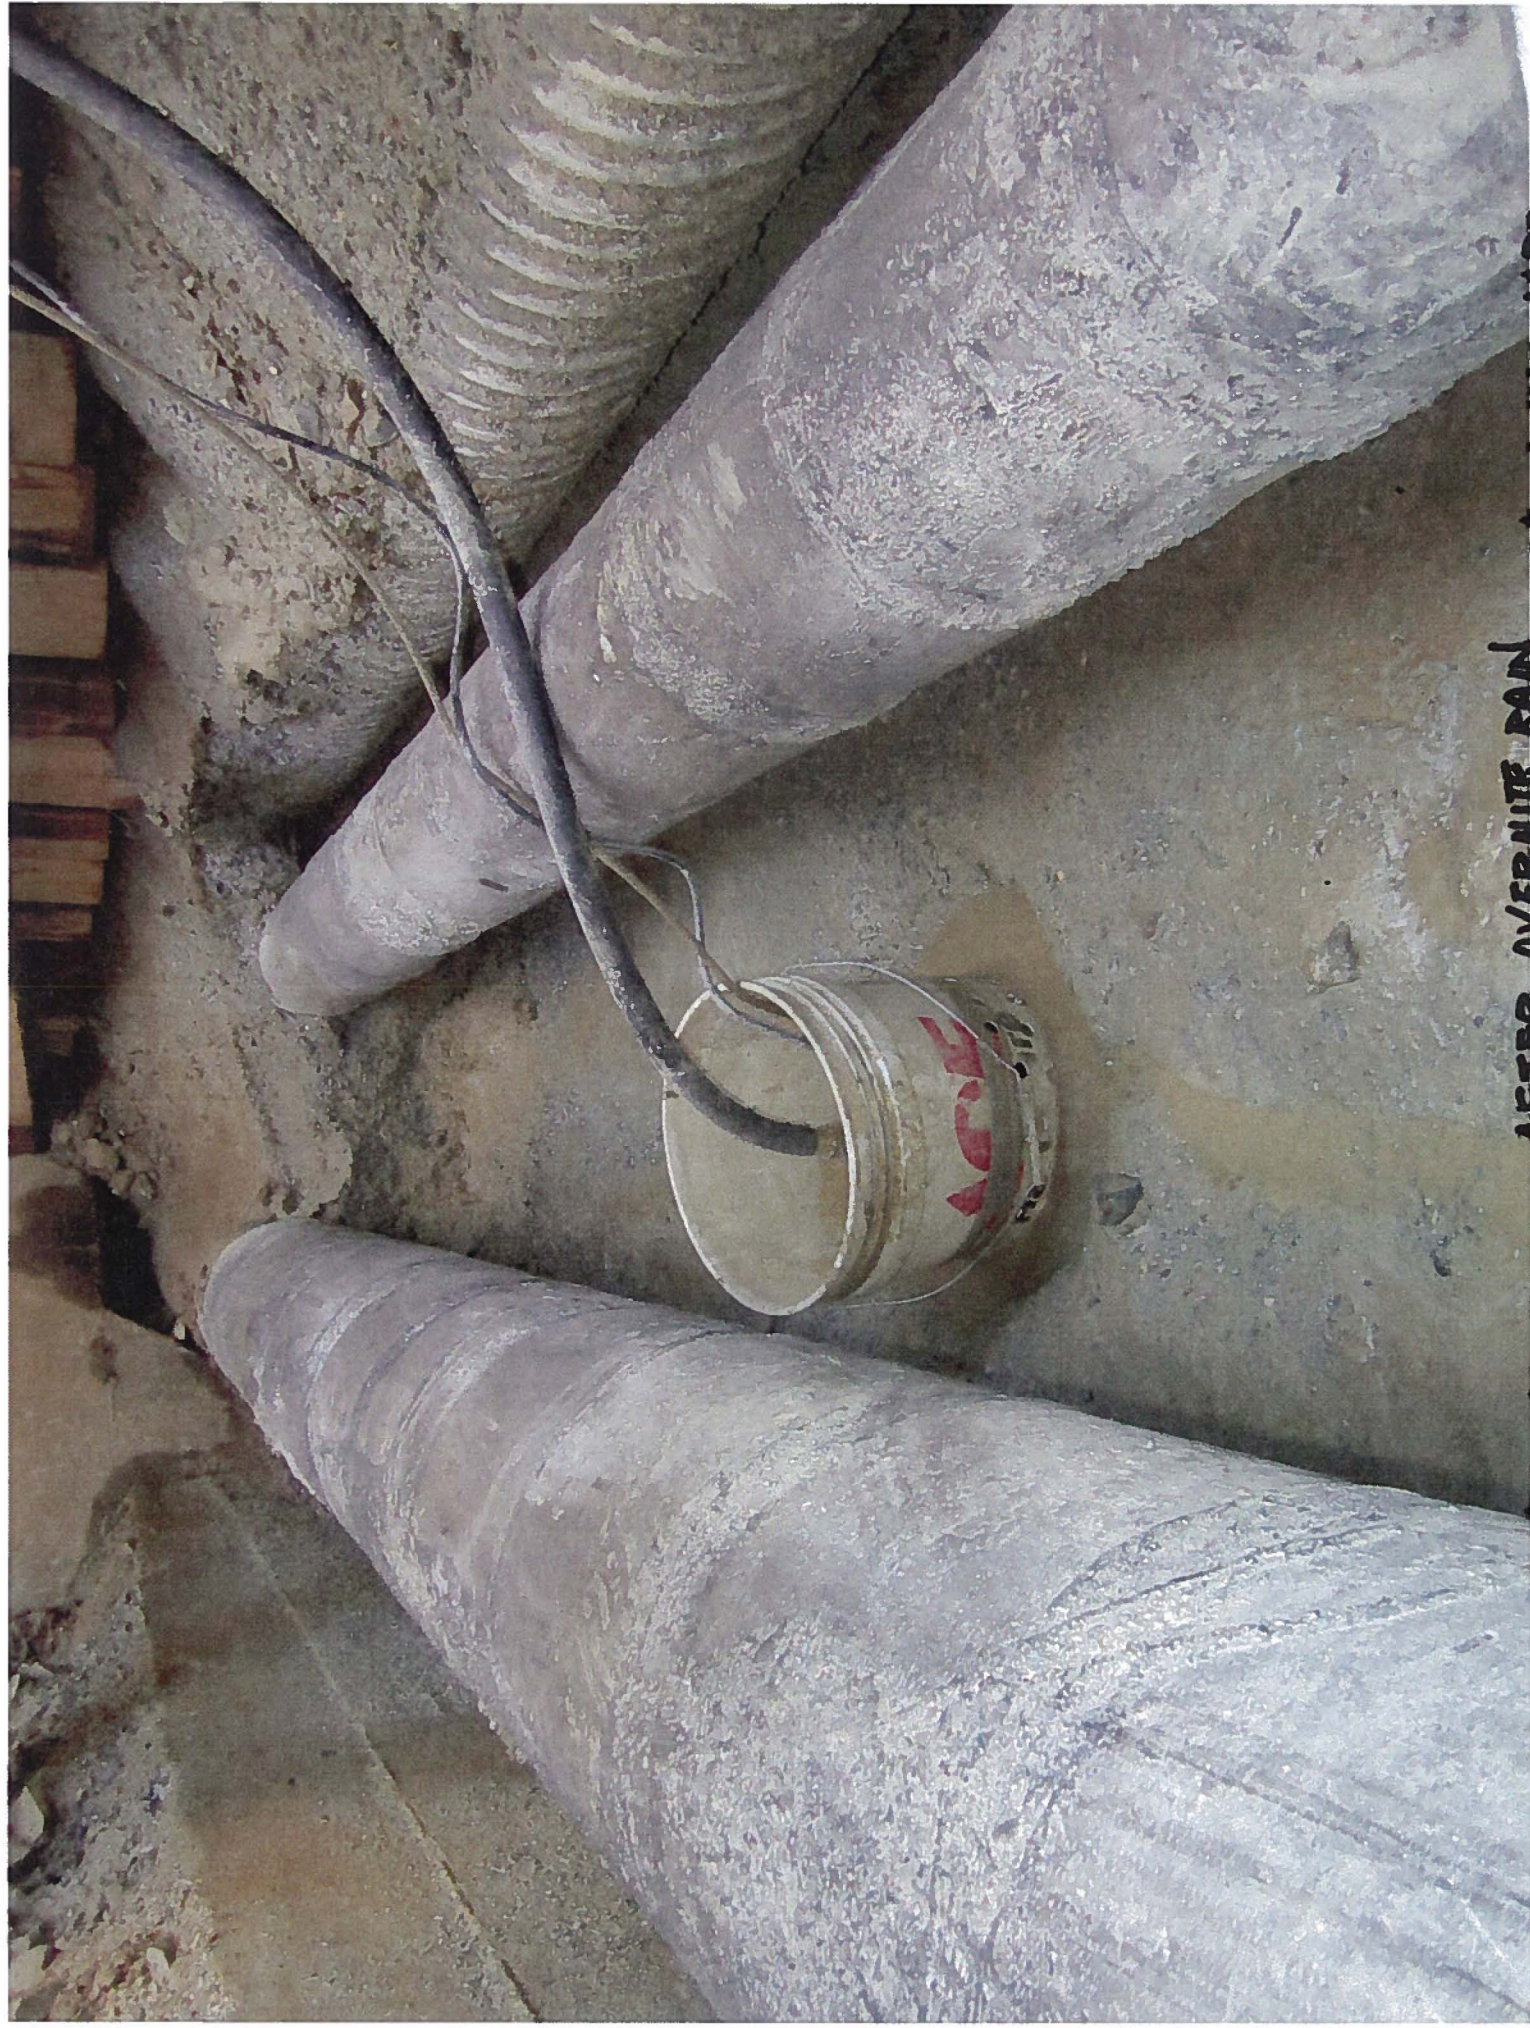
15" LINE IN 20" AFTER OVERNITE RAIN 6" LINE 1050
