**G-Scan Assessment of
Various Buried Piping**

Inspection Dates: September 22nd and 23rd 2009

Submitted to:
Entergy Nuclear
Indian Point Energy Center
November 2009

Report No. 0900235.401.R0

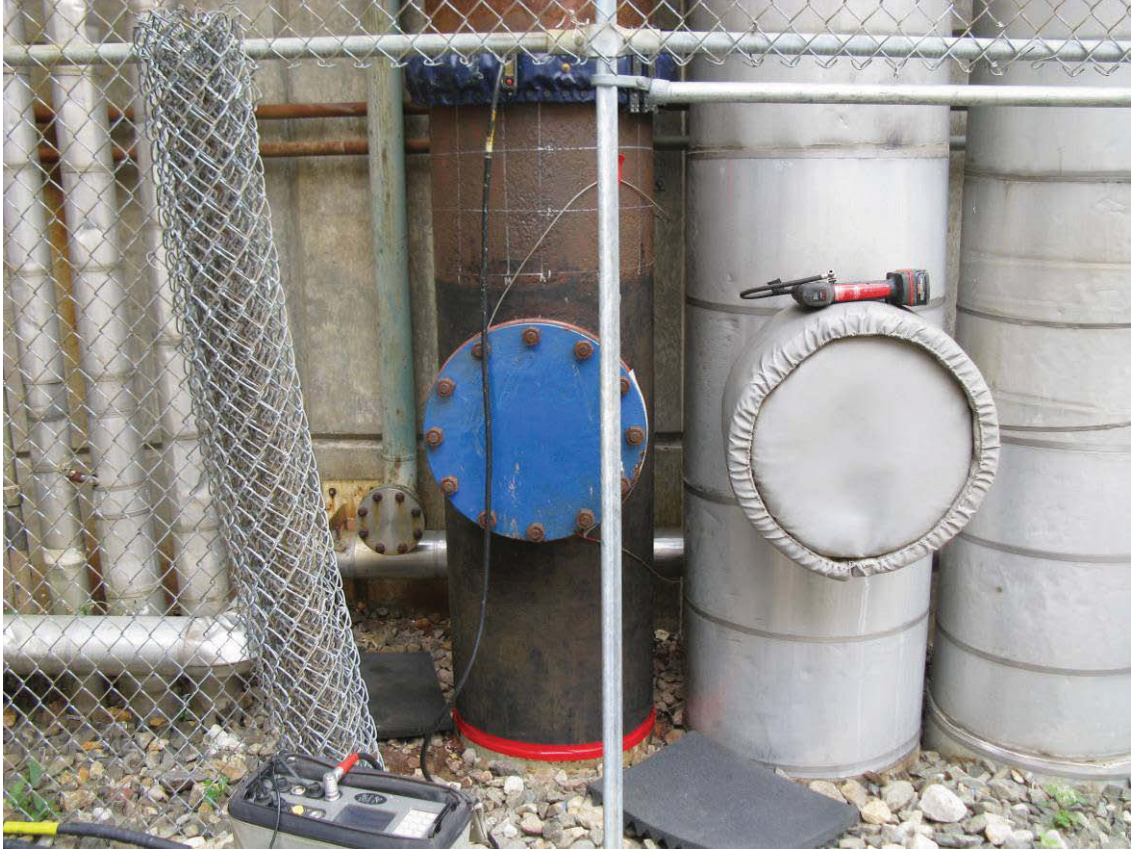
Figure 3.1: Location 1, Service Water Header, Transformer Yard

Figure 3.1 shows Location 1 on a 24-inch service water header. Tests were conducted above and below the 18-inch blind flange. This line is insulated at least down to ground level and may be insulated partially underground. As can be seen in Figure 3.1 and Figure 3.2, under insulation corrosion had occurred on the above ground section. The wall loss is estimated to be 0.070 to 0.080 inches deep.

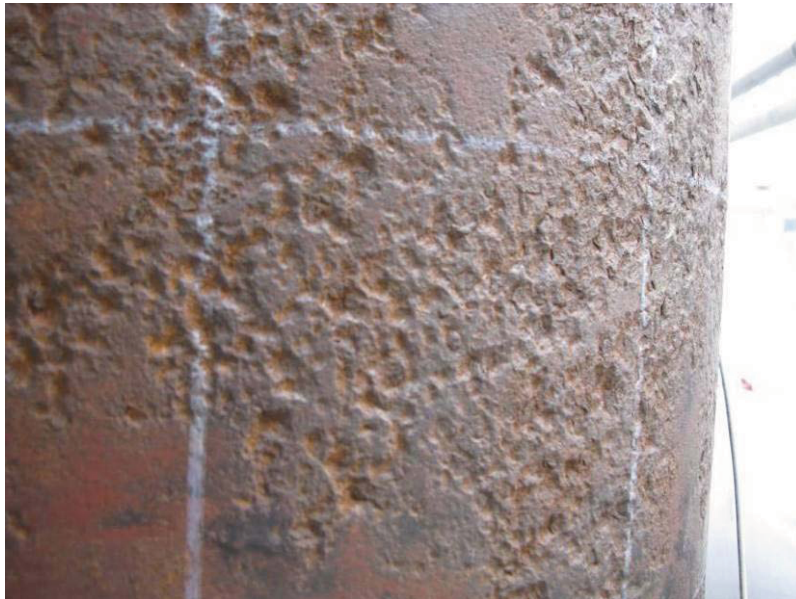
Figure 3.2: Location 1, Service Water Header, Under Insulation Corrosion

The detailed test results, trace and drawing of Location 1 is on the following pages. In summary there was an estimated 0.080 inches of wall loss from under insulation corrosion. Two indications were classified as Level 2 indications because of their pattern in the trace and because it would be helpful to understand if the mortar lining is causing the indications.

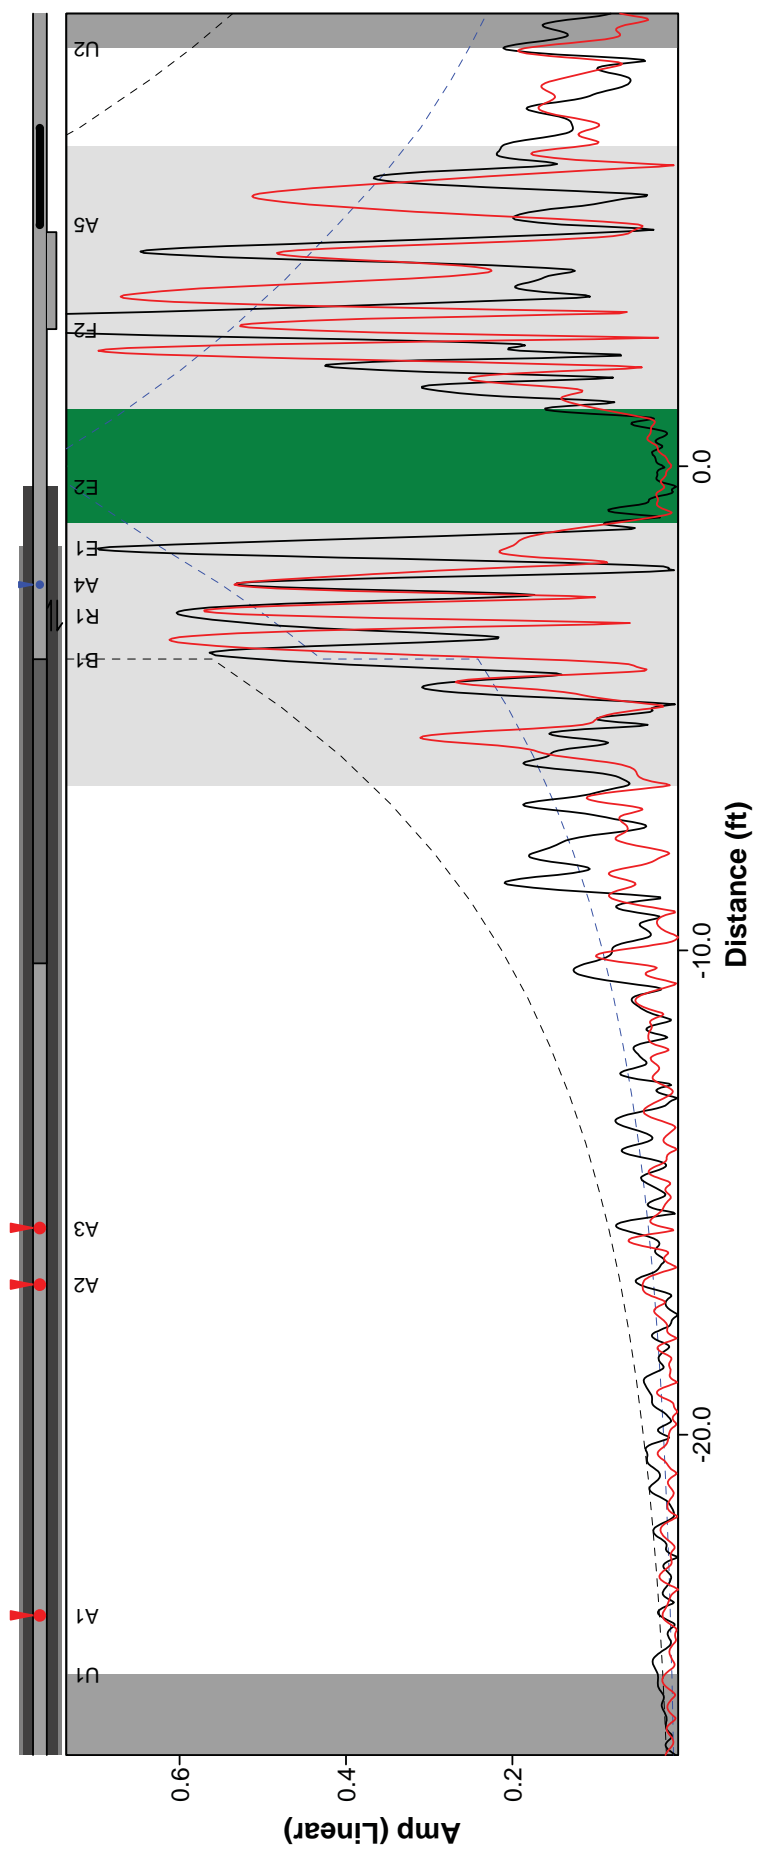
Figure 3.3: Shot 2979 Trace

A4	-2'5"	Cat 2	Corrosion like indication. Could be start of coating also. Excavation would be necessary to confirm				
R1	-3'1"	False Echo	From large branch connection				
B1	-4'0"	1D Bend	Assumed from information provided by plant staff. It may be shorter than a 1 D				
A3	-15'9"	Cat 1	Indications are corrosion like. Could be location of mortar failure or coating failure, Level 2				
A2	-16'11"	Cat 1	Indications are corrosion like. Could be location of mortar failure or coating failure, Level 2				
A1	-23'9"	Cat 1	Indications are corrosion like. Could be location of mortar failure or coating failure, Level 3				
U1	-24'11"	End					
F1	-36'5"	Branch	Estimated location of 3" to instrument air compressor from drawing 9321-F-2700				
F2	2'10"	Y	Visually confirmed				
A5	5'0"	Cat 3	Visual confirmed pitting. Approximately 0.080 inches deep or 20% wall loss.				
U2	8'8"	End

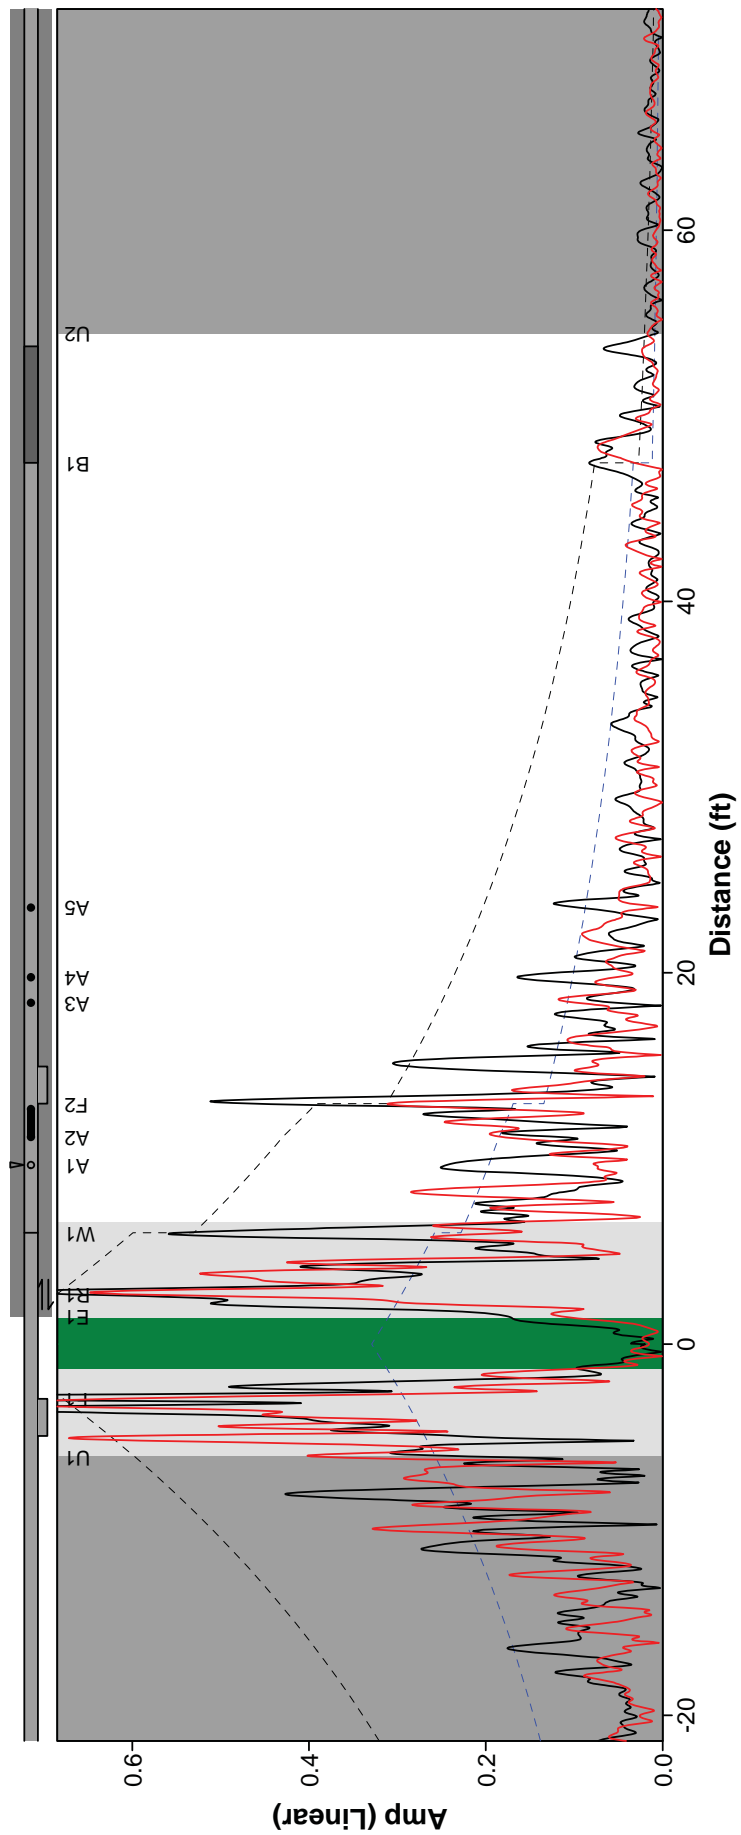
Figure 3.5: Trace of Shot 2982, Location 1

Test ID: G3-76#2982 Pipe: 24" SW 408 Site: Indian Point, Unit 2 Location: 1, Transformer Yard Flange -26" Size: 24 inch (.375") Tested: 22 Sept 2009 Tested by: Craig Chaney		Ring: R2B24(1102) Configuration: 12.0FR, T(0,1) Calibration: Automatic (2007.36 mV) Version: 3.97, Wavemaker G3-76 Client: Indian Point Procedure: GU 1.1 DACs: Call=10%, Weld=23%	
Summary: Service water pipe that is reported to have mortar lining. Above ground line is insulated and heat traced. Under insulation corrosion visually confirmed. Reported noise problem in the shot is due to poor coupling of transducers on the corroded surface. No B-Scan readings were taken in this area due to the external corrosion and the inability to couple the transducer to the corroded surface. Shot distance and confidence level is low after shooting through the 18 inch branch connection. Under insulation corrosion is also expected above branch connection.

Feature	Location	Class	Notes
F1	-2'11"	Y	Visually confirmed
E1	1'6"	Sleeve	Insulation
R1	2'8"	False Echo	From 18 inch branch connection
W1	6'0"	Weld	From signal trace
A1	9'8"	Cat 0	
A2	11'2"	Cat 3	From trace. Level 4
F2	12'11"	Y	18" branch connection and reducer that goes into Aux Building
A3	18'5"	Cat 3	From trace. Level 4
A4	19'9"	Cat 3	From trace. Level 4
A5	23'6"	Cat 3	From trace. Level 4
B1	47'5"	Bend	Visually verified
U2	54'5"	End	
U1	-6'1"	End

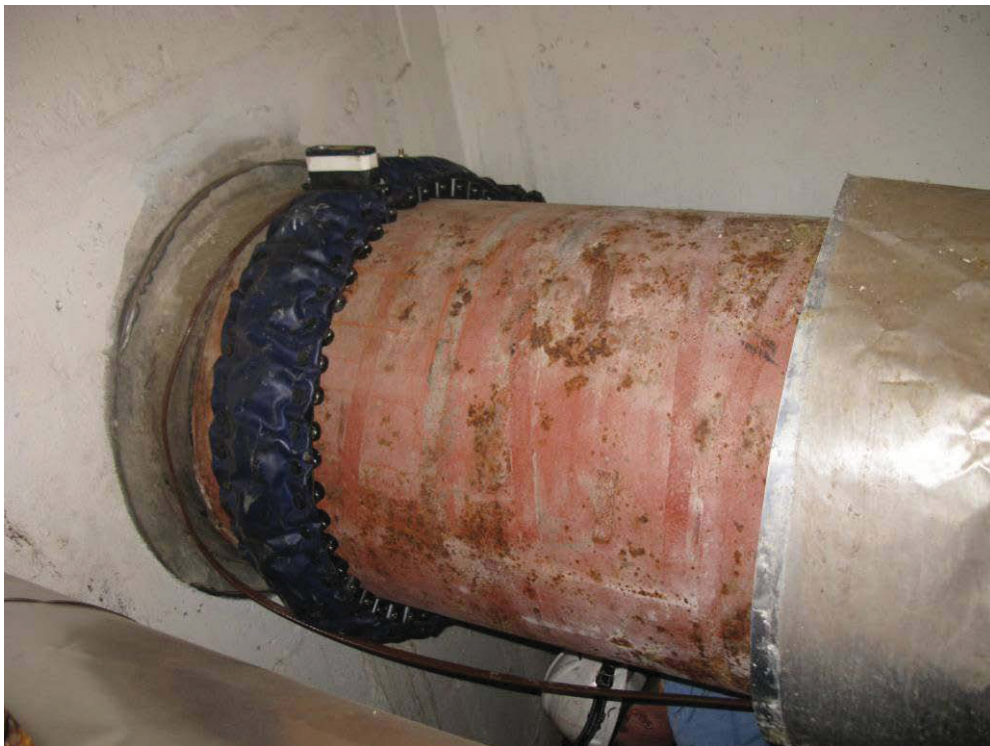
Figure 3.7: Location 2, Service Water Valve Pit

Figure 3.7 shows Location 2, a 24-inch service water header that was in the service water valve pit.

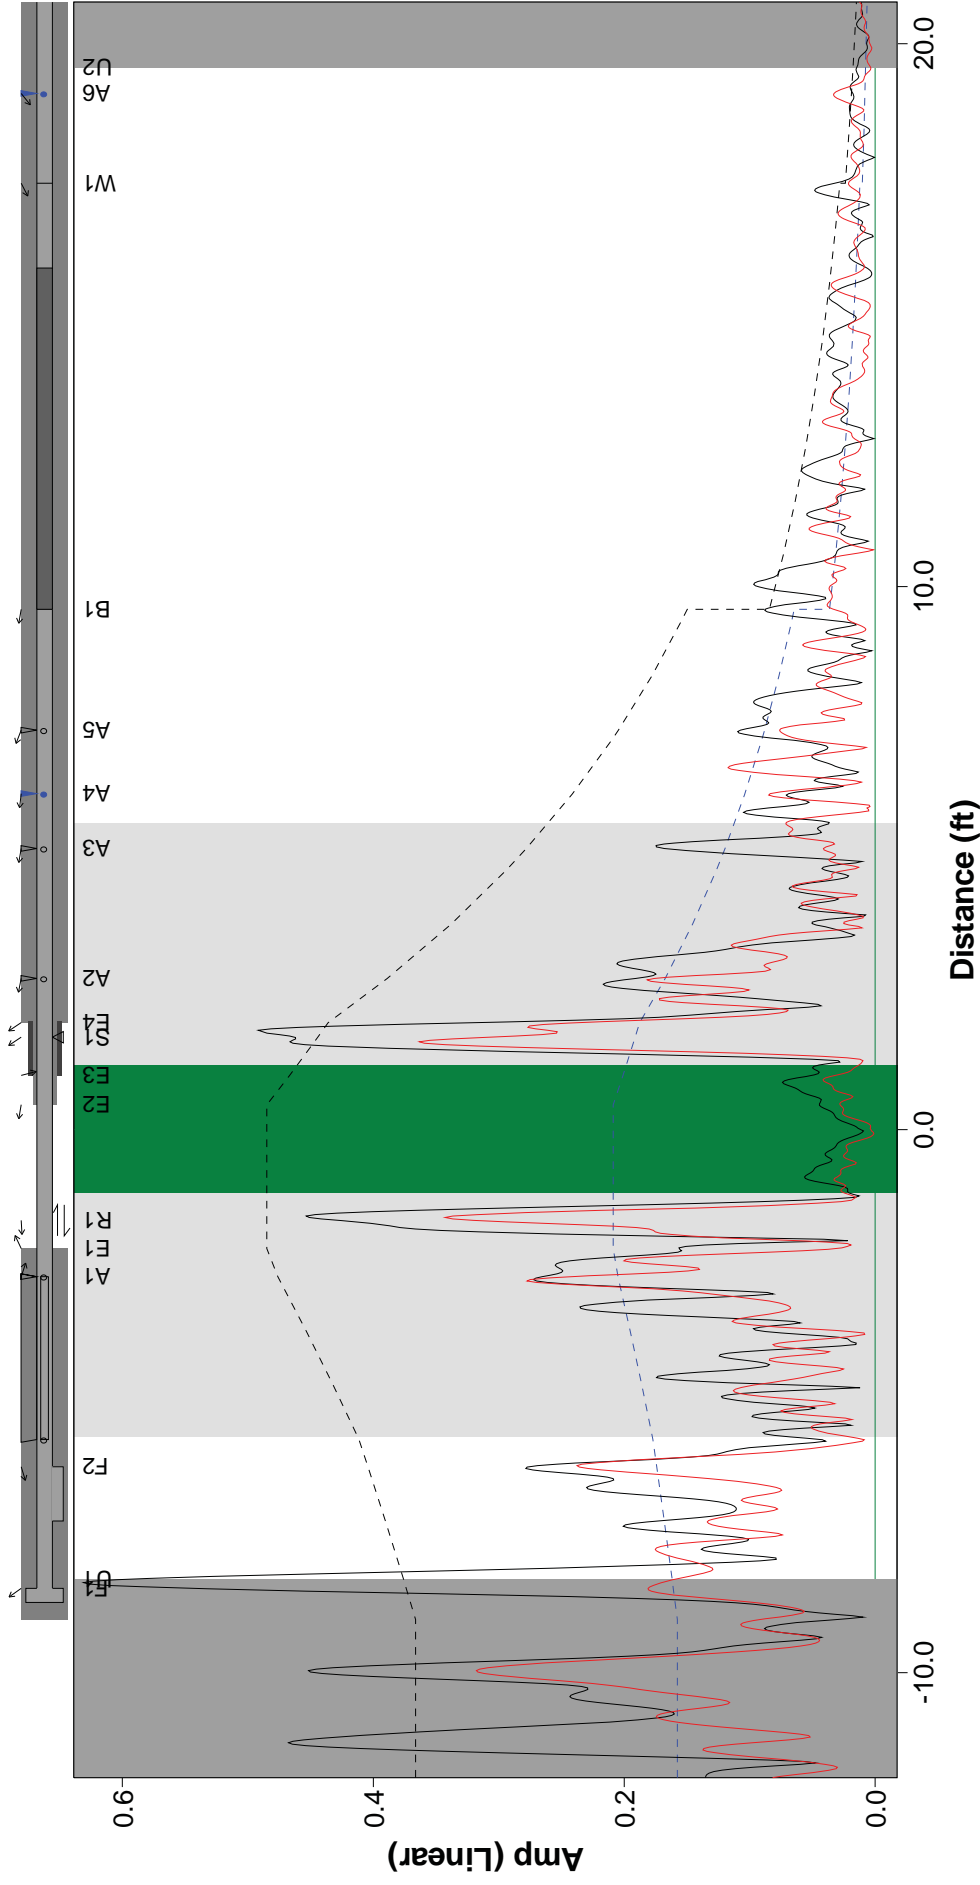
Figure 3.8: Trace of Shot 2983, Location 2

This shot was taken in the service water valve pit at Unit 3. The pipe ran through a concrete wall and then into soil. The piping is reported to have a mortar lining. At the location of the collar the pipe had paint. A bitumen coating that was 1/4" thick was noted as the pipe entered the vault wall. B-Scan readings are 0 to 90; 0.388", 90 to 180; 0.393", 180 to 270; 0.393" 270 to 0; 0.389" No internal wall loss was detected from the B-Scan tests.

Feature	Location	Class	Notes
A6	19'1"	Cat 2	Level 3
A5	7'4"	Cat 0	Appears to be a change in mortar coating
A4	6'2"	Cat 2	Level 3
A3	5'2"	Cat 0	Appears to be a change in mortar coating
A2	2'9"	Cat 0	Appears to be a change in mortar coating
A1	-2'8"	Cat 0	Variation caused by the mortar lining
B1	9'7"	1D Bend	The location of the bend does not correspond with the drawing but was selected here due to the initial weld response of the bend
E4	2'0"	Earth	Assumed location of earth
E3	1'0"	Wall	Assumed wall thickness from partial details shown on drawings.
E2	0'5"	Bitumen	0.25" Thick
E1	-2'2"	Entrance	Insulation visibly verified
F2	-6'2"	Branch	
F1	-8'5"	T	
R1	-1'8"	False Echo	
S1	1'8"	Support	Welded ring to seal the vault from water and soil shown on drawings.
U2	19'7"	End	
W1	17'5"	Weld	From trace

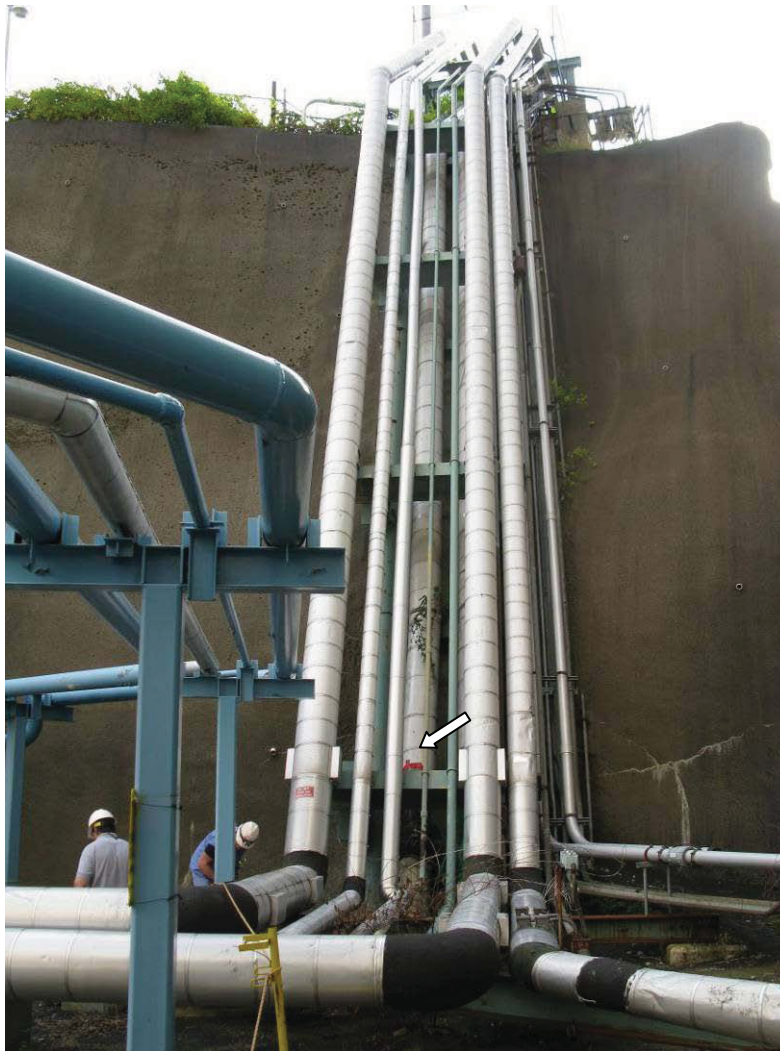
Figure 3.10: Location 3, 8-inch Line from the AFW Building up to CST

Pipe #1080. This line runs up the hillside at a 65 degree angle on welded supports. In the other direction it runs into the earth and has a 65 degree bend approximately four feet below ground. Minor corrosion was observed in the trace above and below ground. This location has Level 3 indications.

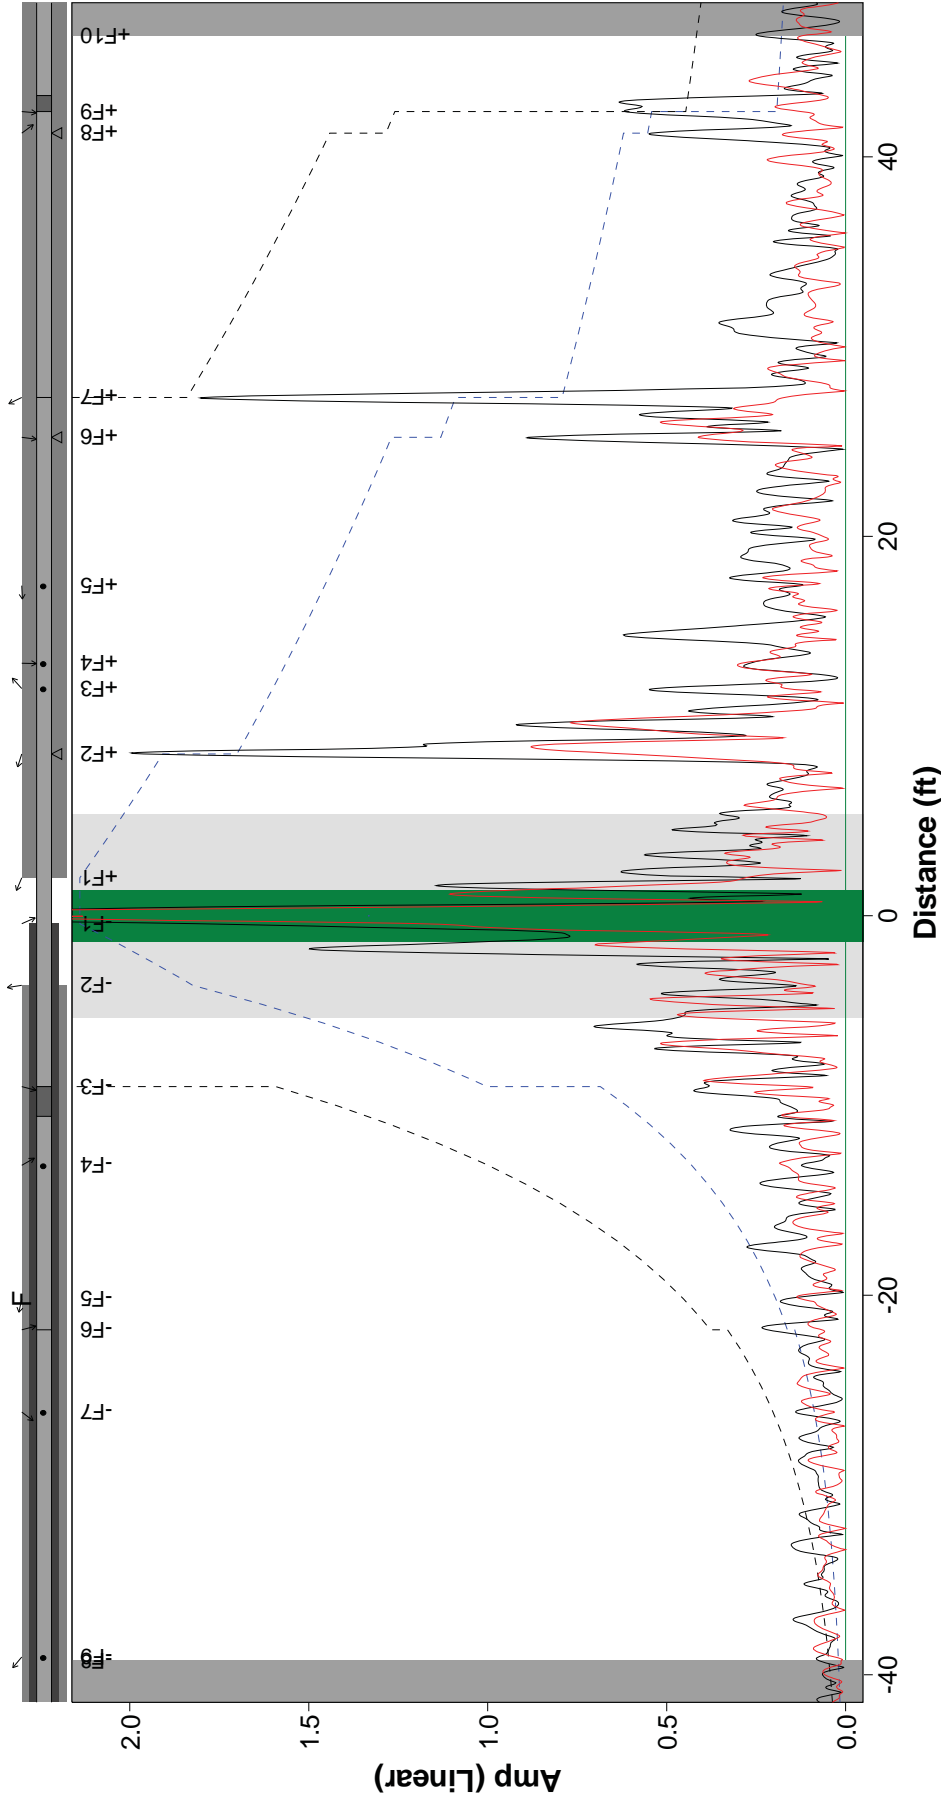
Figure 3.11: Trace of Shot 2984, Location 3

Feature	Location	Class	Notes
W1	-21'10"	Weld	Identified from trace
W2	27'4"	Weld	From Trace
U1	-39'3"	End	
U2	-20'2"	Other	Possible coating problem or thickness change
U3	46'4"	End	
S1	8'6"	Weld. sup.	Visually verified
S2	25'3"	Support	Visually verified
S3	41'3"	Support	Visually verified
E1	-3'8"	Earth	Visually verified
E2	-0'5"	Entrance	Hardened foam insulation visually verified
E3	2'0"	Entrance	Hardened foam insulation visually verified
B1	-9'0"	Bend	Identified from trace and drawing. It is a 65 degree bend.
B2	42'5"	45 deg Bend	Visually verified, 45 degree bend.
B3	52'1"	45 deg Bend	Identified from trace and drawing.
A1	-39'1"	Cat 3	Level 3
A2	-26'2"	Cat 3	Level 3
A3	-13'2"	Cat 3	Level 3
A4	12'0"	Cat 3	Level 3
A5	13'4"	Cat 3	Level 3
A6	17'5"	Cat 3	Level 3

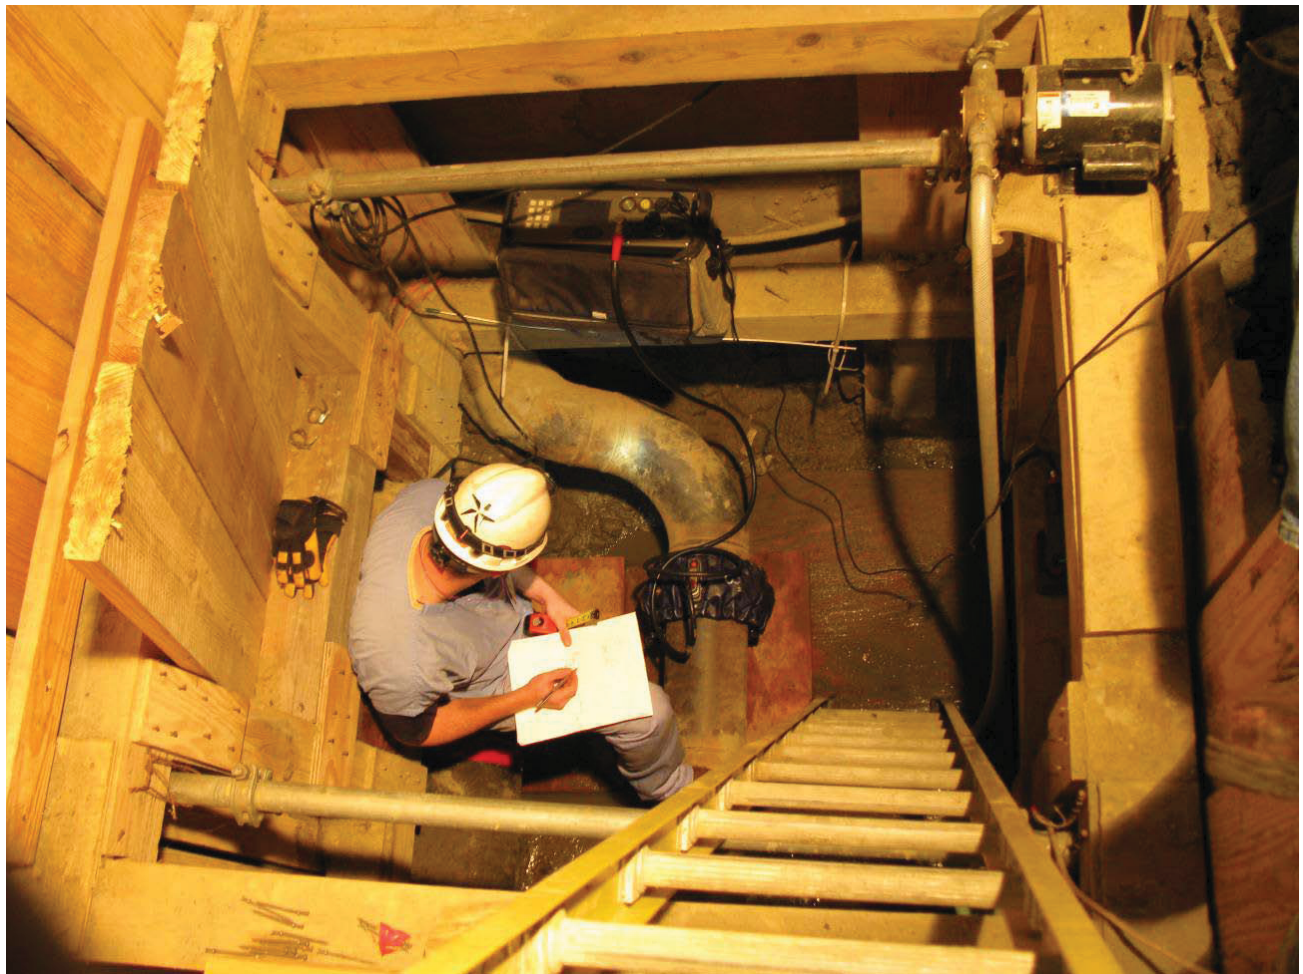
Figure 3.13: Location 4, 8-inch Line in an excavation in the FRV Building

4	2	Cond. Ret. To CST	1509	FRV Bldg Excavation	2991	3	This section of line had through wall leaks in February 2009. The leaking section of pipe was replaced in February 2009 and is the location of the transducer collar for this test. Minor corrosion indications were noted. This is a Level 3 area.
5	2	CST TO AFP	1505	FRV Bldg. Excavation	2993	2	Several indications are observed in the piping towards the elbow. Because of the nature of these indications they are categorized as Level 2 indications.
6	3	CST to AFP	1070	Unit 3 CST to AFP Bottom of Hill	2995	2	Minor corrosion of 0.025" deep was noted at the collar location. Several corrosion like indications were identified in the buried sections of the pipe. These indications are categorized as a Level 2.

It is recommended the Level 3 indications be monitored over time. The indications in the FRV building may be further explored with direct examination, pressure tested or monitored over time. This piping may benefit from localized cathodic protection to mitigate further degradation.

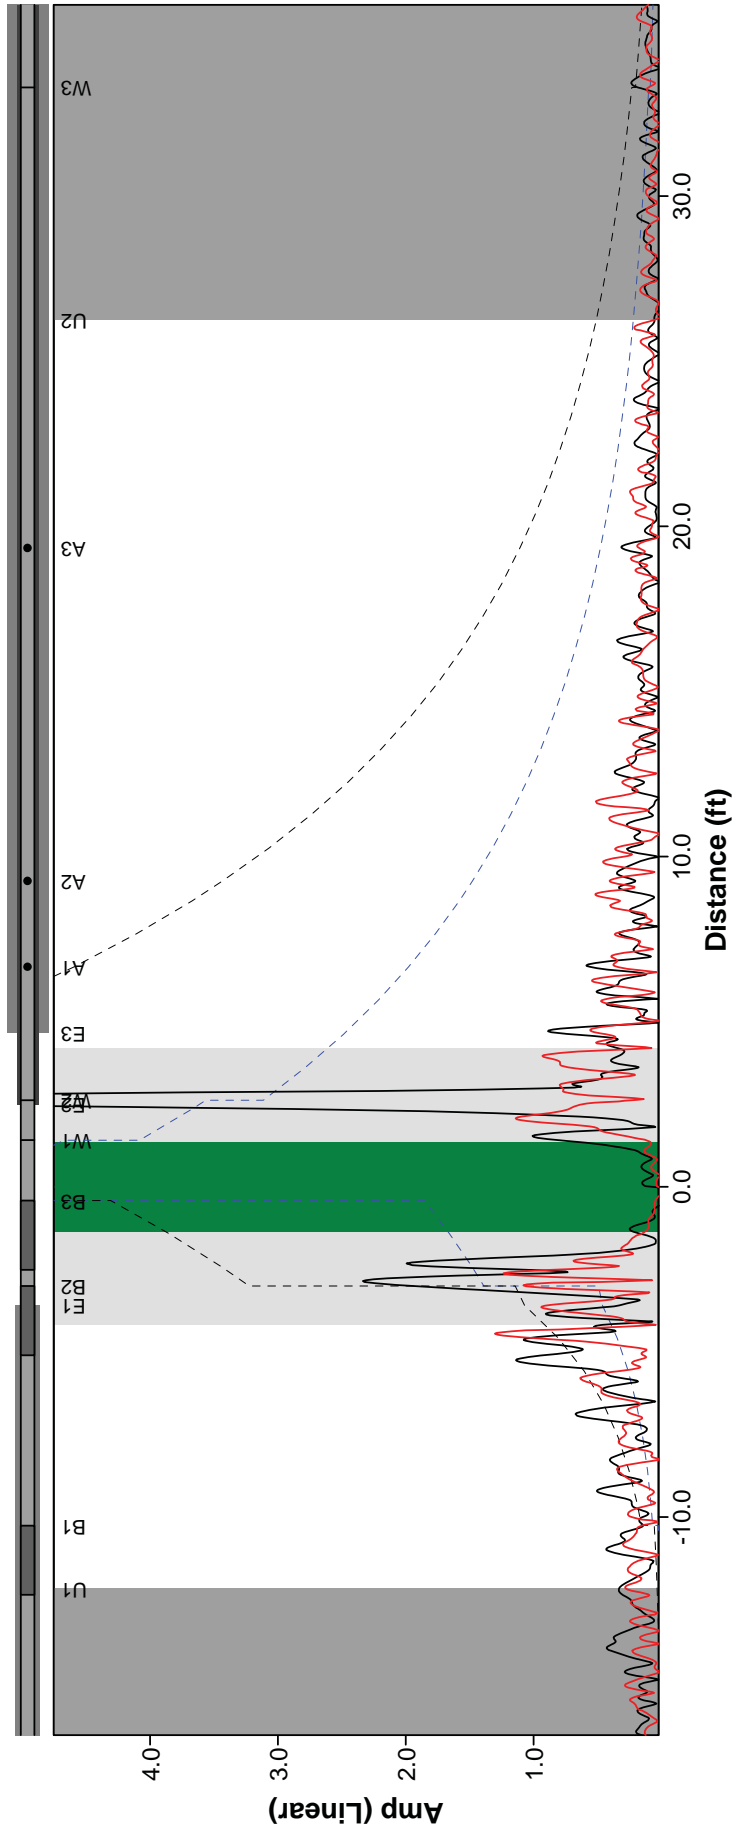
Figure 3.14: Trace of Shot 2991, Location 4

Test ID: G3-76#2991 Pipe: IP2 - 8" CST Return Site: Indian Point, Unit 2 Location: Weld 1'5" Size: 8 inch Tested: 23 Sept 2009 12:55 Tested by: Craig Chaney				Ring: R2B08(900) Configuration: 3.3FR, T(0,1) Calibration: Automatic (2372.37 mV) Version: 3.97, Wavemaker G3-76 Client: Indian Point Procedure: GU 1.1 DACs: Call=10%, Weld=23%			
Summary: IP2-8" CST Return for Unit 2 in excavation that was in the feed regulator valve building. This section of line had through wall leaks in February 2009. This section of pipe was replaced in February 2009 and is the location of the transducer collar for this test. Minor corrosion indications were noted. This is a Level 3 test.							
Feature	Location	Class	Notes				
U1	-12'2"	End					
B1	-10'3"	Bend	Assumed from piping configuration				
E1	-3'7"	Bitumen	Visually verified				
B2	-3'0"	1D Bend	Visually verified				
B3	-0'5"	1D Bend	Visually verified				
W1	1'5"	Weld	Visually verified

W2	2'7"	Weld	Assumed from trace				
E2	2'6"	Bitumen	Visually verified				
E3	4'8"	Earth	Visually verified				
A1	6'8"	Cat 3	Level 3 indication				
A2	9'3"	Cat 3	Level 3 indication				
A3	19'4"	Cat 3	Level 3 indication				
U2	26'3"	End					
W3	33'3"	Weld	Assumed from trace.

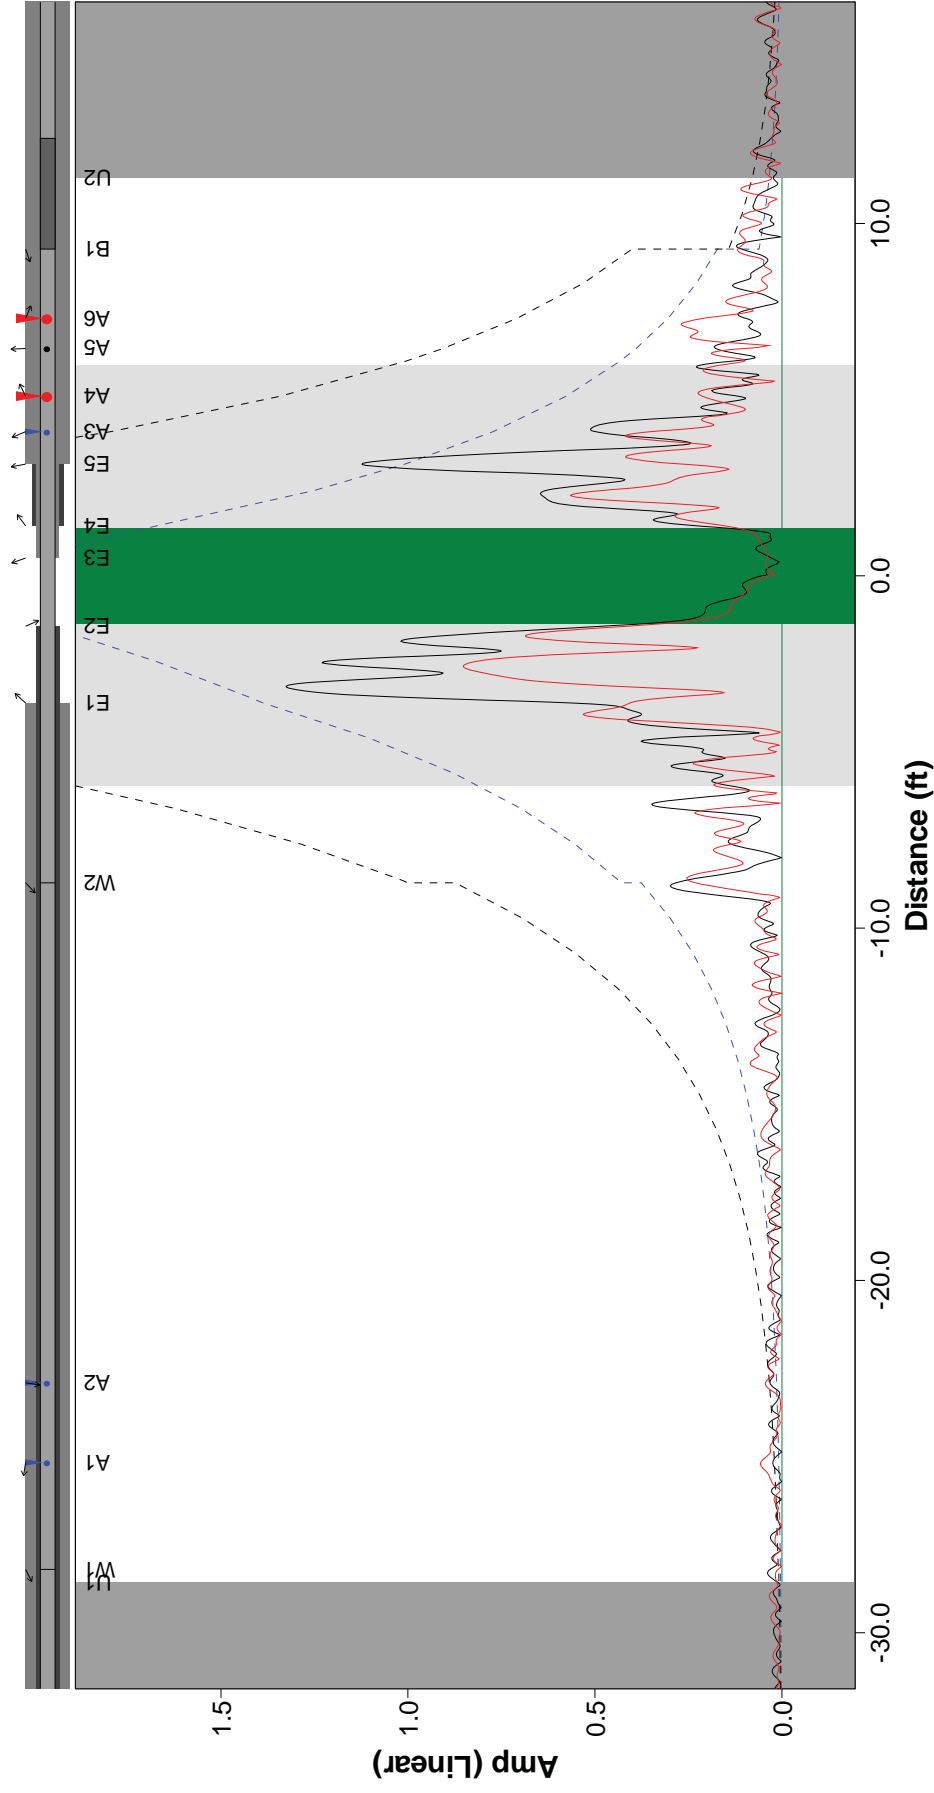
Figure 3.17: Trace of Shot 2993, Location 5

Test ID: G3-76#2993 Pipe: IP2 - 12" AFP Suction Site: Indian Point Location: Wall 3'0" Size: 12 inch Ring: R2B12(1368) Configuration: 7.4FR, T(0,1) Calibration: Automatic (6864.49 mV) Version: 3.97, Wavemaker G3-76 Tested: 23 Sept 2009 Tested by: Craig Chaney Client: Indian Point Procedure: GU 1.1 DACs: Call=10%, Weld=23%			
Summary: Unit 2 12" Aux Feed Pump Suction from CST in excavation. Several indications are observed in the piping towards the elbow. Because of the nature of these indications they are categorized as Level 2 indications.			
Feature	Location	Class	Notes
E1	-3'7"	Earth	Visually verified
E2	-1'5"	Bitumen	Visually verified
E3	0'6"	Bitumen	Visually verified
E4	1'5"	Earth	Visually verified Partial earth coverage of pipe approximately 90 degrees
E5	3'2"	Earth	Visually verified Full coverage of pipe
A3	4'1"	Cat 2	Could be coating variation. Level 2
A4	5'1"	Cat 1	Could be coating variation. Level 2

A5	6'5"	Cat 3	Could be coating variation. Level 2
A6	7'4"	Cat 1	Could be coating variation. Level 2
B1	9'3"	Bend	Level 3
U2	11'3"	End	
W2	-8'8"	Weld	Weld has a high flexural response recommend follow-up UT examination, Level 3
A2	-22'11"	Cat 2	Level 3
A1	-25'2"	Cat 2	
W1	-28'2"	Weld	Level 3
U1	-28'7"	End

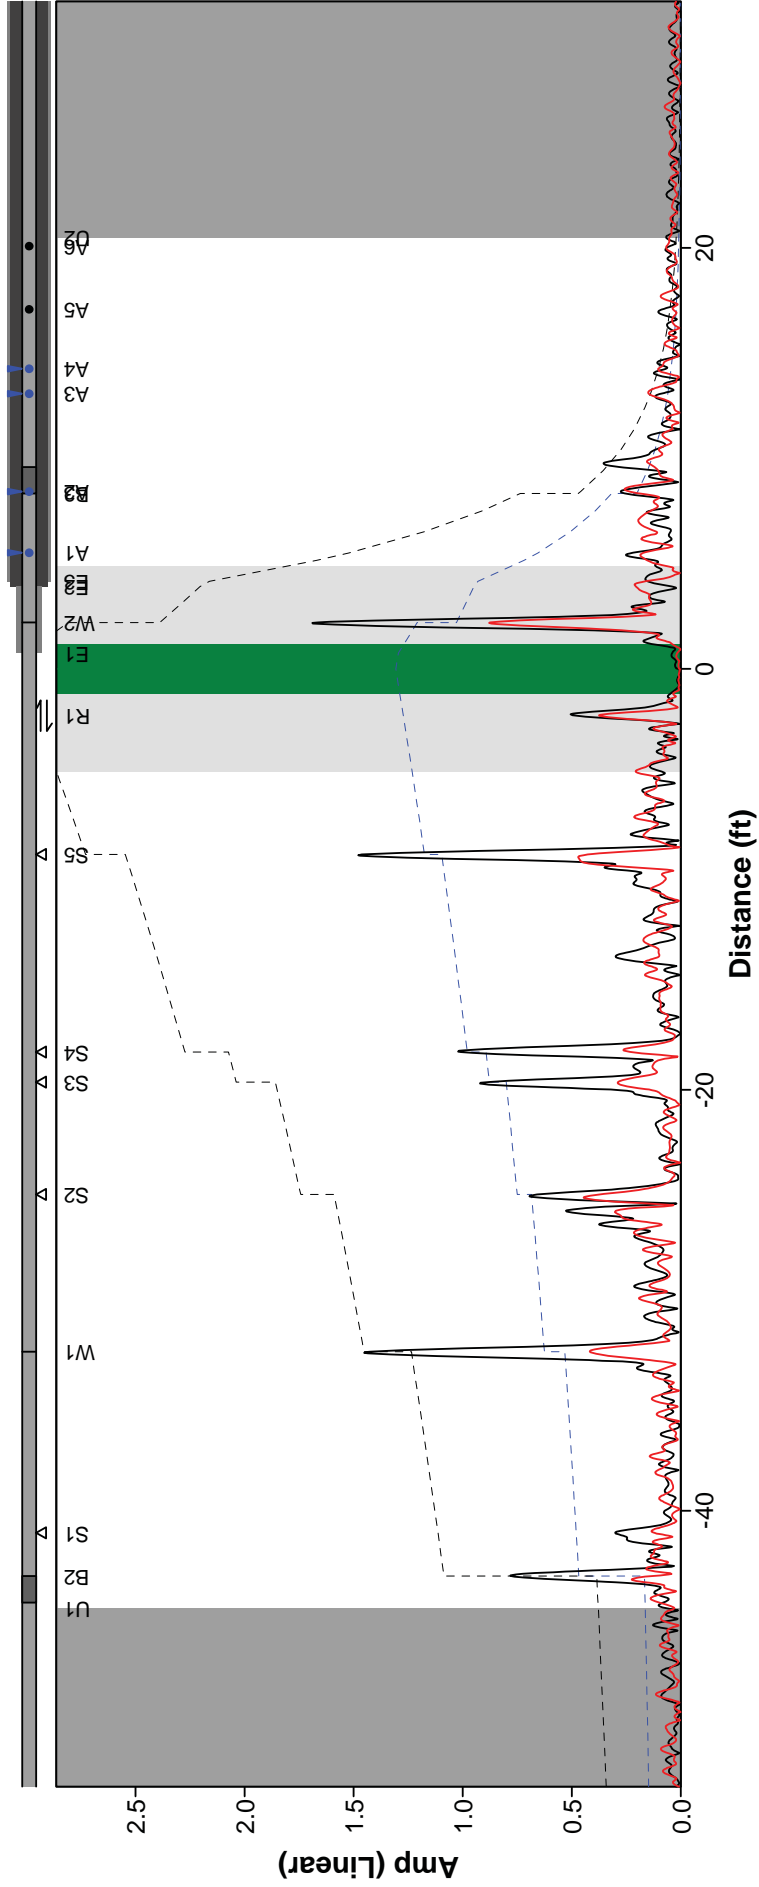
Figure 3.20: Trace of Shot 2995, Location 6

Test ID: G3-76#2995 Pipe: IP3 - 12" AFW Suction Site: Indian Point Location: Earth +3'11" Size: 12 inch (.250") Tested: 23 Sept 2009 Tested by: Craig Chaney				Ring: R2B12(1368) Configuration: 8.4FR, T(0,1) Calibration: Automatic (2571.19 mV) Version: 3.97, Wavemaker G3-76 Client: Indian Point Procedure: GU 1.1 DACs: Call=10%, Weld=23%			
Summary: IP3 - 12" AFP Suction shot taken in the yard going up the hill. Minor corrosion noted under the collars of 0.025". Several corrosion like indications were identified in the buried section of the pipe. These indications are categorized as a Level 2.							
Feature	Location	Class	Notes				
U1	-44'7"	End					
B1	-59'3"	45 deg Bend					
B2	-43'1"	45 deg Bend	Visually verified				
S1	-41'0"	Support	Visually verified				
W1	-32'5"	Weld	From trace				
S2	-25'0"	Support	Visually verified				
S3	-19'8"	Support	Feature appears to be a support although no support was visible

S4	-18'2"	Support	Feature appears to be a support although no support was visible				
R1	-2'3"	False Echo	From weld				
S5	-8'10"	Support	Visually verified				
E1	0'9"	Entrance	Insulation begins, visually verified				
W2	2'2"	Weld	From trace				
E2	3'11"	Earth	Visually verified				
E3	4'2"	Bitumen	Assumed				
A1	5'6"	Cat 2	Level 2 indications				
B3	8'4"	45 deg Bend	Actually a 65 degree bend				
A2	8'5"	Cat 2	Level 2 indications				
A3	13'1"	Cat 2	Level 2 indications				
A4	14'3"	Cat 2	Level 2 indications				
A5	17'1"	Cat 3	Level 3 indications				
A6	20'1"	Cat 3	Level 3 indications				
U2	20'6"	End
