United States Nuclear Regulatory Commission Official Hearing Exhibit	
In the Matter of: Entergy Nuclear Operations, Inc. (Indian Point Nuclear Generating Units 2 and 3)

ENTERGY	ENGINEERING STANDARD	EN-EP-S-002-MULTI	REV. 0
	Buried Piping and Tanks General Visual Inspection	PAGE 11 OF 12

Piping / Tank	10-inch City Water/Fire Water Line at the IP2 Maintenance Training Facility (MTF)	INSPECTION DATE:	11/23/09
ELEVATION: 120' EL. (approx. grade)	LOCATION DWG: NYPA-3899-G-202-0, zone C-11	INSPECTOR:	R. Allen

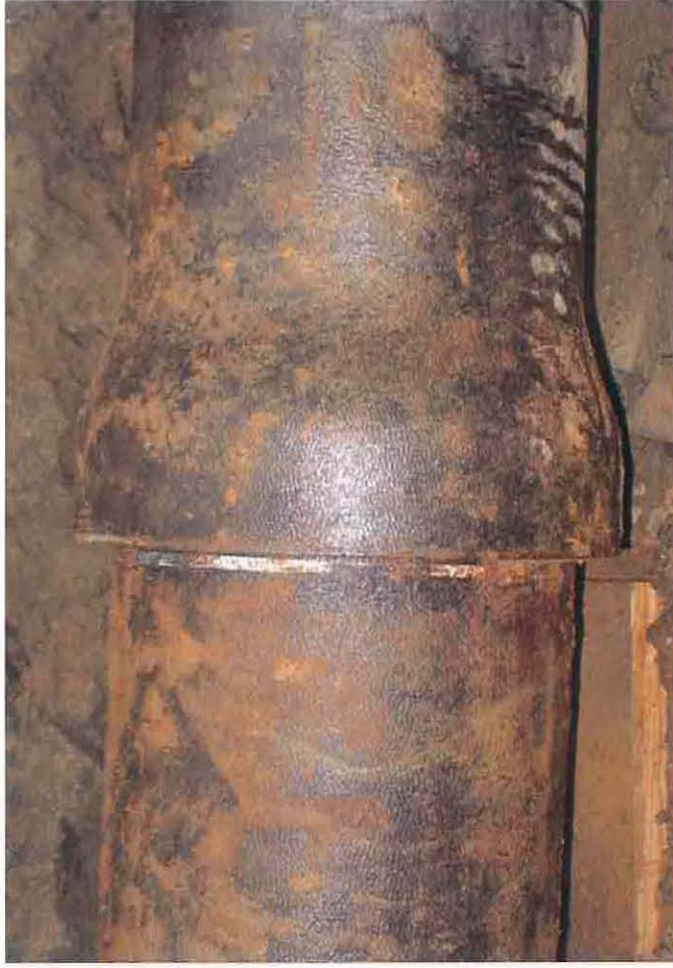
10" City Water / Fire Line to Tipton Waste Storage Facility. Orangeish - mat' on pipe OD was hardened red-clay-like soil, which could be removed w/ water spray + light wiping.

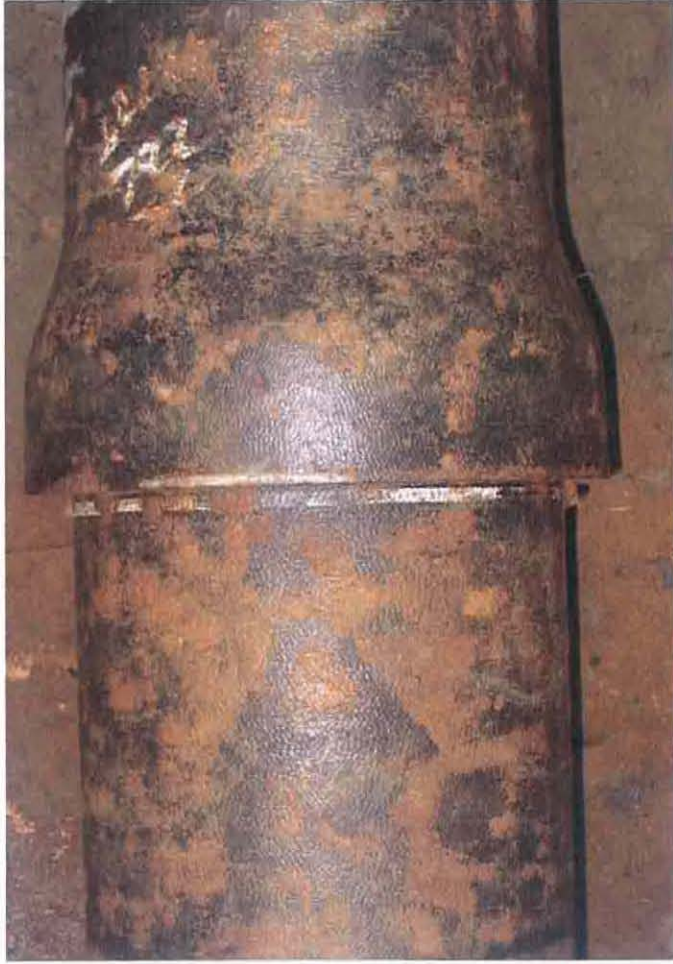
10" Bell and Spigot joint

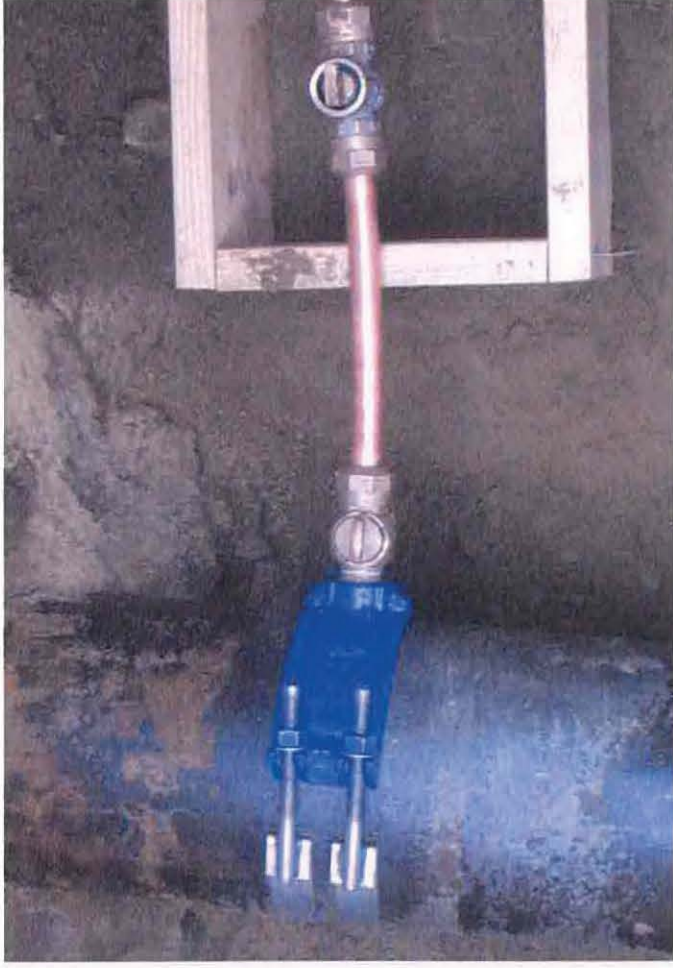
Plan view of Saddle clamp and 1" branch to MTF

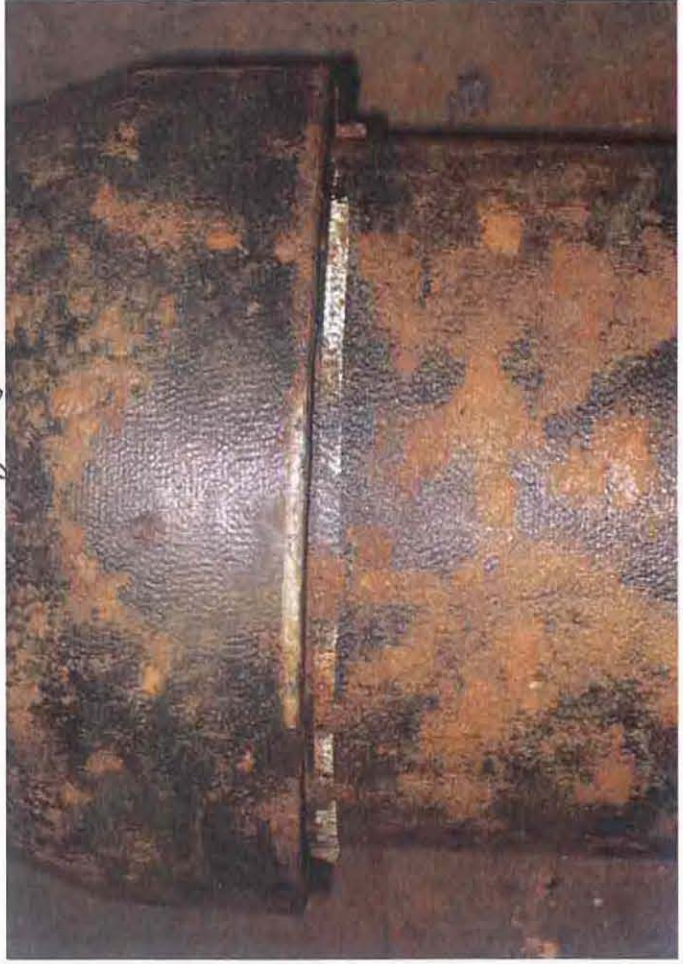
10" Bell & Spigot joint.

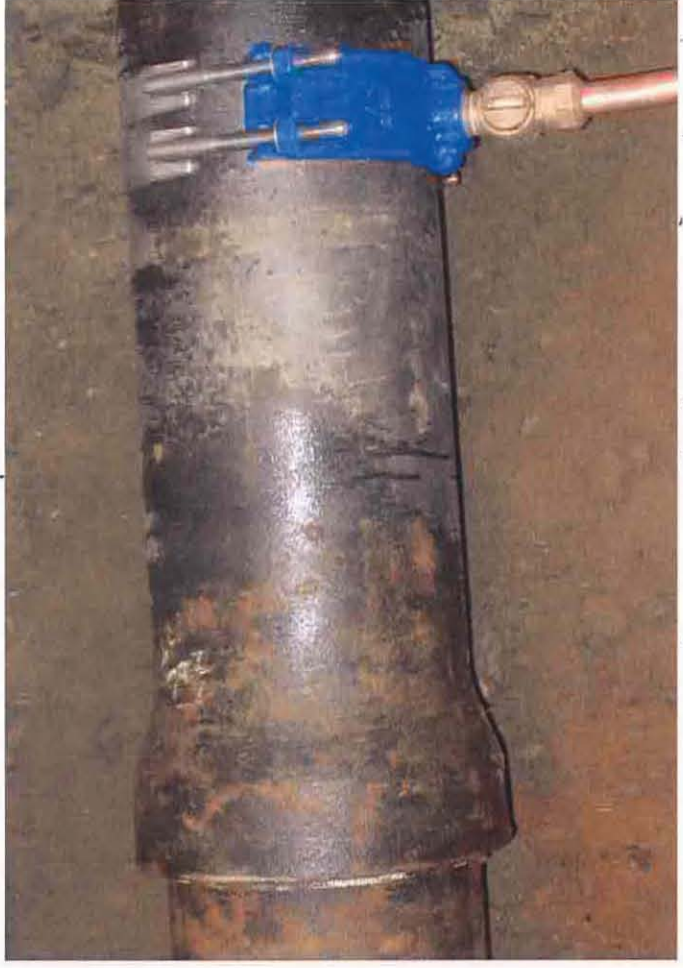
Plan view of excavated pipe. WEST is to the right

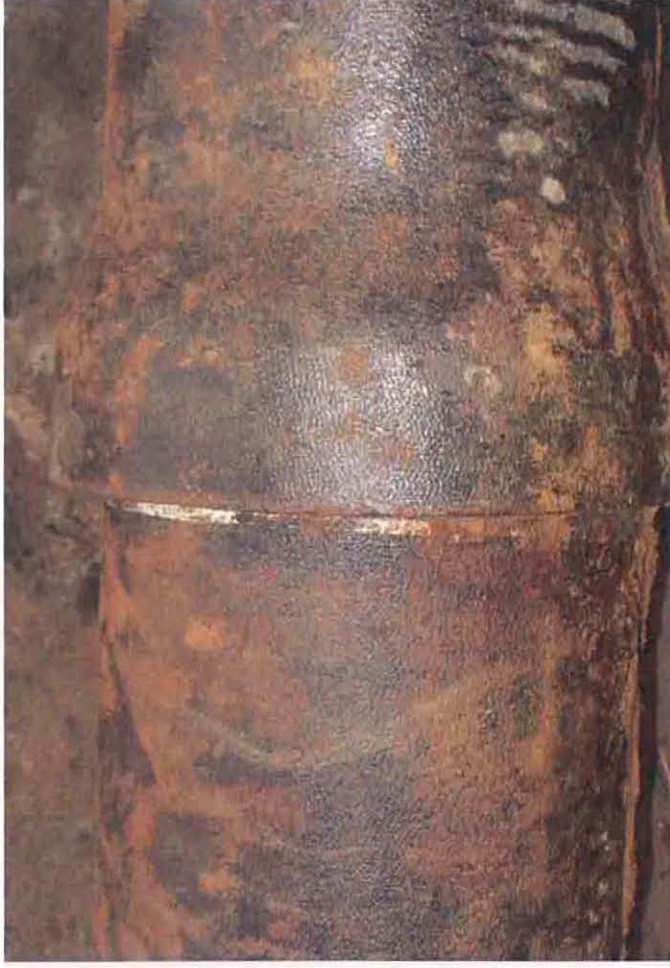
10" CW piping Bell & Spigot Joint

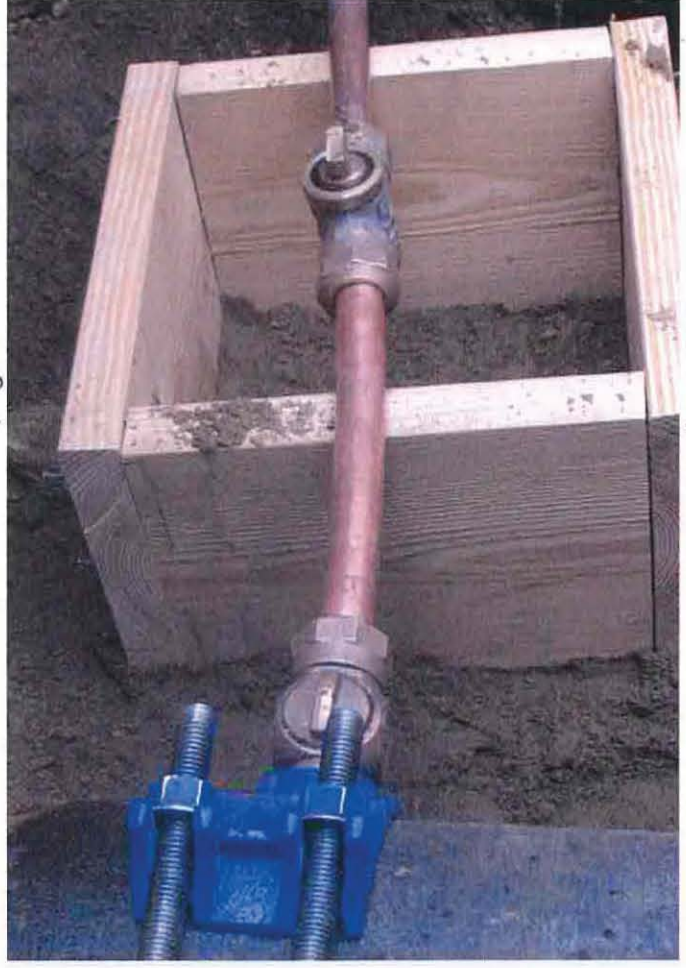
1" Branch connection to MTF w/ 1" curb valve

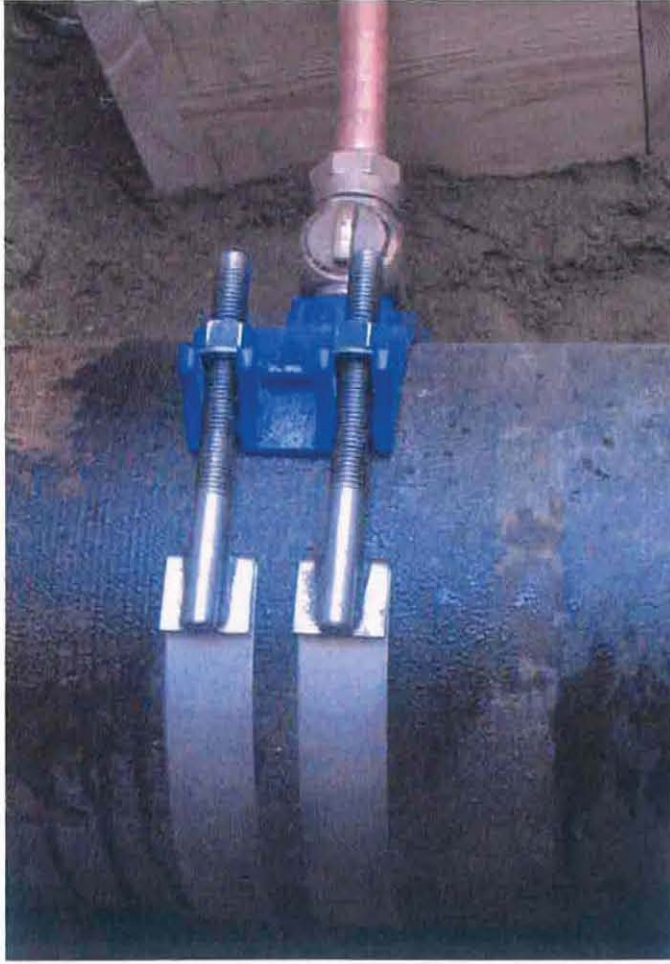
10" double strap Saddle + 1" Branch to MTF

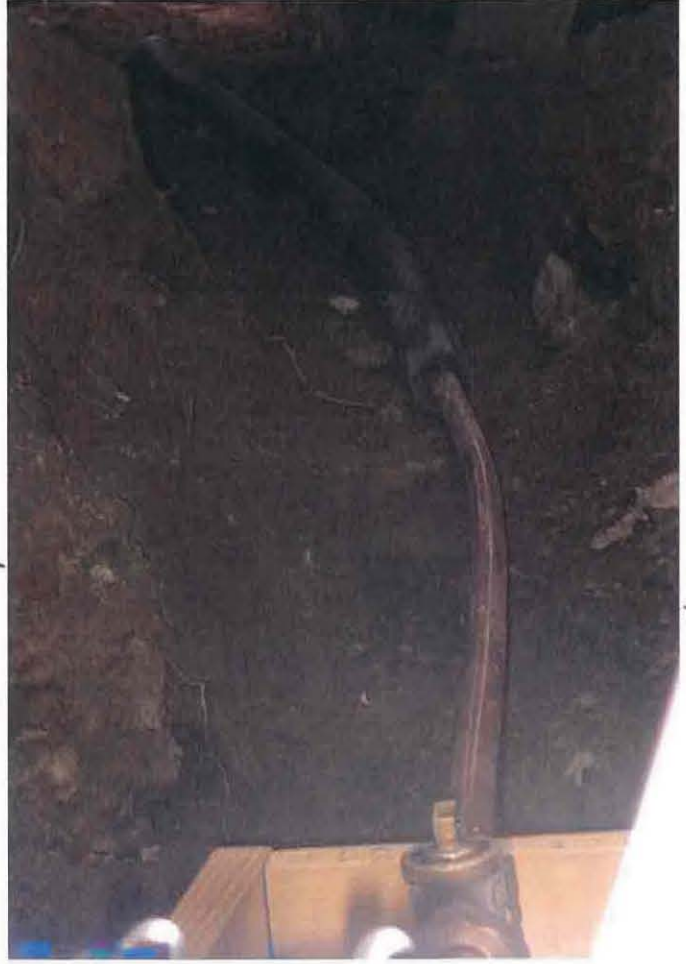
1" Branch to Maint Trng Facility
