United States Nuclear Regulatory Commission Official Hearing Exhibit	
In the Matter of:	Entergy Nuclear Operations, Inc. (Indian Point Nuclear Generating Units 2 and 3)

ATTACHMENT 7.1

INSPECTION CHECKLIST

Piping / Tank	16-inch City Water Line from CWST	INSPECTION DATE:	10/21/09
ELEVATION: 120' EL. (approx. grade)	LOCATION DWG: 138057, zone D-5	INSPECTOR:	J. Peterson

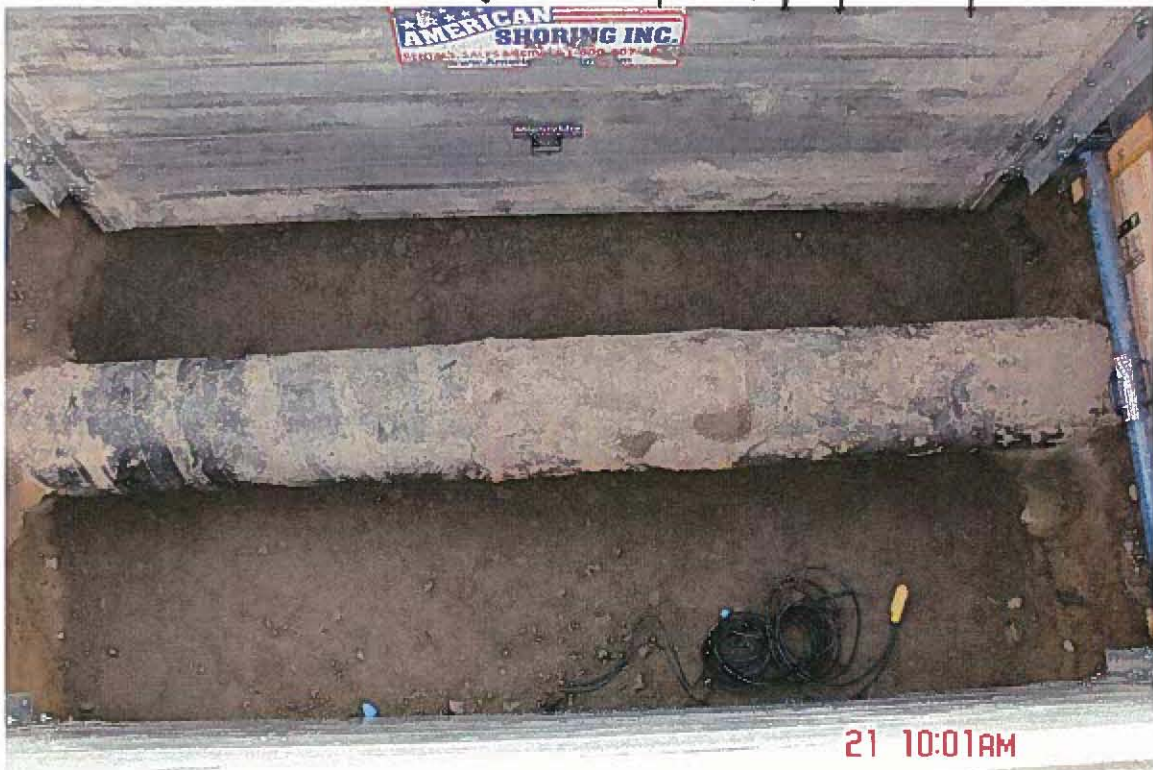
Length of exposed piping = 10 ft.

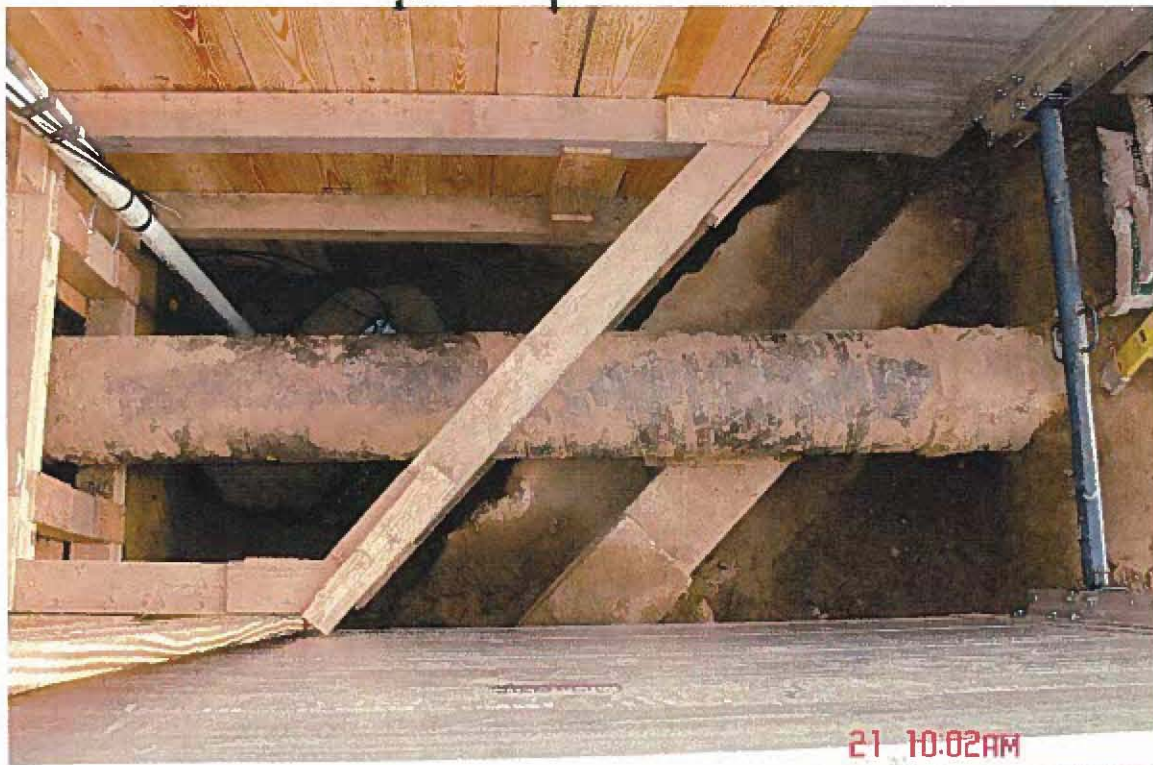
Length ~ 10 ft
