ENTERGY	ENGINEERING STANDARD	EN-EP-S-002-MULTI	REV. 0
	Buried Piping and Tanks General Visual Inspection		PAGE 12 OF 12

**ATTACHMENT 7.1 INSPECTION CHECKLIST**  
Sheet 1 of 2

<b>Piping / Tank</b>	IP2 Service Water 24-inch Line 409 (WO # 279576-02)	<b>INSPECTION DATE:</b>	11/23/11
<b>ELEVATION:</b>	pipe centerline @ EL. 8'-6"; grade @ EL. 15' (approx.)	<b>LOCATION DWG:</b>	9321-2700 (Zone B-3)
		<b>INSPECTOR:</b>	M. Terpening

IP2 Service Water Lines 408 & 409 Inspections (Nov. 2011)

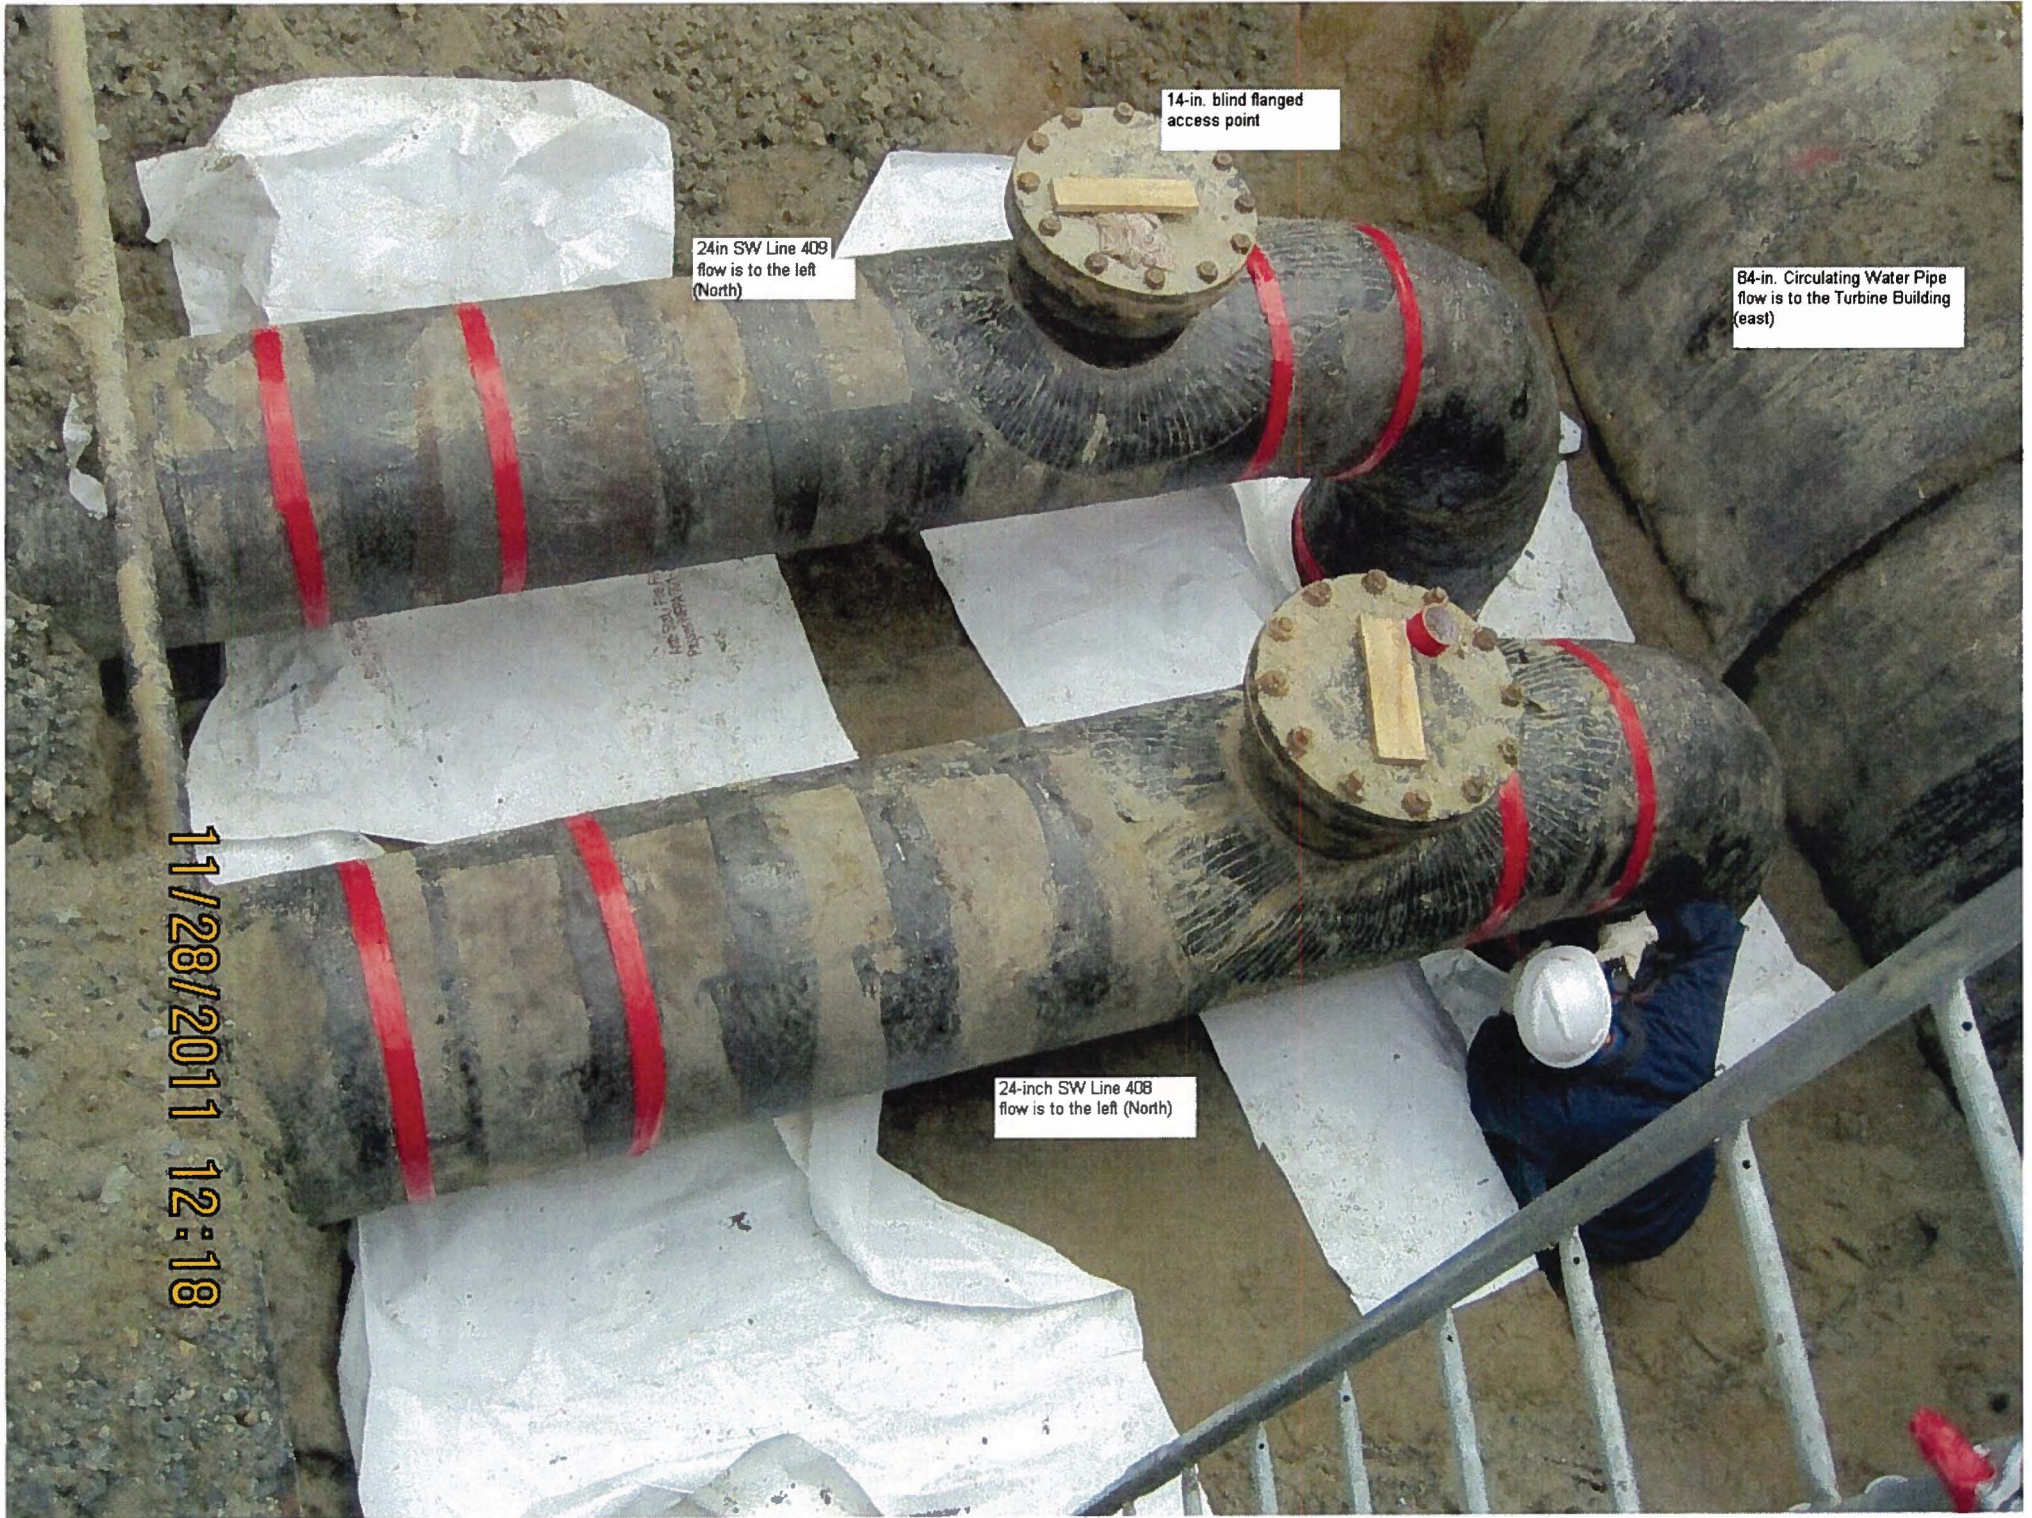
14-in. blind flanged access point

24in SW Line 409  
flow is to the left  
(North)

84-in. Circulating Water Pipe  
flow is to the Turbine Building  
(east)

24-inch SW Line 408  
flow is to the left (North)

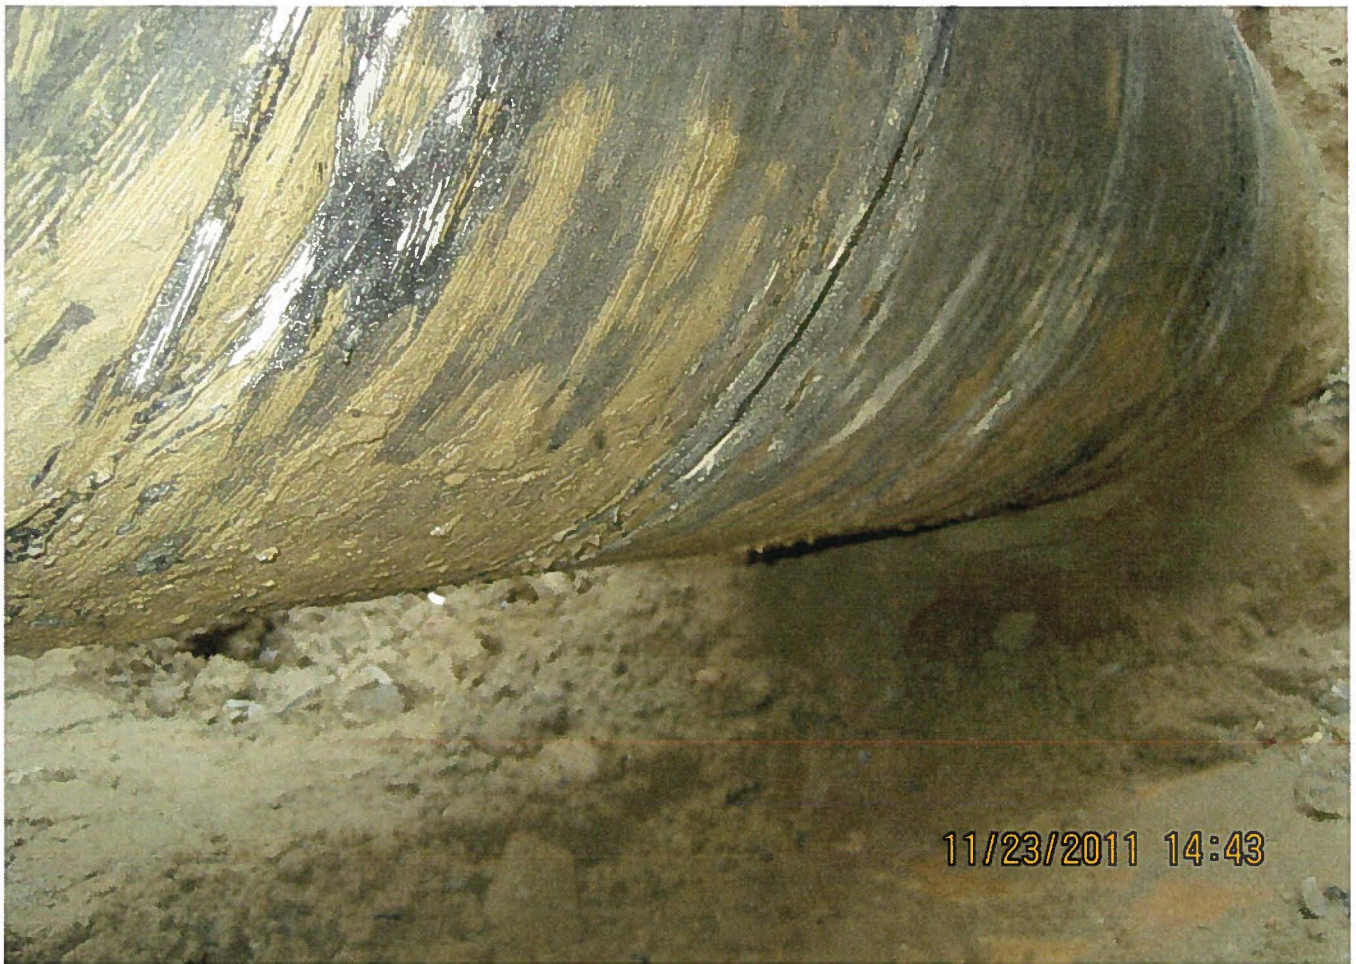
24" SW LINE 409

2" STATION AIR LINE CROSSING @ 90°

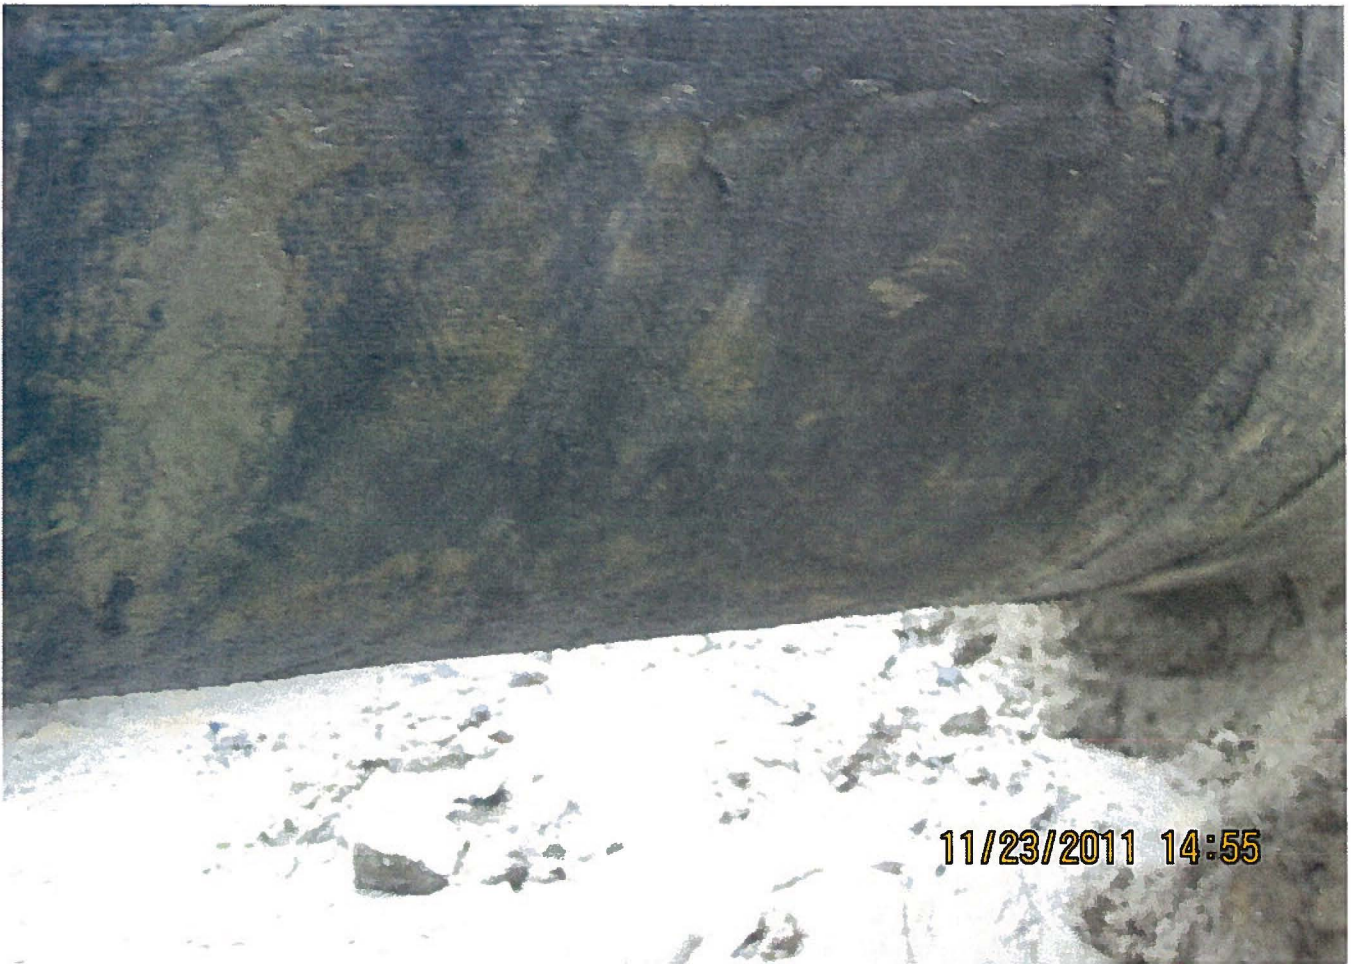
5. ANY EMBRITTLEMENT (COATING)?	<input checked="" type="checkbox"/>	<input type="checkbox"/>	
6. ANY EMBEDDED ROCKS (COATING AND/OR METAL)?	<input type="checkbox"/>	<input checked="" type="checkbox"/>	small, fine cracks in top layer of wrap, but no unprotected metal

FINE CRACKS IN TOP LAYER OF WRAP ↓
