ENTERGY	ENGINEERING STANDARD	EN-EP-S-002-MULTI	REV. 0
	Buried Piping and Tanks General Visual Inspection		PAGE 12 OF 12

<b>Piping / Tank</b>	<b>IP2 Service Water 24-inch Line</b>	<b>INSPECTION DATE:</b>	<b>11/22/2011</b>
	<b>408 (WO # 279576-02)</b>		
	pipe c-line @ EL. 8'-6"; grade @ El. 15' (approx.)	<b>9321-2700 (Zone B-3)</b>	
<b>ELEVATION:</b>	<b>LOCATION DWG:</b>	<b>INSPECTOR:</b>	<b>M. Terpening</b>

IP2 Service Water Lines 408 & 409 Inspections (Nov. 2011)

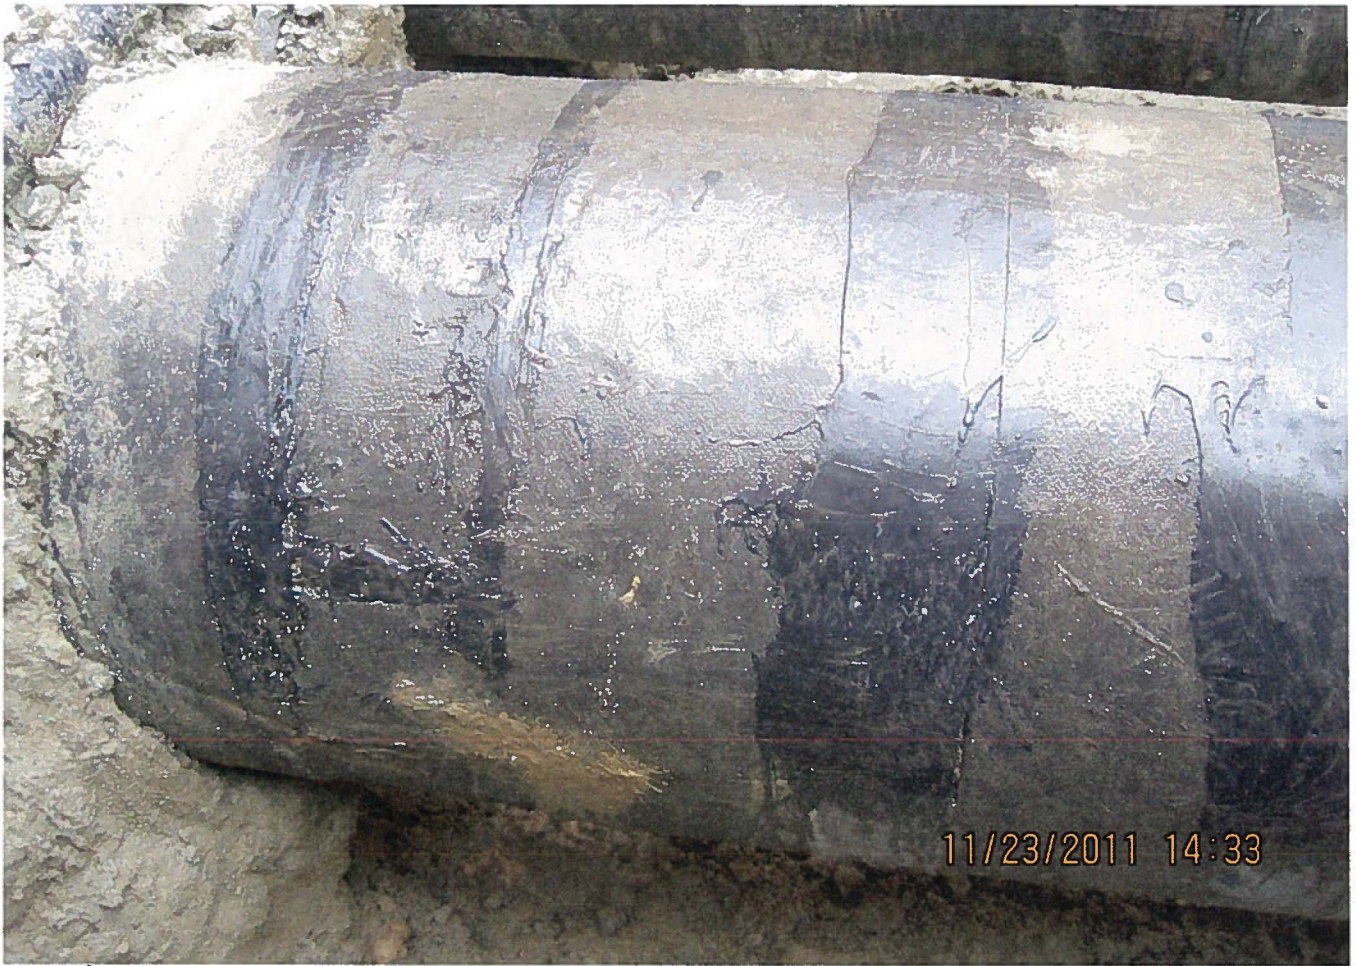
↑ NORTH END, LOOKING EAST & DOWN

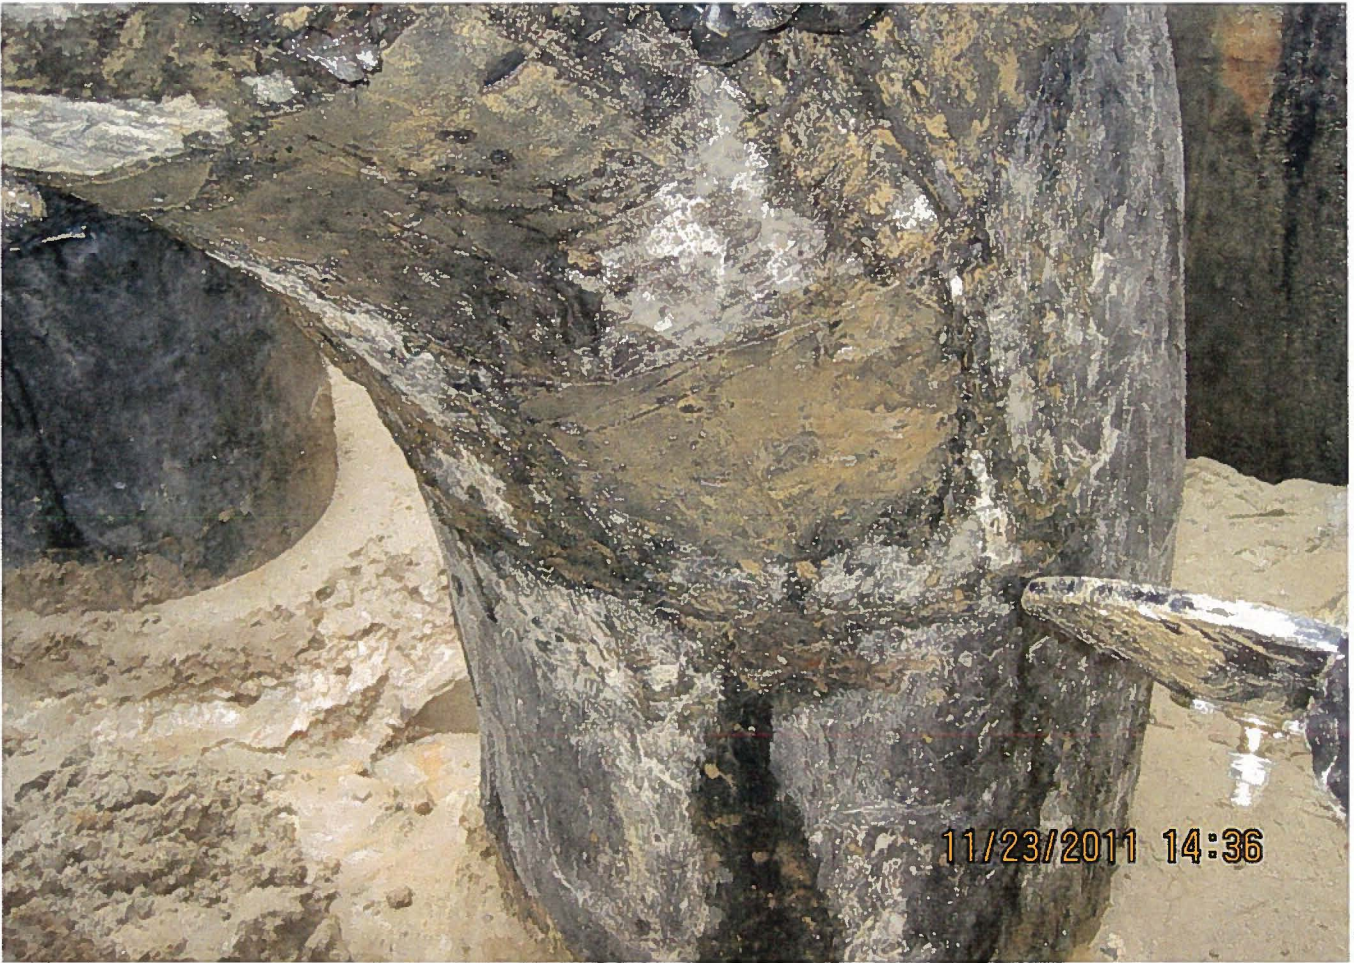
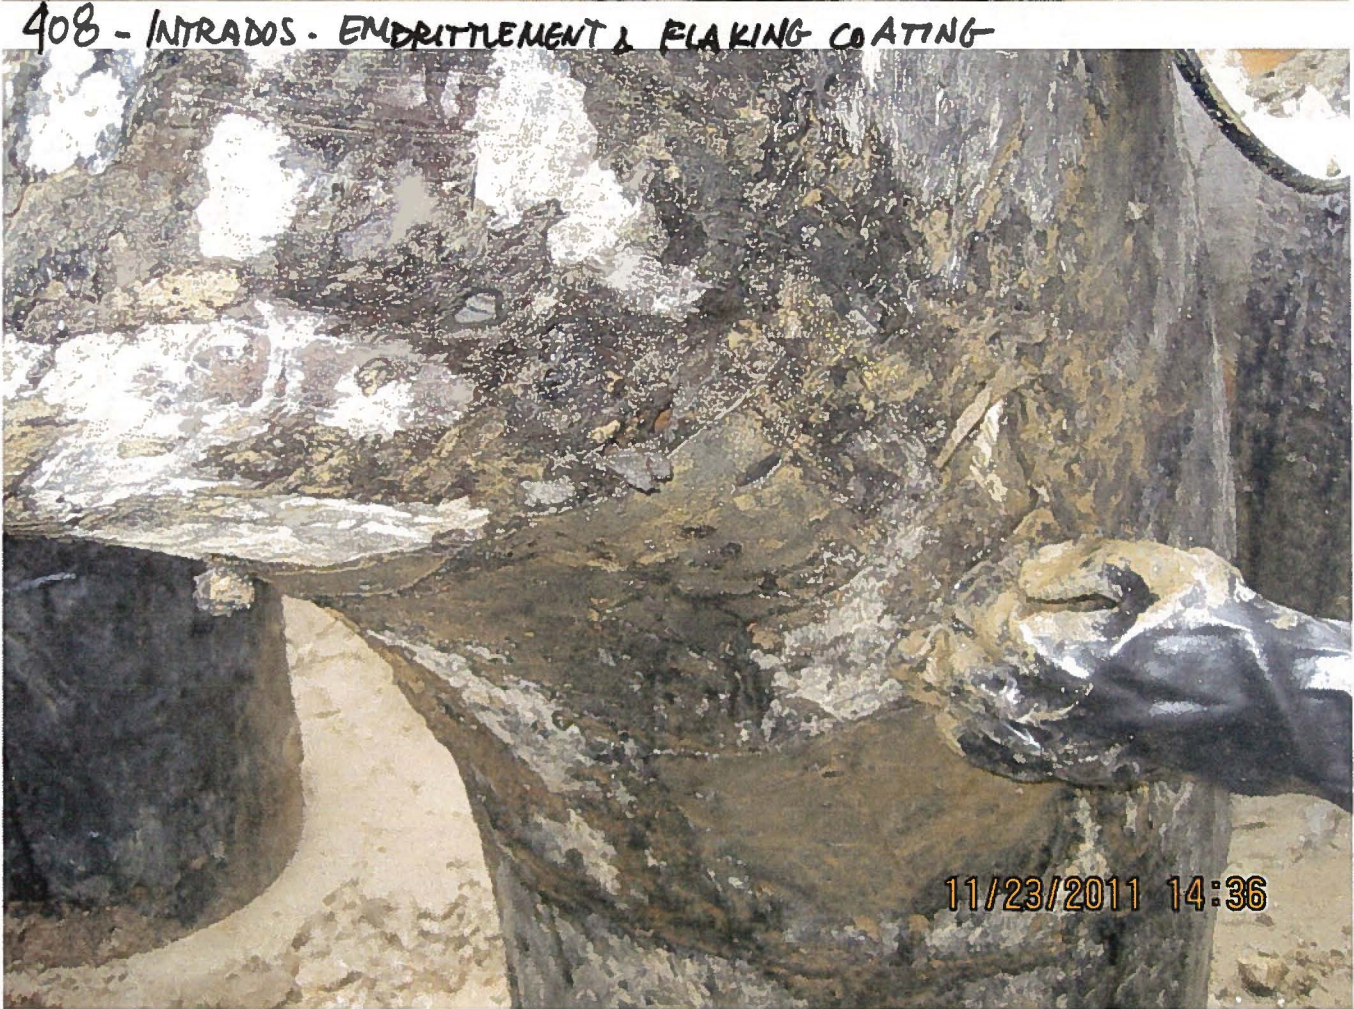
- Line 408 90 deg elbow, at the inner radius, had an area of coating that had separated from the pipe and came apart upon application of finger pressure. When probed the area of coating that had come off was estimated to be approx. a one ft. square.

LINE 408 INTRADOS COATING EMBRITTLEMENT

408 - INTRADOS - EMBRITTLEMENT & FLAKING COATING

I inspected the coatings on service water lines 408 & 409 in the excavation on the riverfront. For the most part the coatings are in fairly good shape. My main concern is for the condition of the elbow on Line 408, riverside pipe, for the proper application of a coating repair. Thus this elbow needs to be stripped of the existing coating and wrap down to the pipe. The condition of the surface shall be roughened for the application of the new coating repair system. The inspection sites and the adjacent several inches of coatings shall also be roughened for the acceptance of the new coating.

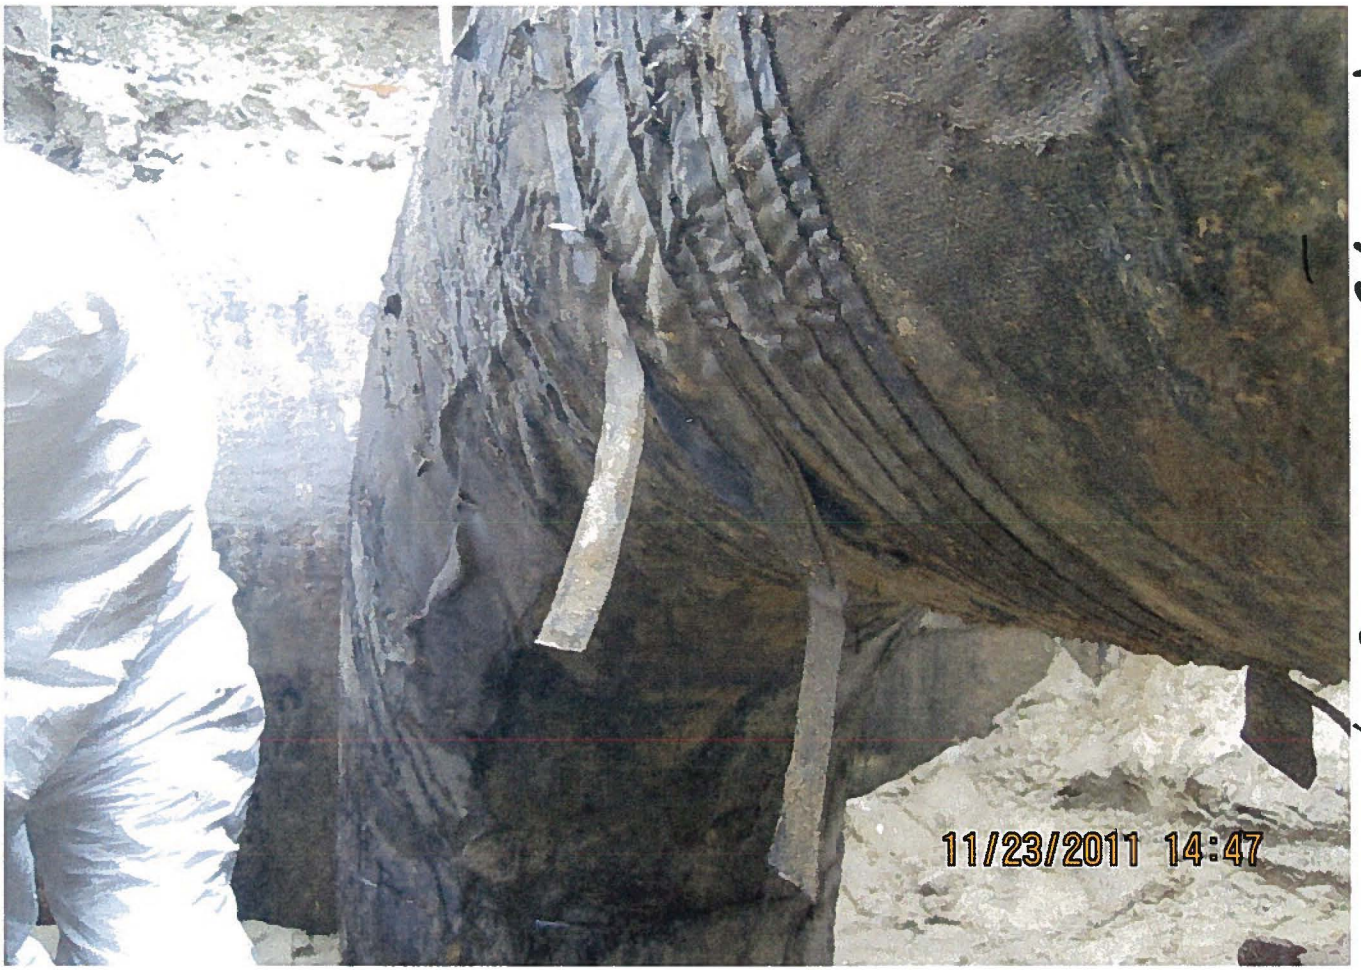
HORIZ TO ELBOW (7/6 SIDE)

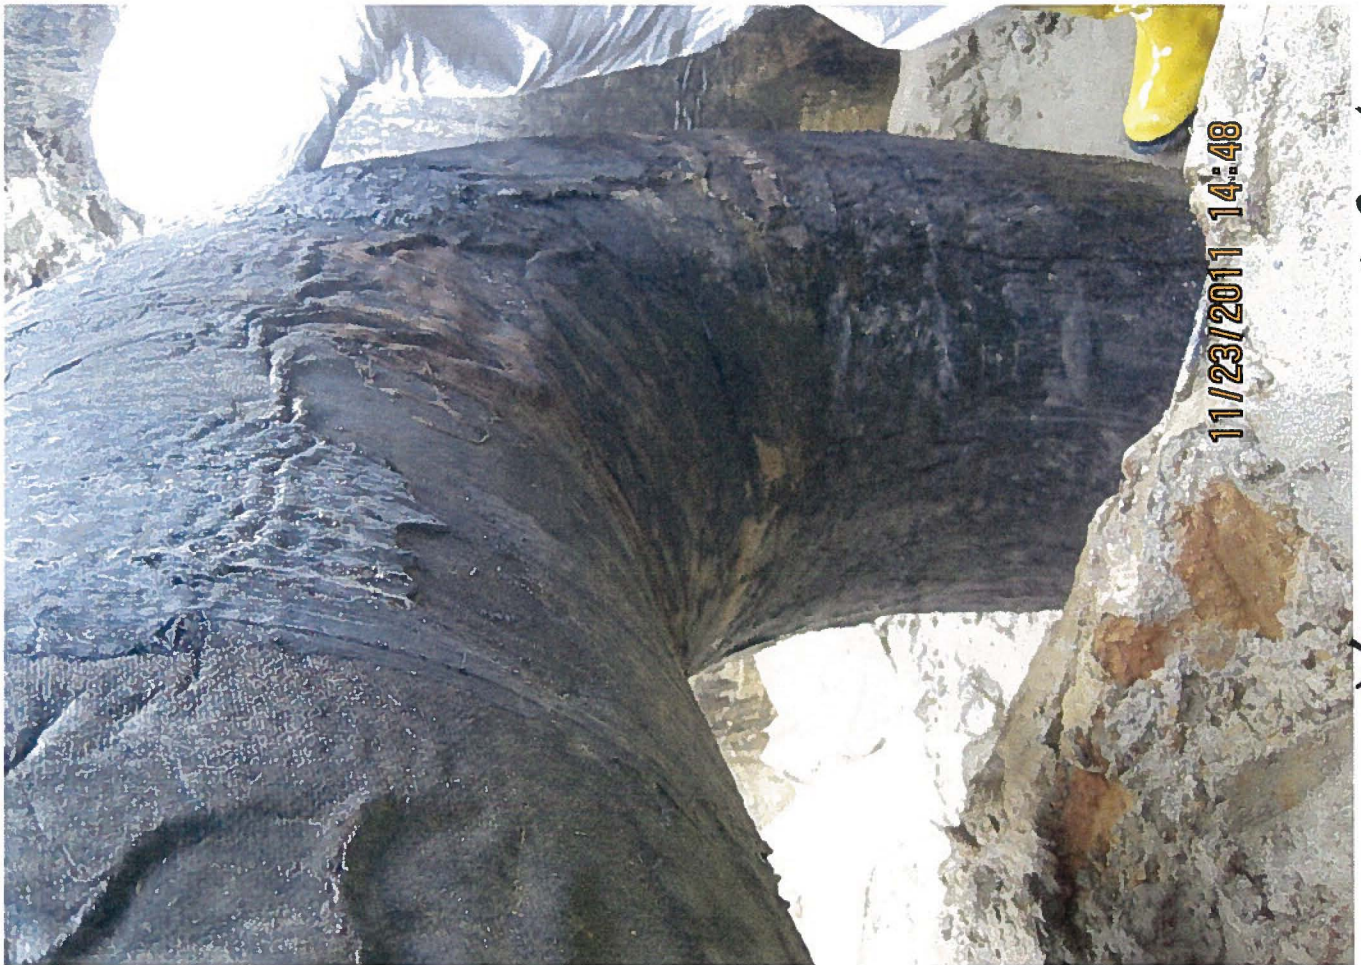
R/S OF LINE#08 ELBOW

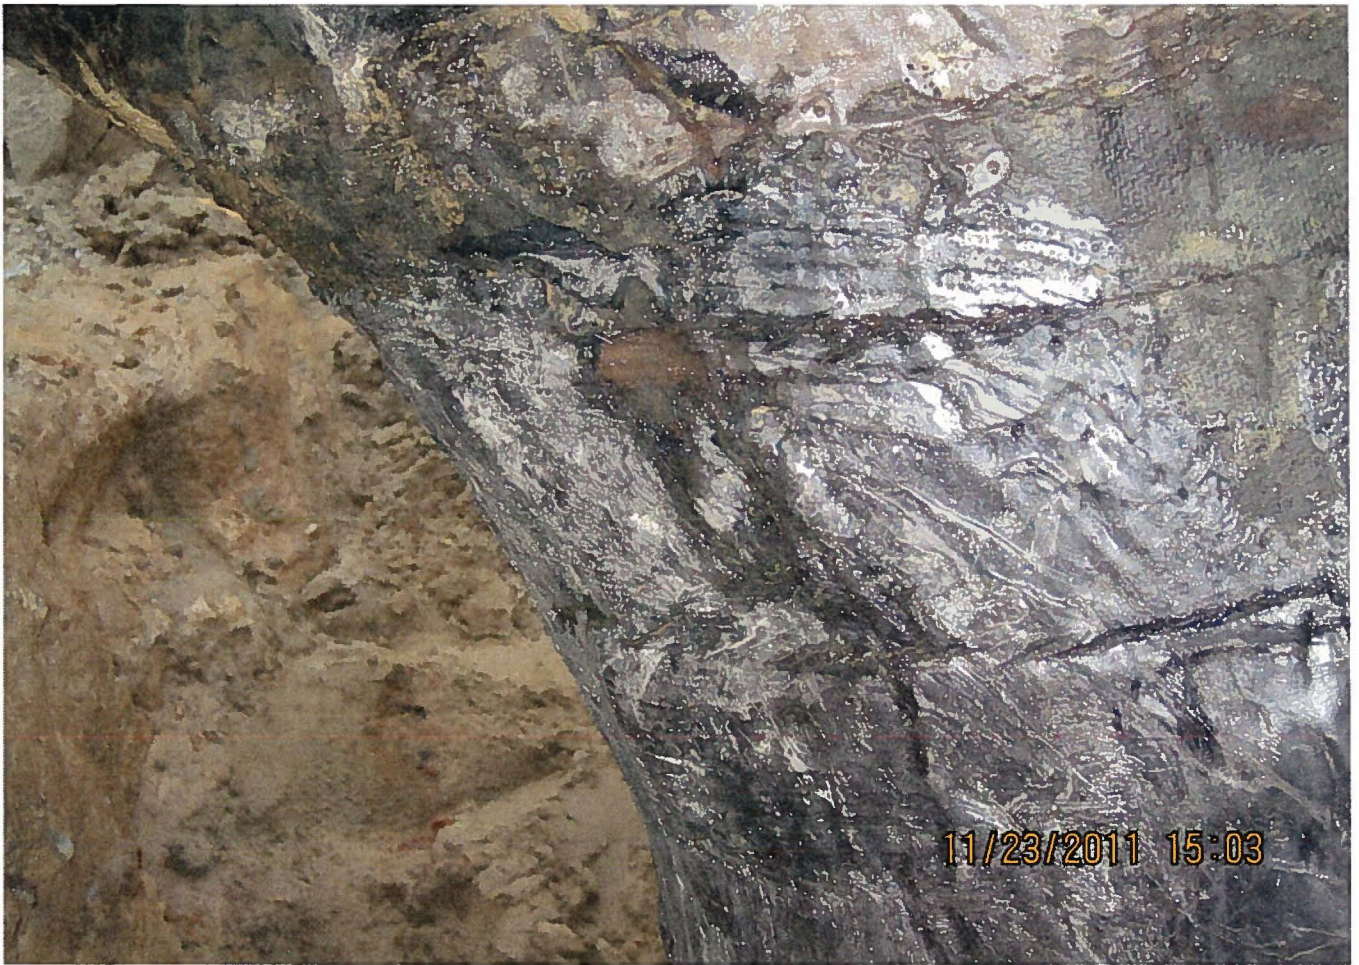
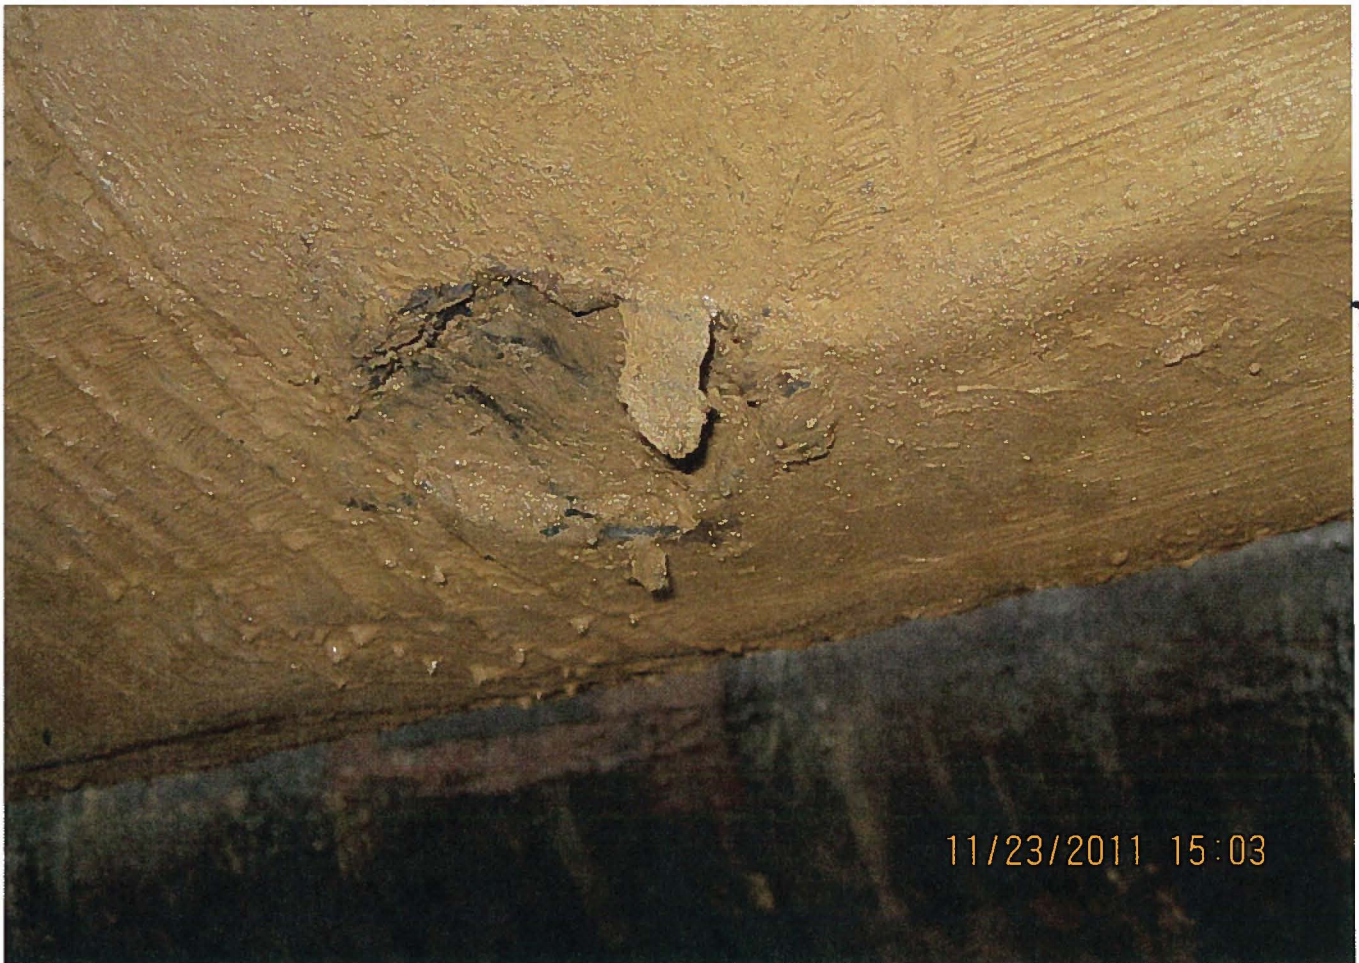
- On Line 408 (river side) have one area (approx. 4 sq. in) on the underside of the straight section of pipe that separated from the pipe and came off with the application of moderate finger pressure.

UNDERSIDE OF HORIZ. SECTION  
QUARTER SIZE COATING DEFECT/DAMAGE
