SUBJECT: LER: 2012-005, Transformer Installation Error Causes Loss of Off-Site
Power
James A. FitzPatrick Nuclear Power Plant
Docket No. 50-333
License No. DPR-59

1. FACILITY NAME James A. FitzPatrick Nuclear Power Plant		2. DOCKET NUMBER 05000333	3. PAGE 1 OF 7														
4. TITLE Transformer Installation Error Causes Loss of Off-Site Power

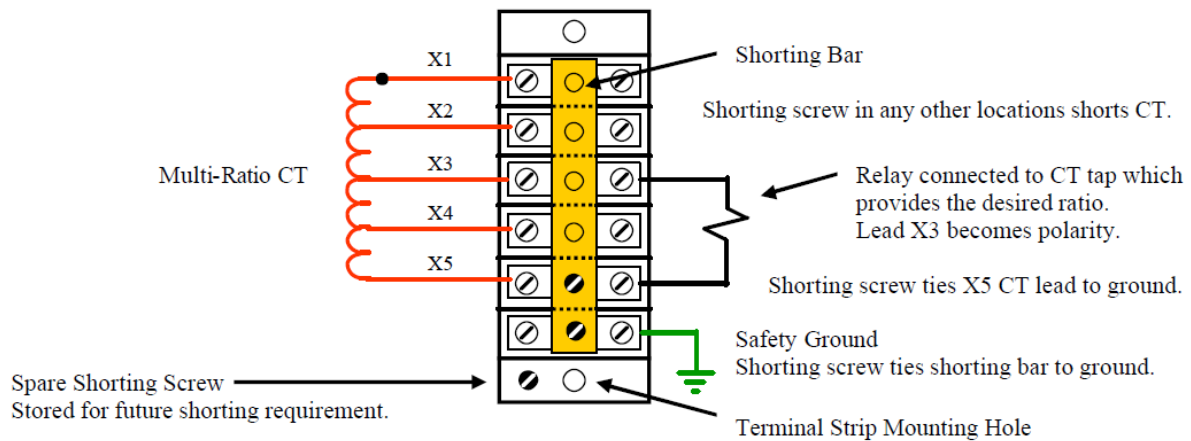
**Figure: CT Termination Block**

The transformer CT lead connections are made in the transformer control panel on shorting terminal blocks. These shorting terminal blocks are equipped with a conductive bar (shorting bar), which is isolated from the block's termination points.

The shorting bar is grounded at one end and equipped with holes over each termination point. The holes are used to allow the installation of a machine screw to connect the shorting bar to a termination point, thereby grounding the CT. See Figure below:

The transformers are shipped from the factory with the CT shorting bars installed. The manufacturer installed the shorting bars to in order to prevent the generation of high voltages in the CT. This precaution protects equipment and personnel safety during transport and storage. The drawing with this factory configuration was included with the work order package used during installation.

The drawing given to the installing contractor was incorrect and showed the shorting bars installed in the CTs. The work order however, contained the appropriate step to remove the shorting bars on the CT terminal blocks for CTs that would be placed in service. Workers questioned this discrepancy and after some review, were directed by the responsible JAF engineer to install the transformer per the drawing. The supervisor for the installing contractor subsequently signed off the work order step indicating the shorting bars were removed and that the step had been verified by engineering.

The root cause of this event was an individual not performing the work order steps as written. The contributing causes were conflicting information between the drawing and the work order instructions; inadequate verbal communication between the project manager and the responsible engineer; and inadequate review of the engineering change in accordance with new requirements specified in revision 6 of EN-DC-149, "Acceptance of Vendor Documents."

- Performance counseling was performed by the contractor companies for individuals involved with this event.
- The drawing has been updated to reflect the current operational configuration.
- The CT configuration for both RSSTs, 71T-2 and 71T-3, was corrected.
